# Unique Application of Epoxy Repair Gel to Eliminate Draft-Tube Surface Wear and Cavitation Potentially Improving Turbine Power Generation Efficiency

Norm Klapper / PEC  
Milamar Coatings, LLC  
Division of CASS POLYMERS  
Oklahoma, City, OK

ICRI - San Juan, P.R.  
March 16-21, 2016

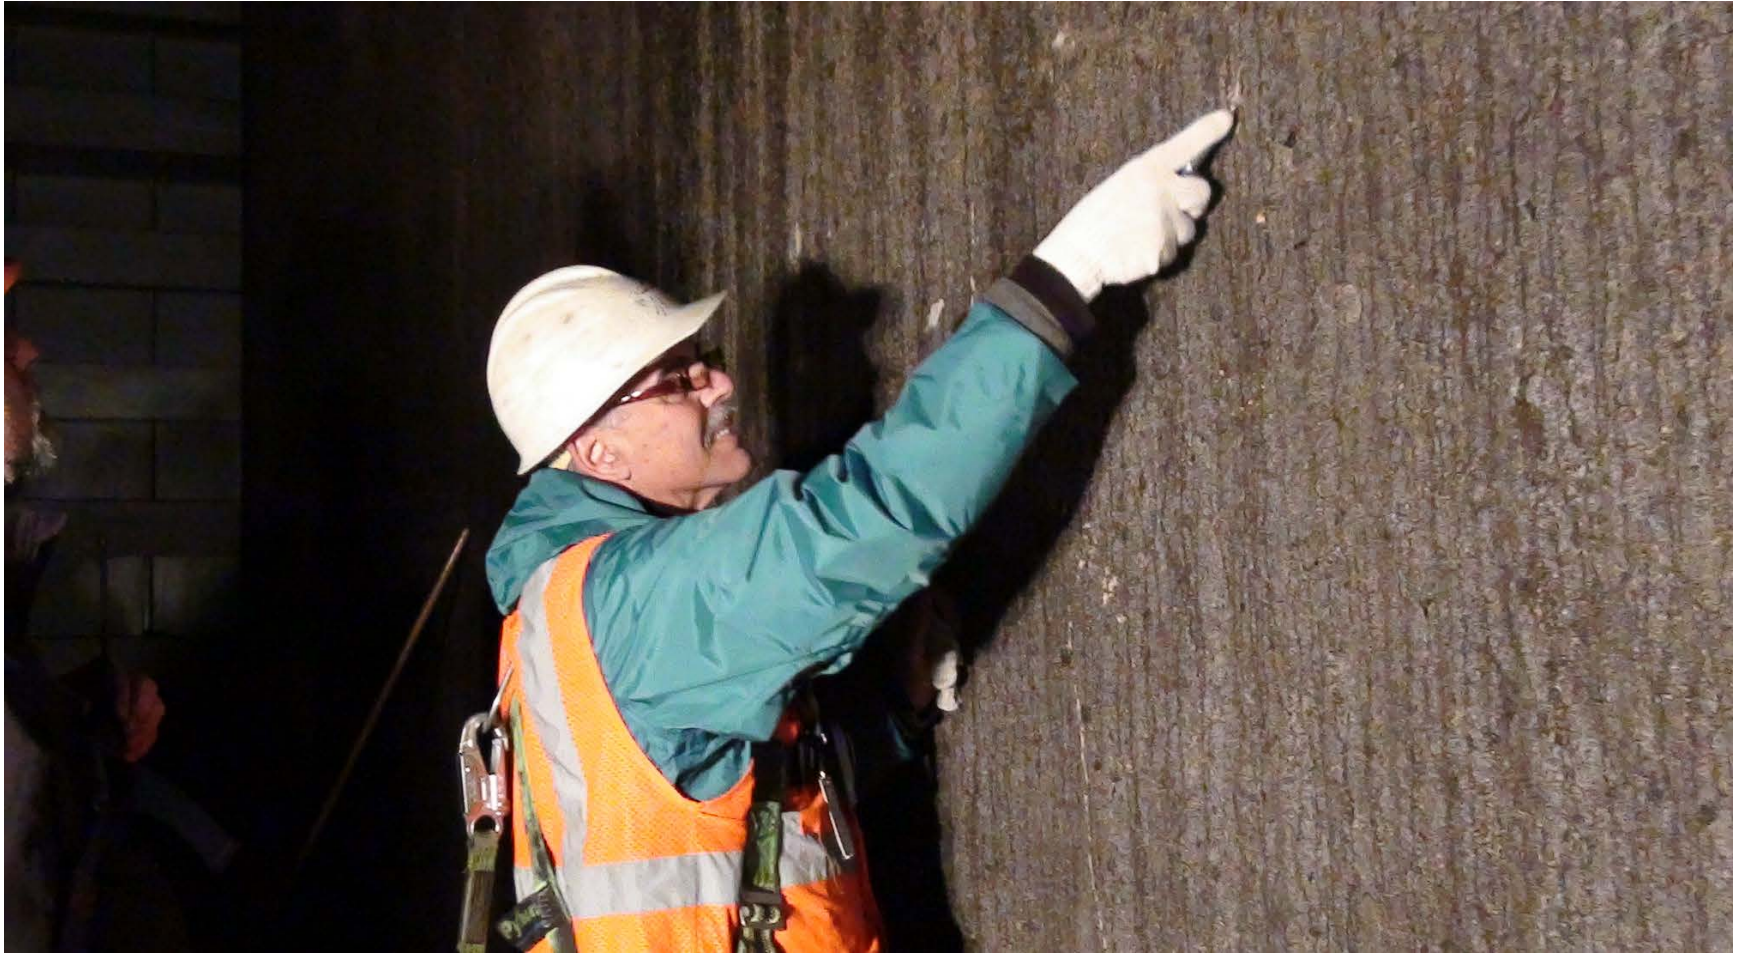
# Initial Site Inspection

- Extremely deep wear/erosion from abrasion on entire concrete surface
  - $\frac{1}{2}$ " to  $\frac{3}{4}$ " deep linear wear lines, over entire 6400 SF surface, 40" x 40' x (4) surfaces
  - Holes, severe surface wear
  - Dirt and debris deeply impregnated in surface
- Potential cavitation from draft tube outflow
  - Back-pressure on water flow exiting from turbine
- Poor flow characteristics due to cavitation
  - Hazen-Williams friction factor

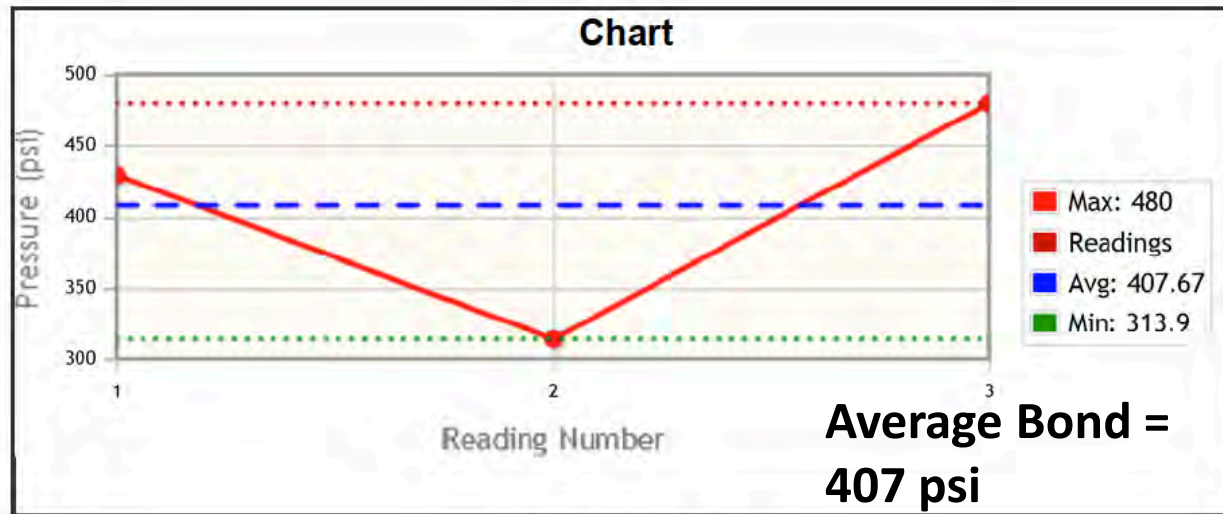
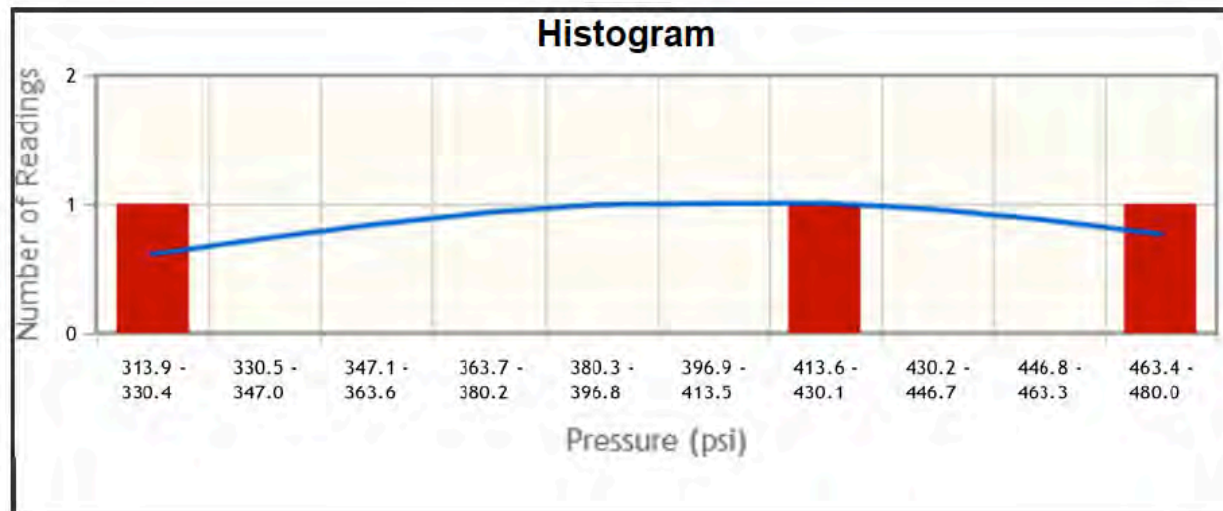
# Pull Tests on Prepared Bare Concrete

Andritz Hydro      Draft Tube Adhesion Test: Concrete Only      Test Date: 12/16/13

#	$\bar{x}$	$\sigma$	↓	↑
Exist Concrete	3	407.67	85.10	313.9	480.0

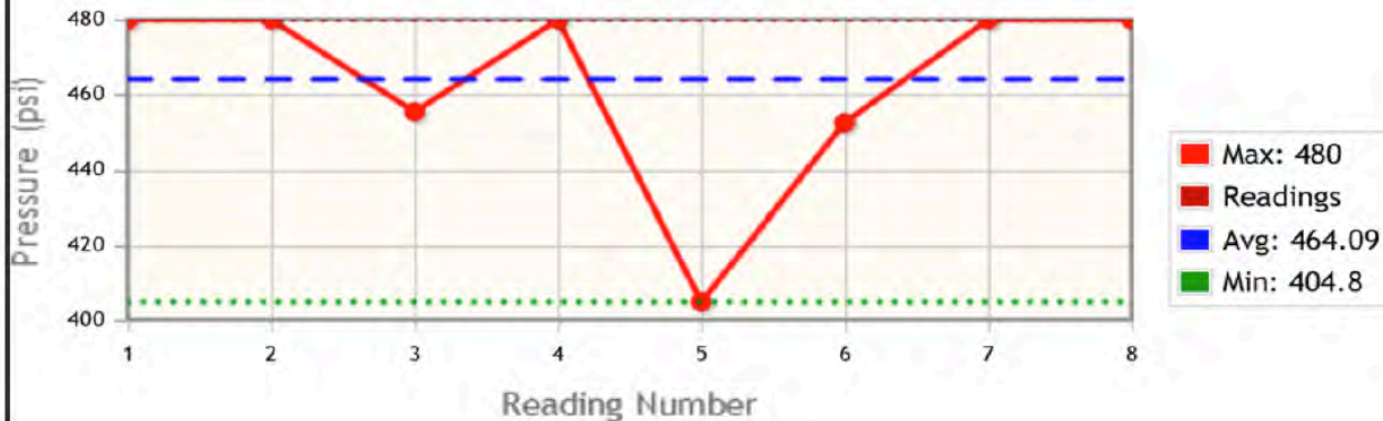
Reading #	psi	Ignore	Notes
1	480.0	<input type="checkbox"/>	Rate 8.0 psi/sec, Dur. 57.66 sec, Dolly 50 mm.
2	480.0	<input type="checkbox"/>	Rate 8.0 psi/sec, Dur. 57.66 sec, Dolly 50 mm.
3	455.4	<input type="checkbox"/>	Rate 8.0 psi/sec, Dur. 54.68 sec, Dolly 50 mm.
4	480.0	<input type="checkbox"/>	Rate 8.0 psi/sec, Dur. 57.66 sec, Dolly 50 mm.
5	404.8	<input type="checkbox"/>	Rate 8.0 psi/sec, Dur. 48.40 sec, Dolly 50 mm.
6	452.5	<input type="checkbox"/>	Rate 8.0 psi/sec, Dur. 54.30 sec, Dolly 50 mm.
7	480.0	<input type="checkbox"/>	Rate 8.0 psi/sec, Dur. 57.60 sec, Dolly 50 mm.
8	480.0	<input type="checkbox"/>	Rate 8.0 psi/sec, Dur. 57.60 sec, Dolly 50 mm.

**Average Bond =  
464 psi  
(concrete failed)**

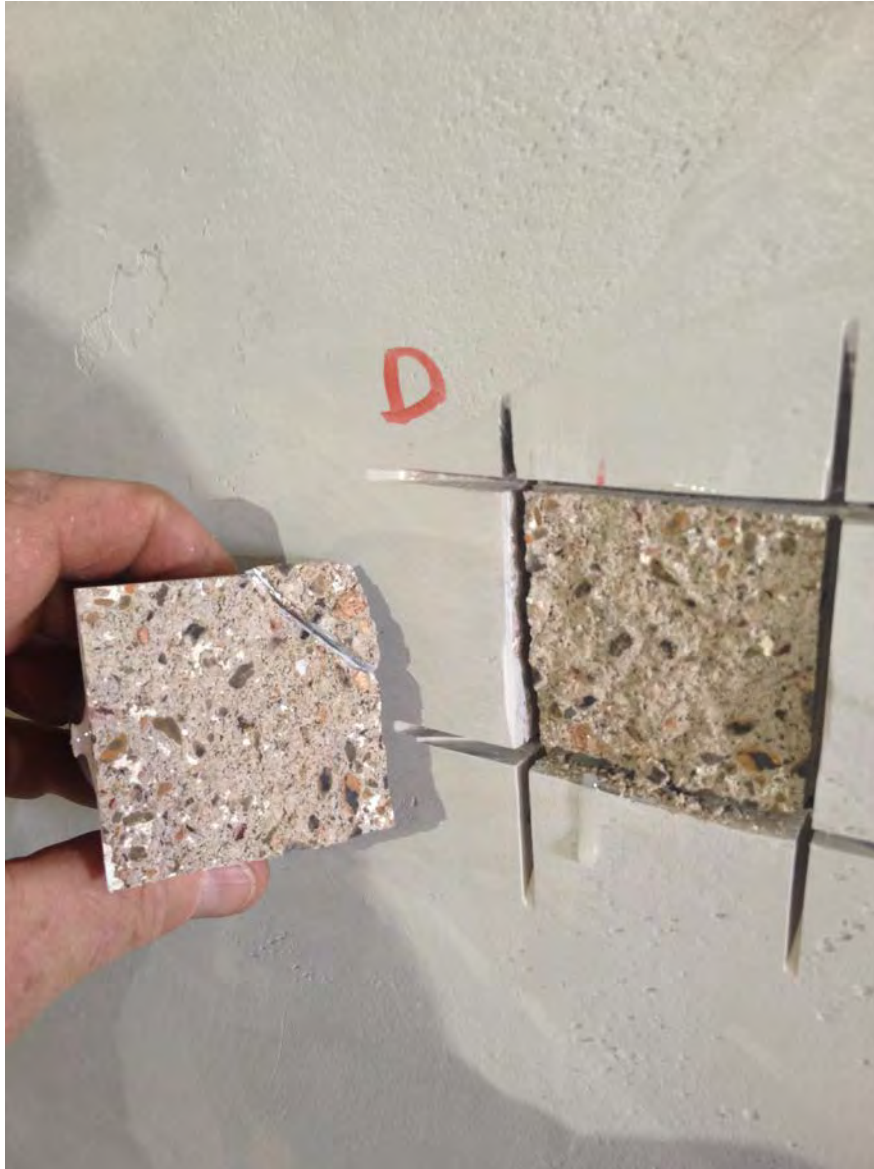
Elcometer™ Pull Test  
Concrete Failure @ 380 psi  
Bond Strength of Epoxy Gel  
Was Adequate – Note Concrete  
Present on Surface
