**Preliminary Structural Evaluation of Historic Water Main Valve Vaults for Rehabilitation Prioritization in Minneapolis**  
 ICRI Fall Convention – Cleveland, Ohio

Presented by:  
 Mike Mitchell, P.E., S.E.

November 9, 2016

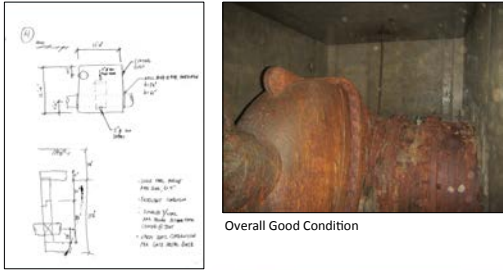
### Structure Type: Precast (1990 - 2002)

Overall Good Condition

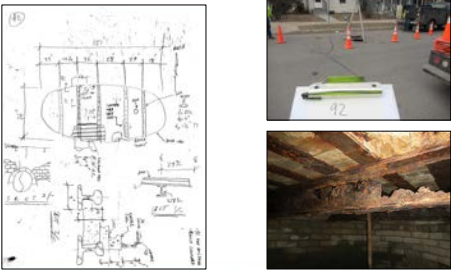
42

### Critical Vaults

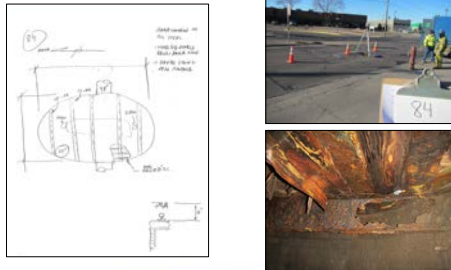
84

### Critical Vaults

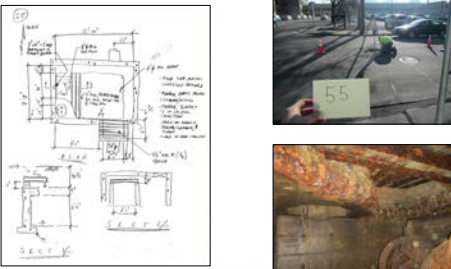
55

### Critical Vaults

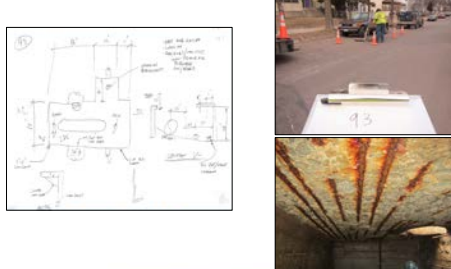
93

### Critical Vaults
