Rehabilitation of Historical Arch Railway Bridge in Bangkok

2000 Award of
Excellence Winner,
Transportation Category

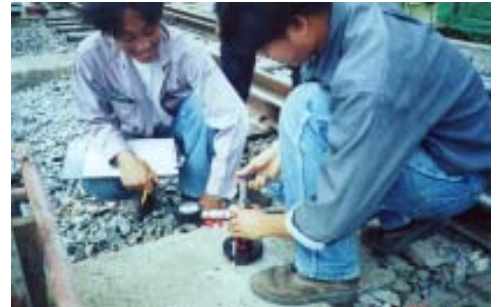
1. Old concrete was saw cut and the deteriorated concrete was removed.
2. A pneumatic needle scaler was used to remove corrosion from the affected steel.
3. The entire structure was sandblasted.
4. A bonding agent was applied, followed by a cementitious anti-corrosion coating and patching with repair mortar.
5. Narrow cracks were repaired by use of low-viscosity epoxy injection. Major crack areas were stitched with carbon-fiber composites.

The sequence of the concrete repair work was as follows:

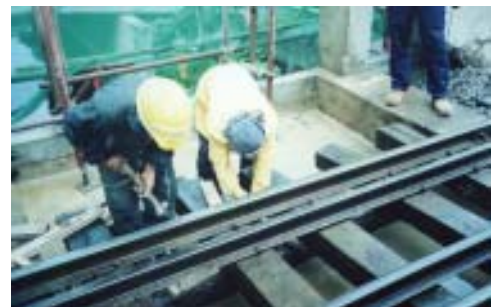
1. Epoxy putty was applied for leveling and smoothing the surface.
2. An epoxy primer was applied to improve the bond strength to the system.
3. Fiber sheets were installed with an epoxy adhesive to strengthen the superstructure.
4. A latex coating mixed with cementitious materials was applied over the carbon fiber to add UV protection. The repair work was completed with an application of a colored and textured finish.
5. Pull-off tests were repeated. It was found that the fiber sheet had bonded very well with the concrete surface, and no bond failures were found.

Proper preparation of the concrete surfaces before the installation of carbon-fiber sheets was very important to the success of the operation. Surface preparation of concrete consisted of sandblasting of the entire surface after all required concrete repair procedures were completed. To complete the carbon fiber installation:
