# Nondestructive Evaluation (NDE) Methods for Quality Assurance of Epoxy Injection Crack Repairs

By Yajai Promboon, Ph.D., Larry D. Olson, P.E., and John Lund, P.E.

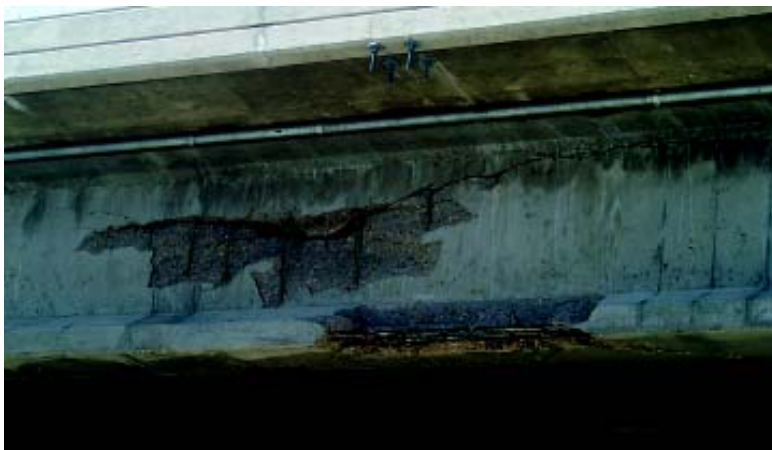
The impact on the bottom flange of the bridge girder caused the girder to rotate inward, toward the center of the bridge. The rotation was resisted by the concrete diaphragm attached to the web of the girder, causing a large amount of spalling and cracking to occur in the region of the diaphragm. The full- and partial-depth spalled web areas were repaired by chipping out all loose or damaged concrete using light (15 lb) electric chipping hammers, so that the repaired areas were approximately rectangular in shape. The edges of the repaired areas were cut perpendicular to the girder, a minimum of  $\frac{3}{4}$  inch deep. The repair area was presaturated with water and the surface allowed to air-dry to a saturated surface-dry condition. A polymer-modified structural repair mortar was installed using the form-and-pour method and cured for 7 days. After the web repairs were complete, the bridge girder was preloaded and the bottom flange repairs were completed as detailed above. After the web and flange repairs were complete, approximately 800 linear feet of cracks were injected with epoxy (Figure 2 shows beam prior to epoxy injection; Figure 3 shows injection ports in place). As part of the overall quality control process, inspections were performed by the structural engineer prior to placement of the repair mortar and at other critical times during the repair work.

Fig. 1: Damage on the eastmost concrete girder before the repairs

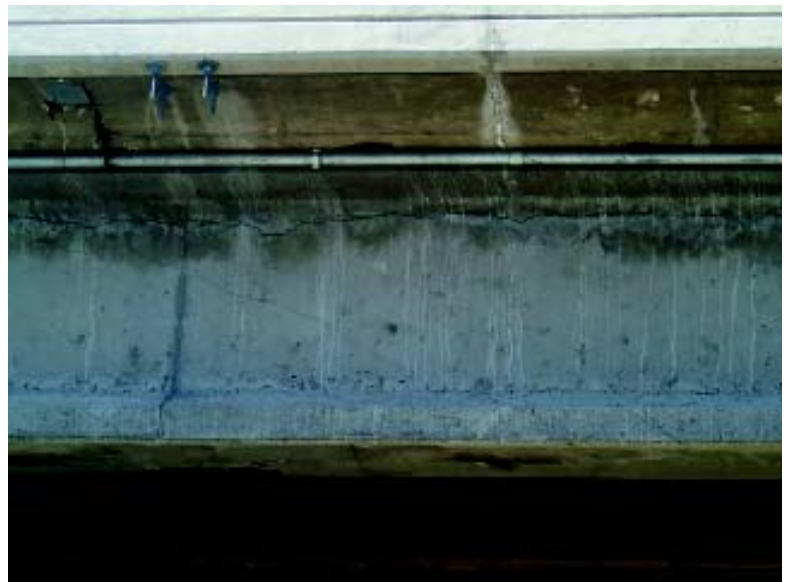
Fig. 2: The damaged girder prior to epoxy injection repairs

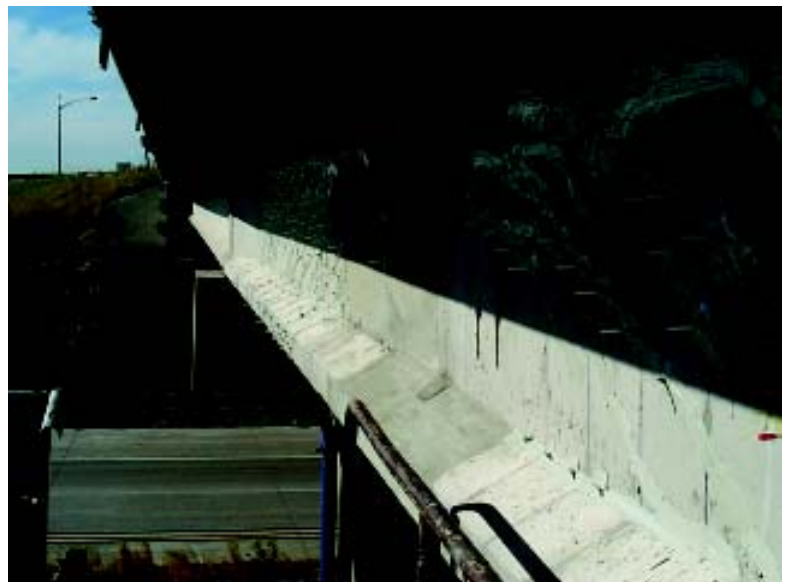
Fig. 3: The damaged girder with injection ports in place

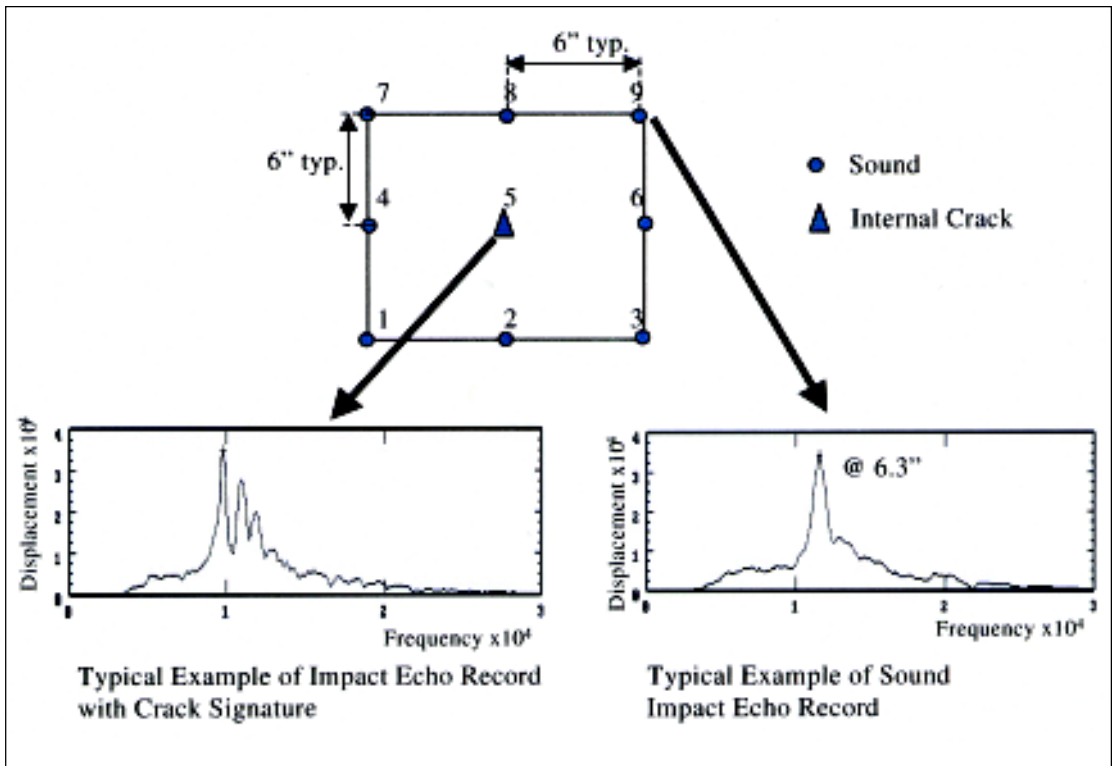
This section presents example IE and UPV results from one test station (Station O) on the repaired bridge girder. The graphical IE frequency results from Station O on the web area are shown in Figure 8. The IE data from Location 5 shows a signature of internal cracking (unfilled), as can be seen by multiple echo peaks in the frequency domain. A typical IE record indicating sound concrete at Location 9 is also included in Figure 8. Data from the rest of the tested points on Station O were similar to data from Location 9, indicating sound concrete with no internal cracks. The typical sound concrete record from Location 9 shows a resonant echo peak from the back wall of the web at a frequency corresponding to a depth of 6.3 inches (using Equation 1), which is close to the design thickness of 6.0 inches. The IE record with a crack

signature shows multiple peaks resonating from different depths, which indicates a strong possibility of unfilled, internal concrete cracking at that point.

Fig. 8: Example IE results showing records of sound and cracked concrete

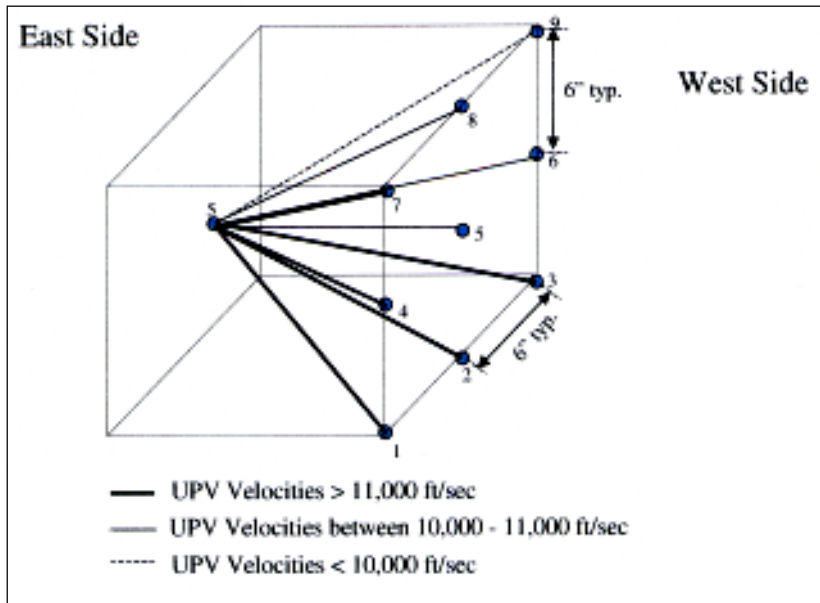
Graphical UPV test results from Station O are presented in Figure 9. The UPV results were classified into three categories based on the UPV velocity results. The first category contained UPV velocities greater than 11,000 ft/sec; the second category contained UPV velocities between 10,000 and 11,000 ft/sec; and the last category contained UPV velocities below 10,000 ft/sec. As discussed previously, higher velocities normally indicate higher concrete quality. For Station O,

Fig. 9: Example ultrasonic pulse velocity results from Station O

the UPV velocity results indicated that the concrete qualities for Paths 5-1, 5-2, 5-3, 5-4, and 5-7 were higher; the concrete qualities for Paths 5-5, 5-8, and 5-6 were lower; and those for Path 5-9 were in the lowest-quality category.

Based on the UPV results, an area of unfilled cracks was located on the south corner of Station O. From the IE tests, the results from Location 9 were sound with no internal cracks. Taken together, the NDE results showed that the unfilled cracks lie in an angle across Paths 5-5, 5-6, and 5-9, with a wider open area between Path 5-9 and a tighter crack tip between Path 5-5. The unfilled cracks did not appear to spread to the south end (Location 9) of Station O, since the IE results from Location 9 were sound.
