# Sea Colony Promenade Repairs

By Brian Daley

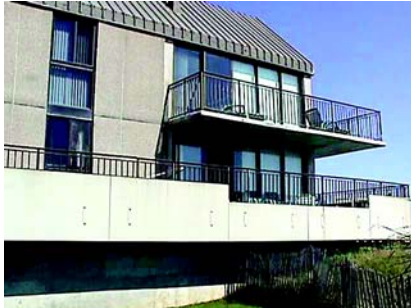
Promenade parapet panels

Along both ocean-facing and west-facing perimeters of the conventionally reinforced portion of the promenade, vertically mounted precast concrete panels had been installed as part of the original construction to serve as parapet walls for safety and for appearance. These panels were mounted by welding their embed plates to angles welded on the promenade deck.

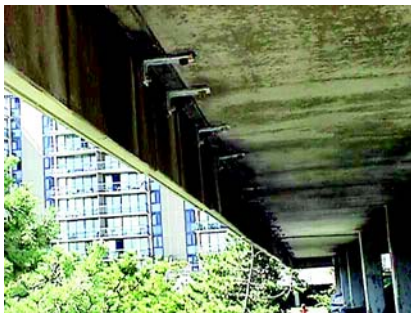
Bottom view of through-bolted angles

When these attachments started to fail due to corrosion from exposure during the 1990s, bolts and restraining bars were drilled through and mounted on the panels to secure them to the angles.

The angles were also bolted through the deck slab to secure them to the concrete structure. The metal strap bars mounted on the panels significantly detracted from their original appearance.

A greater problem was that the ferrous metal hardware used to make these attachment configurations soon began to rust in the humid, salty beach air. This rusting metal, in turn, caused concrete cracking and spalling around the bolt hole penetrations in the promenade. At the same time, areas of unprotected concrete slab top, underside, beams, and columns in both the reinforced and post-tension areas had deteriorated and failed over the years. In some cases, this was due to inadequate concrete cover over the reinforcing steel or PT cables when the project was first constructed. In other areas, it was due to shrinkage cracks expanding from freezing-and-thawing cycles, which allowed water penetration to reach the reinforcing steel, causing cracking and spalling from rust. A third cause of concrete failure was the railing around the perimeter of the post-tension half of the promenade, whose embedded posts rusted, causing cracking and spalling of the deck around them.

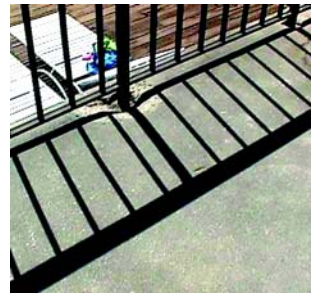
Rail embed spall

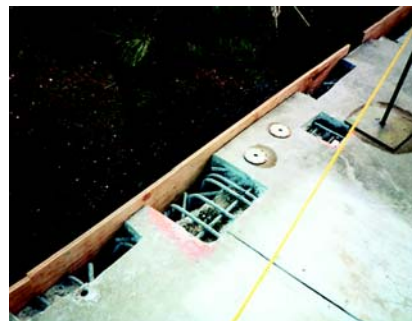
*Parapet panels off and slab demolished*

Using shooting boom forklifts to support the parapet panels, the restoration contractor released all panel anchor bolts and removed all perimeter parapet panels. Railings were removed from interior locations where they were to be replaced. Failing concrete at all parapet angle locations and at all rail post embed locations was demolished to prepare for new concrete patch construction.

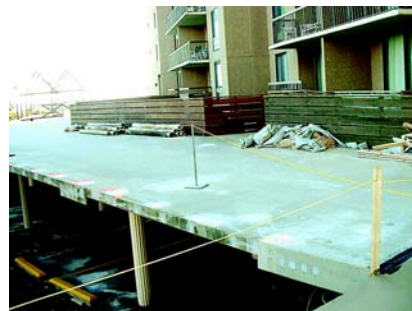
*Slab and edge repairs complete*

In cooperation with the engineer's inspector, the contractor located all additional hollow and spalled concrete in the main field of the promenade section and demolished it with chipping hammers to reach sound material. The exposed reinforcing steel was cleaned and coated. Concrete patching was then performed. Appropriate bag-mix repair concrete was used for top surface patches, for slab edge reconstructions, and for vertical and soffit repairs. Wing-gland mechanical expansion joints were installed at junctions between the test area and surrounding promenade sections. As weather improved in the spring, beams and columns on the undersides of the promenade were coated with elastomeric coating to protect the concrete and inhibit corrosion from the salt air.

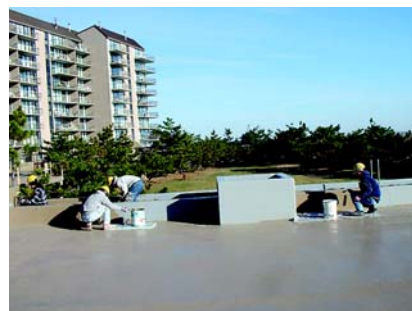
*Applying urethane coating*

On the top of the promenade, the deck was first prepared by a high-pressure power wash to open

concrete pores for adequate bond, then a primer and multi-coat urethane pedestrian coating system was applied to the top surface, edges, and planter exteriors. Finally, sections of stainless steel all-thread were epoxy-anchored in the promenade slab, and new anodized aluminum rails were bolted onto the all-thread anchors, surface-mounting the rails at the perimeter of the promenade, along an elevation change within the promenade, and at all stair transitions between levels. Following completion of the test area, the restoration contractor demobilized from the site through the summer of 2001 to allow summer residents and vacationers use of the property without disturbance from construction.

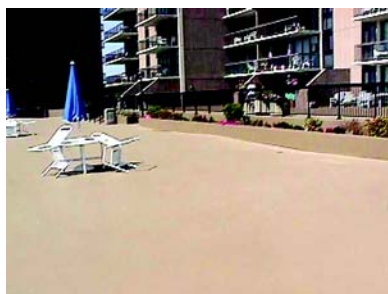
*Promenade coated with planters finished*
