# Repairs to Historic Centralia Dam

By Michael J. Moroni

## Centralia Dam

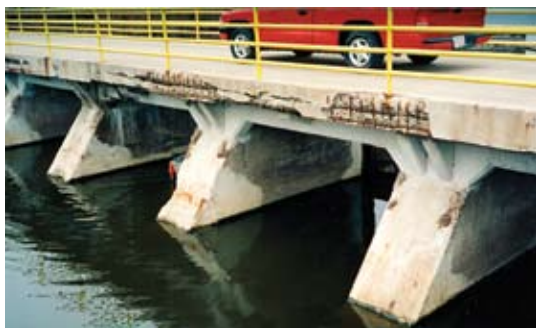
*Guardlock bridge deck prior to repairs (4/12/00).*

The guardlock bridge deck and superstructure were in seriously poor condition. Evidence of delamination, corroded reinforcing steel, and failing repairs was extensive. Much of the deterioration

was corrosion-induced; however, freezing-and-thawing damage was also present at the waterline of the support piers. The bridge safety railings and vehicle capacity were also found to be substandard.

Consideration was given to repair the bridge, but the anticipated life expectancy was insufficient and repair costs were near the estimated replacement cost for the bridge. Therefore, a new precast box girder bridge was designed that would give the owner 20 to 50 years of low-maintenance operation. Demolition of the bridge deck was performed in 60 ft-long (18 m) sections. The top 2.1 ft (0.64 m) of the piers were removed to accept the new precast girders and provide a consistent deck elevation.

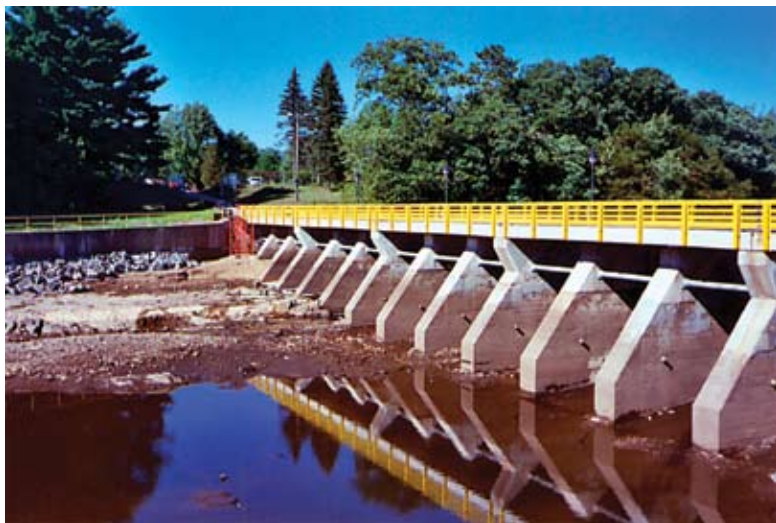
*Completed guardlock bridge deck replacement (9/12/02).*

The original guardlock bridge was a cast-in-place concrete structure that effectively pinned the top of each bridge pier. The new precast girders, however, were not going to provide top-of-pier fixity for 2/3 of the piers because only every third pier was used to support the girders. To provide fixity, pipe struts were installed between each of the piers from abutment to abutment. Struts consisted of prestressed 10 in-diameter (25 cm) pipes located near the tops of the piers.

After placing the girders and installing a cast-in-place deck, new vehicle guard railings were installed. New bridge deck lighting was installed that was consistent with 1920s period-type fixtures. Bridge replacement was completed in fall 2001 and provided safe access to the gated and overflow spillway sections for the 2002 construction season. The bridge is now approximately 4 ft (1.2 m) wider than the previous structure and capable of carrying today's current highway loadings for semi-truck access.

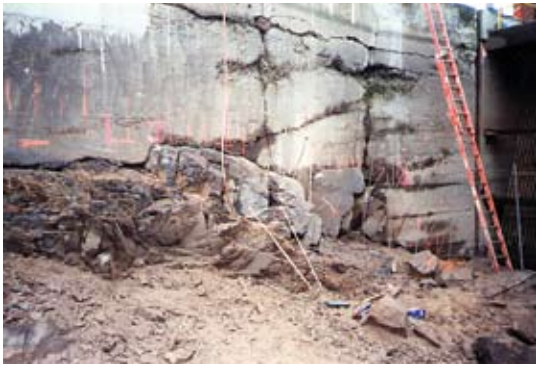
*SE forebay wall pre-existing condition, leaning in 8 in. 10 ft (9/27/02).*

A second unforeseen problem in the forebay was at the south end of the east wall. Here, a 30 ft-long (9 m) section of the wall was leaning in approximately 3 degrees to the inside of the forebay. This was due, in part, to wall construction, wall deterioration, and decay of the bedrock. Much of the bedrock formation in the area is fractured granite, and, over time, the fissures weather and deteriorate the bearing capacity. This problem area is approximately 35 ft (10.6 m) upstream of the No. 1 hydro bay intake, so a large mass of riprap or concrete would not provide an acceptable repair, as it would starve that hydro turbine of water. Therefore, a narrow section repair was needed.

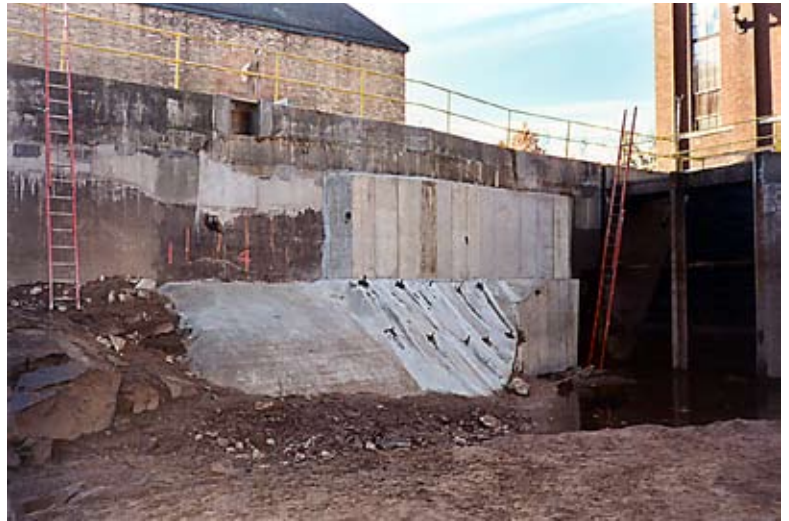
*Completed SE forebay wall rock-anchored buttress wall repair (11/8/02).*

For the repair, the bedrock was cleaned, loose materials were removed, and a reinforced concrete mat was placed to further protect the bedrock from weathering and river current forces. Rock anchors were then drilled through the mat 20 ft (6.1 m) into competent bedrock, grouted, and then locked off under tension to secure the mat. A new reinforced concrete wall was then cast immediately adjacent to the failing wall and fixed to the mat footing. This repair gave the owner a stable wall, which did not impact the operation of the No. 1 hydro turbine.

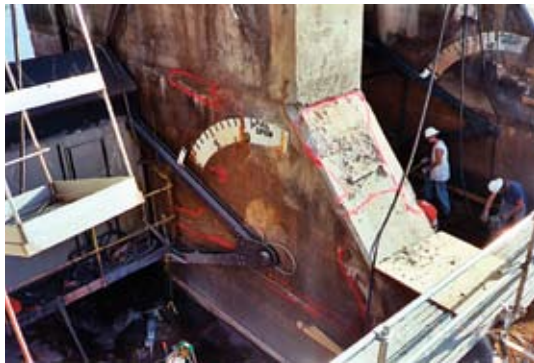
*Gated section repairs in progress (9/5/02).*

Gated spillway repairs were designed and performed at the waterline upstream and downstream of the tainter gates. These repairs were completed by removing the poor concrete down to a level of solid concrete using impact hammers. Final preparation of the repair surfaces was completed by hydro-blasting prior to placement of concrete forms. For repairs less than 4 in. (10 cm) in depth, a latex-modified concrete mixture was used for increased bond strength and higher resistance to wear. In areas where repairs were deeper than 4 in. (10 cm), new reinforcing steel was drilled and epoxied into the sound concrete and conventional cast-in-place concrete used. Less than 30 yd<sup>3</sup> (23 m<sup>3</sup>) of latex-modified concrete was used on the project, as the repairs were found to be much deeper than originally anticipated. Repair depths in some cases were in excess of 18 in. (46 cm) but averaged 6 to 7 in. (15 to 18 cm) in depth.

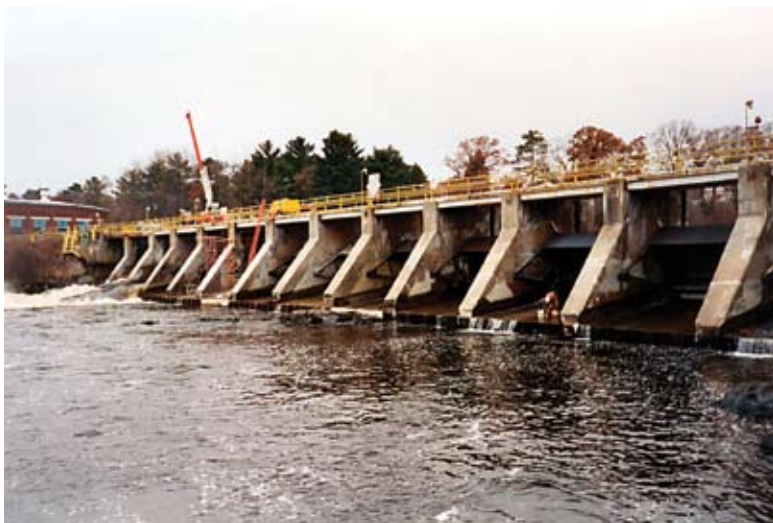
*Completed gated section repairs (11/18/02).*

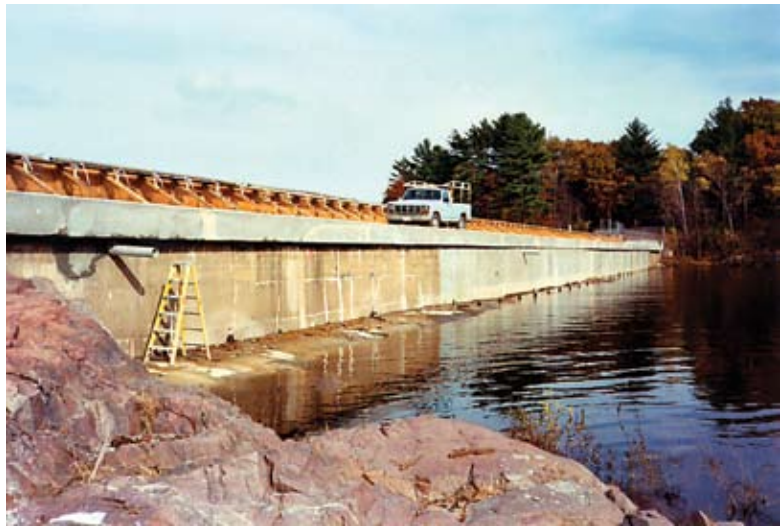
The flashboard spillway section was a very tired rock-filled timber crib structure with a 50-year-old concrete cap. The cap relied entirely on the timber crib and rock fill for support and over time settled along with the timber crib structure. The new concrete cap design used the existing upstream and modified downstream walls for support independent of the timber crib section. Therefore, as the timber crib section continued to settle, the remaining cap would be an independent, stable structure. There was an

*Completed overflow spillway deck replacement (10/30/02).*

approximately 400 ft-long (122 m) section of the spillway that did not have a downstream wall or footing. This was addressed by the construction of a tremied strip footing on bedrock. Due to the thickness of the river debris and the extreme variability of the bedrock formation in this area, the contractor could not clean out the bedrock sufficiently. Therefore, to achieve the desired performance, the footing would need to be anchored to the bedrock in lieu of intimate contact. The strip footing for the downstream wall consisted of approximately 850 yd<sup>3</sup> (650 m<sup>3</sup>) of concrete. Rock anchors were installed on 8 ft (2.5 m) centers, 6 ft (1.8 m) into the bedrock along the entire length of the footing to resist rotational and lateral forces pushing the structure downstream. The new downstream wall and cap slab elements were then installed on the new foundation.

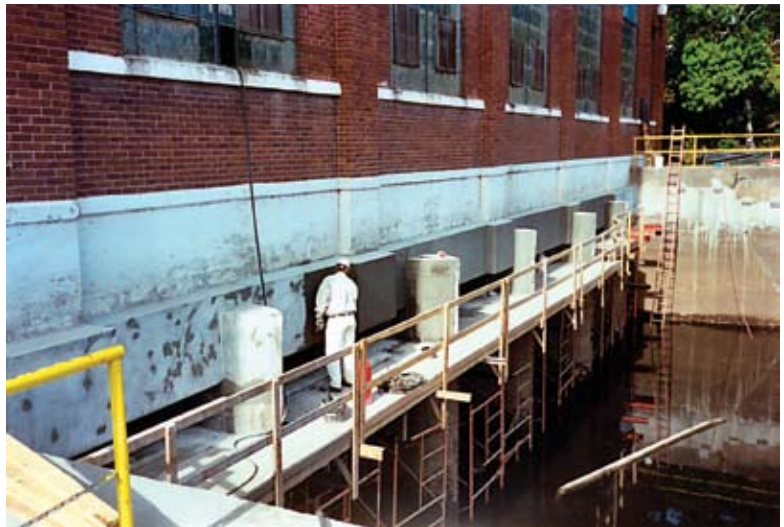
The final element of the project consisted of powerhouse beam repairs. The concrete support beam above Flumes 6, 7, and 8 was deteriorated, exposing reinforcing steel at and below the waterline. It was originally anticipated that the concrete was in sound enough condition that only a surface repair would be required. During demolition, it was found that 8 to 15 in. (20 to 38 cm) of concrete was in poor condition and was removed. The repair was completed by installing new reinforcing stirrups into the competent concrete above the repair area and using the sound existing horizontal reinforcing. A conventional concrete mixture was used for these deep repairs.

*Completed powerhouse support beam repair (10/16/02).*
