# 100 South Gay Street Parking Garage Rehabilitation

By Robert Wychulis

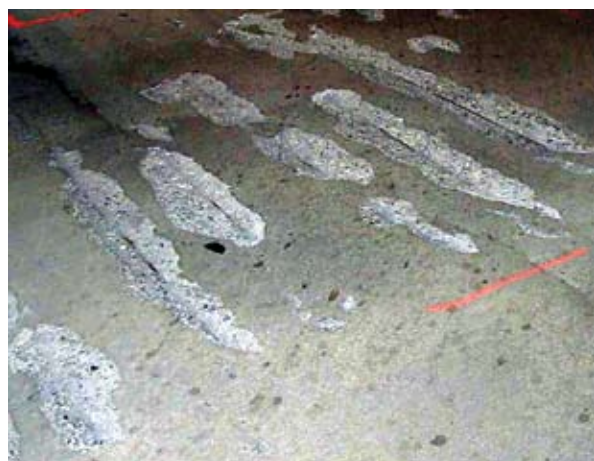
Top surface concrete delaminations and spalls in the waffle slab portion of the garage. The top mat of reinforcing bars can be seen in the spalled areas.

The waffle slab construction used in the garage addition is reinforced with uncoated reinforcing bars and is, therefore, subject to deterioration due to corrosion of the embedded reinforcing steel. Large delaminations can be found throughout the garage. In some cases the delaminations extend for several bays, or 12 to 15 parking stalls in one area. The lower levels of the garage have greater corrosion-related deterioration when compared with the upper levels. In a large garage such as 100 South Gay Street, the parking turnover

rate is very high on the lower levels. More cars using the parking stalls allow for greater amounts of deicing salts to attack the concrete. Higher levels within the garage had lesser quantities of delaminations. For example, the lower four levels contain an average of 35% delamination in the waffle area top surface, whereas the upper levels average 15% concrete deterioration.

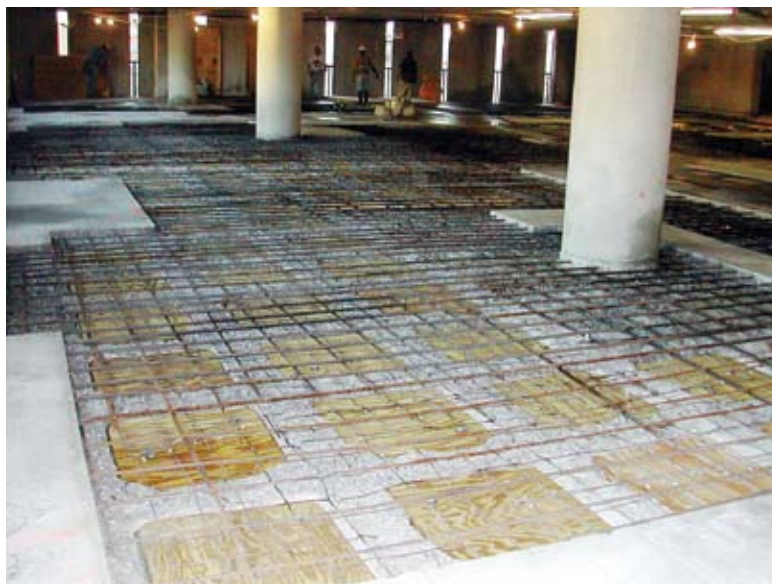
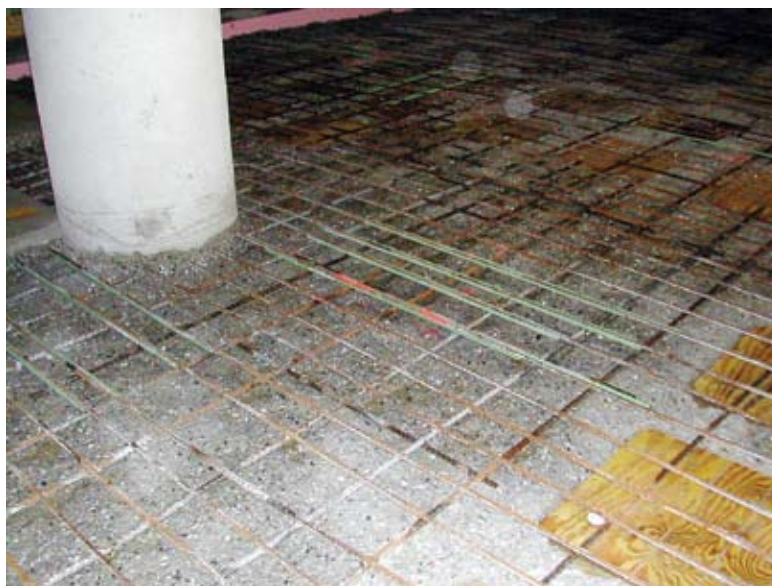
*(Above and below) Large repair areas in the waffle slab portion of the garage prior to the placement of the new concrete. The wood forms are the bottom portion of the dome area of the waffle slab.*

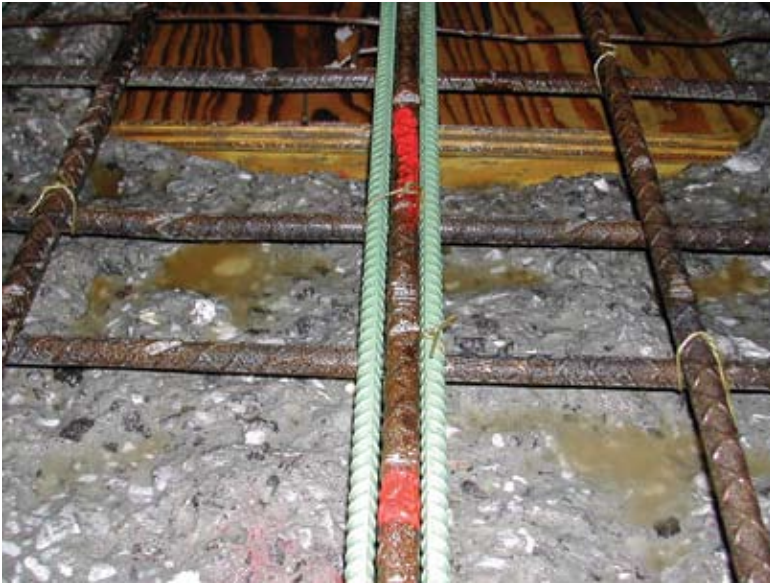
*A close-up picture of an existing reinforcing bar spliced with new epoxy-coated bars. Note the section loss on the existing bar due to corrosion.*

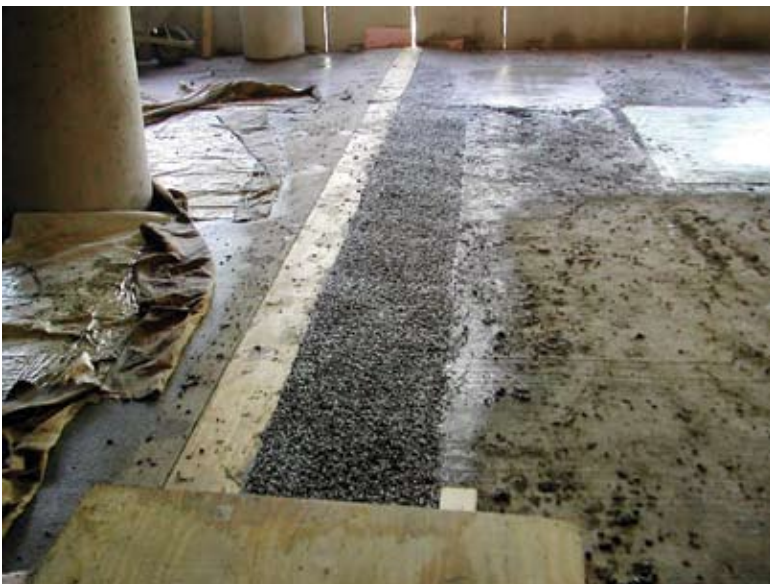
*Newly placed concrete in repair areas and along the existing expansion joint. The block out seen in the picture is for the wings of the new expansion joint seal.*

Each level has an expansion joint separating the two garage types. All of the expansion joints are in poor condition and appear to be leaking. The expansion joint seals that bridge the waffle slab and precast tees have become loose in some areas and have an abrupt transition from one structure to the other. Deterioration in the joint seals was observed in the joints between two of the waffle slabs as well.

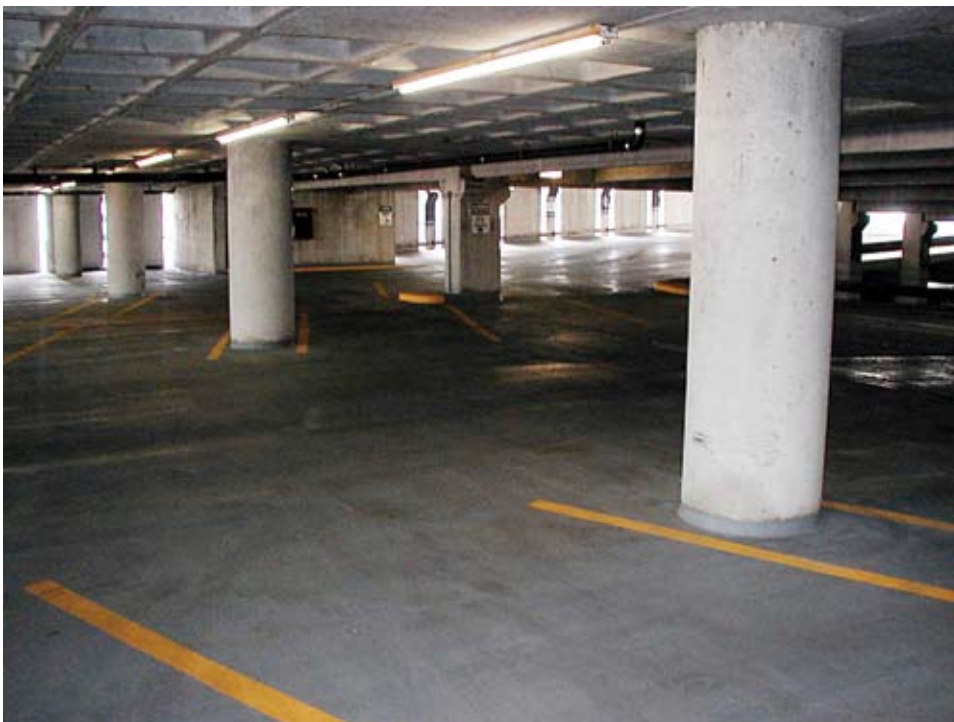
*This is a picture of the finished product in the garage. The waterproofing membrane has sealed and protected the new repairs and original concrete from additional chlorides entering the slabs.*

All the new concrete placed in the repair areas was from a mixture proportion of 5000 psi (34.5 MPa) with a 0.4 maximum water-cement ratio ( $w/c$ ). Four gal./yd<sup>3</sup> (19.8 l/m<sup>3</sup>) of corrosion inhibitor was added to the mixture. Also added was 1 lb/yd<sup>3</sup> (0.6 kg/m<sup>3</sup>) of micro fibers to control shrinkage cracks during curing. New hot-dipped galvanized shear connectors were installed where existing connectors failed due to corrosion. All newly placed reinforcing bars were epoxy coated to replace deteriorated existing bars. The urethane membrane system applied has a minimum dry film thickness of 40 mils in the parking stalls and 52 mils in the drive lanes. All the precast
