Concrete Slab Repair: Getting Flat is One Thing, Staying Flat is Another!

By Scott M. Tarr, Peter A. Craig, and Howard M. Kanare

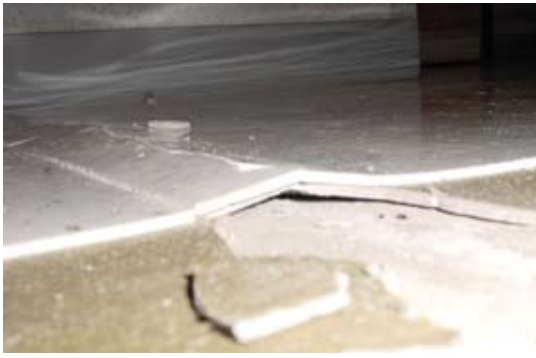
Fig. 1: Buckling of VCT tiles and cementitious underlayment attributed to warping relaxation at concrete slab joints

the reprofiled joints. Often, this slab relaxation places the floor covering into compression. In some cases, the compressive forces are significant enough to cause debonding and/or buckling of the flooring system, which can create a tripping hazard such as that shown in Fig. 1. Where floor covering systems buckle along joints and cracks, the delaminations are commonly referred to as mole holes or mole trails.

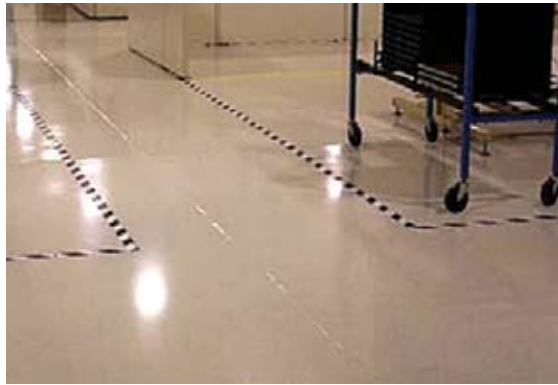
Another condition that can be the result of warping relaxation is the extrusion of filler or leveling material from joints and cracks as shown in Fig. 2, 3, and 4. When slab edges warp upward, joints and cracks become v-shaped in profile (wider at the top surface than at the bottom). Material used to fill in these joints/cracks can be extruded out when the slab returns to its original shape and the joints/cracks close. Yet another form of distress caused by warping reversal is shown in Fig. 5. Often, isolation block-outs around columns and other through-slab structural components are in-filled well after the slab is placed. Depending on the length of time between slab placement and infilling, substantial edge warping can occur. The blockouts are screeded to the top of the surrounding slab surface at the time of filling. Therefore, significant grinding or leveling is not usually necessary for the flooring system in these locations. However, once the flooring system is installed and the moisture gradient equalizes, the warped edges of the surrounding slab relax back downward and the column infill appears to heave upward (Fig. 5).

Fig. 2: Extrusion of semi-rigid joint filler due to reverse warping (photo courtesy of Herman Protze)

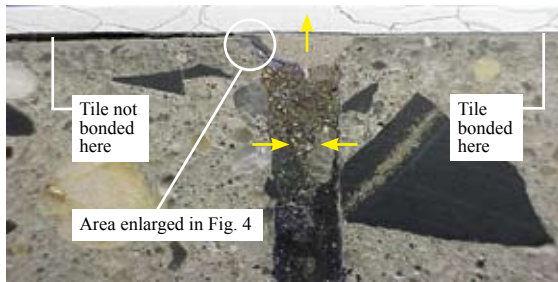
Fig. 3: Lapped cross-section of concrete core at sawcut joint showing patching compound thrust upward. Displacement of patching compound (arrow pointing upward) is caused by narrowing of joint (arrows) as the concrete slab relaxes from its warped posture

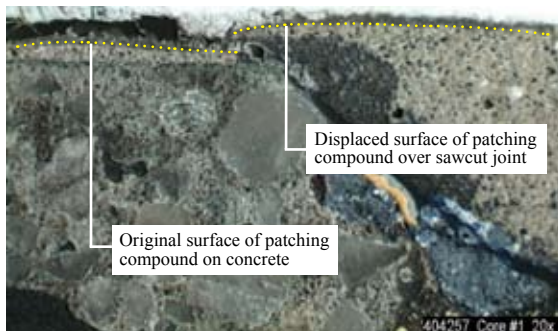
Fig. 4: Photomicrograph in reflected light showing details of patching compound movement upward. Dotted lines indicate original surface and displaced surface due to movement. The black gap at top left is the space created when tile was pulled loose from the patching compound, forming a bubble

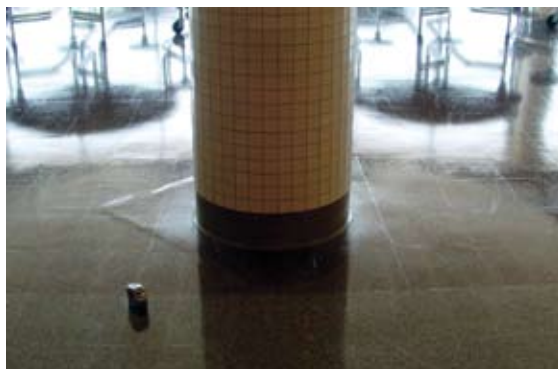
Fig. 5: Reverse warping around isolated diamond blockout at column footing

Warping relaxation is not an isolated event. Conditions such as that shown in Fig. 5 can be found in many retail stores throughout the U.S. Most of the time, if the initial warping was only slight, the relaxation does not become an issue. Unless specifically designed to prevent warping, all slabs can be expected to warp somewhat. It is the magnitude of warping that potentially becomes an issue. As such, the shrinkage potential of the concrete mixture must be considered, regardless of the use of steel reinforcement. No climatic region of the U.S. is immune to excessive shrinkage and moisture-related problems. When upward slab warping has developed in a concrete slab to be covered or coated with a low permeance material, consideration should be given to filling the void beneath the slab edges before reprofiling the slab.

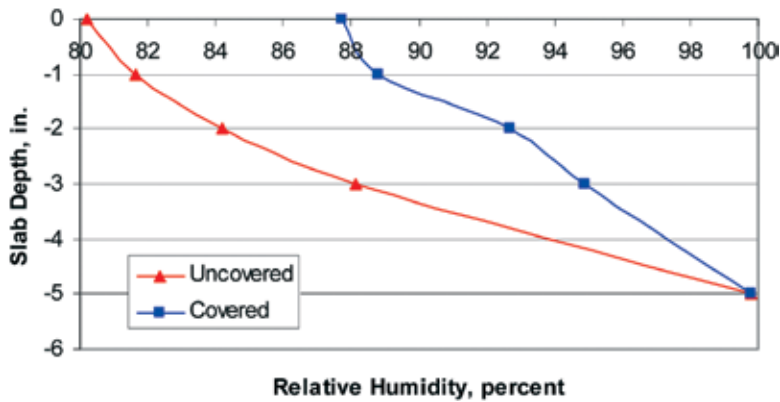
Fig. 6: Relative moisture gradient between uncovered and covered portions of a slab

moisture gradients are compared in Fig. 6, which plots the measured moisture gradient (horizontal axis) with slab depth (vertical axis). As shown, the relative humidity of the base material beneath the slab was nearly 100% for both the covered and uncovered portions of the slab. For the uncovered slab, however, the moisture gradient that developed was large (nearly 20% relative humidity) as the slab surface was trying to reach equilibrium with the ambient air. Once the slab was covered with the low-permeance tile system, the moisture levels within the slab increased and the overall gradient was reduced by nearly half. As the moisture gradient was reduced, the warping magnitude decreased from as high as 0.80 in. (2.03 cm) to as little as 0.18 in. (0.46 cm), as shown in Fig. 7. As a result, the joints narrowed and the cementitious filler material was extruded (Fig. 3 and 4) and the ESD tiles buckled, as shown in Fig. 8. The same distress has been seen in other flooring systems such as poured polyurethane gymnasium floors, as shown in Fig. 9 (at a crack).

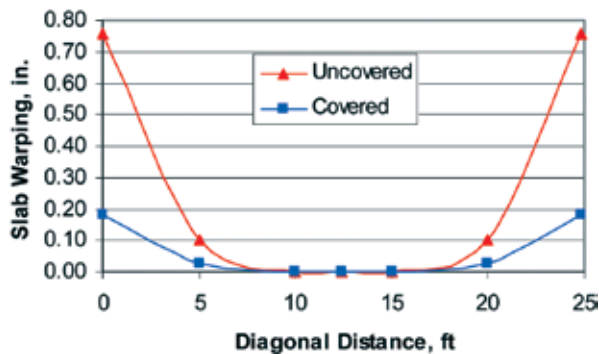
Fig. 7: Relative warping profile between uncovered and covered slab panels

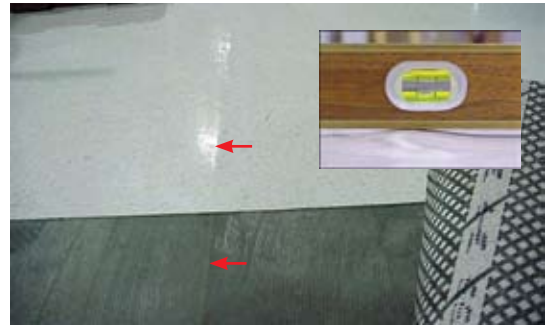
Fig. 8: Debonding and buckling of ESD tile flooring (note hump at arrow and insert)

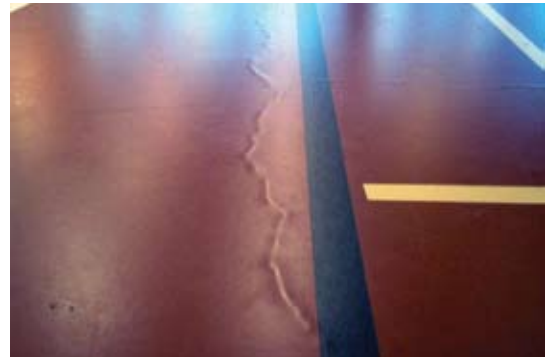
Fig. 9: Extrusion of crack filler beneath poured polyurethane gymnasium flooring
