St. Mark's Church Historic Restoration

By Dave Clark, Tim Crawford, and Mark K. Howell

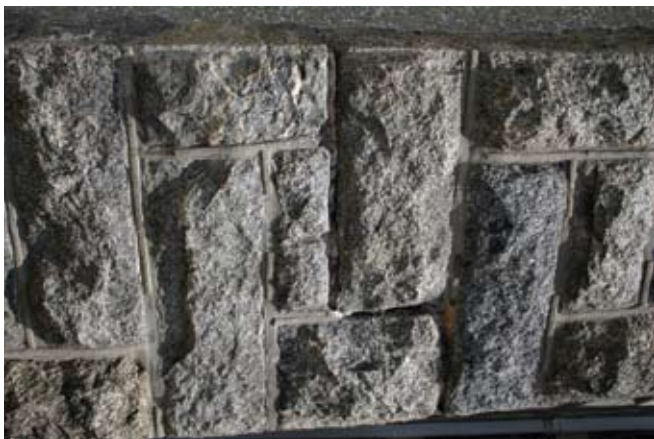
Fig. 1: Typical existing condition at deteriorated masonry joints

The new scope involved repairing deteriorated mortar joints and spalled ornamental stucco. The mortar joints had been in need of maintenance for several years, and a recent, substandard repair attempt was found at the ground level. The prior maintenance attempt was performed using a hard, inappropriate mortar for repointing of the stone. The contractor's alternate approach involved matching new mortar material in color and strength to the original mortar material. With regard to the ornamental stucco, random areas were spalling off of the granite and brick sub-base. The contractor recommended the removal of the loose material followed by a process during which they would set mechanical anchors in the substrate, apply mortar, carve ornamental details, and stain the stucco to blend all existing sections with the new repair areas (Fig. 4).

Several mortar samples were made in order to find the right color mixture for the deteriorated mortar ribbon joints and the random joints needing repointing. After placing samples on the wall and evaluating color after a week of weathering, the contractor selected a high-grade mortar material made specifically for restoration applications (Fig. 7).

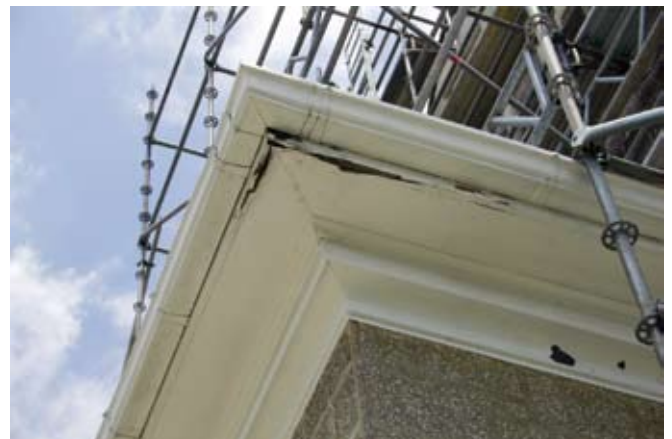
Fig. 2: Pre-existing wood trim condition

Another repair area involved the wooden trim and details, including doors and soffits, which had rotted in various locations. New wood was installed in those areas, and the wood in all of the locations was coated with an industrial-grade exterior paint. The contractor also replaced the protective glass that covered the stained glass windows. To achieve an aged appearance that matched the existing glass, the new pieces were kiln-fired.

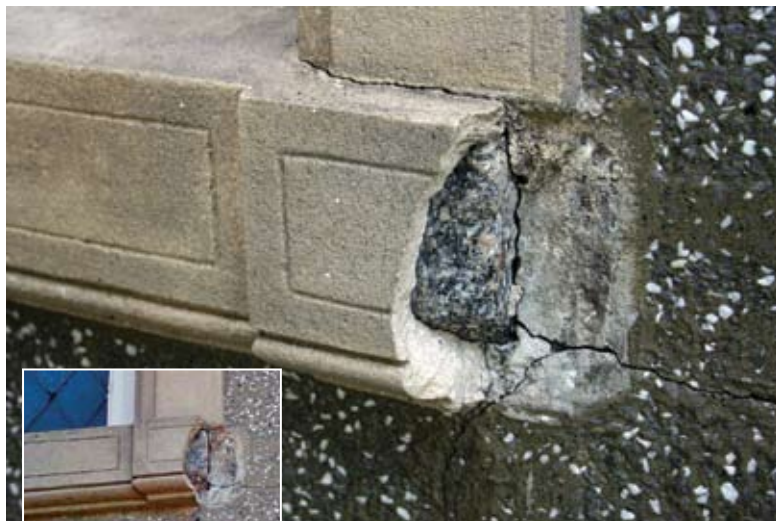
Fig. 3: Typical existing condition at faux limestone sill

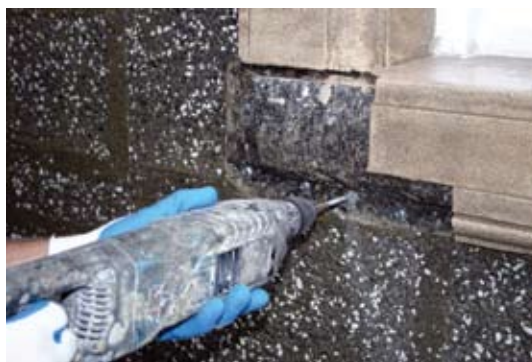
Fig. 4: Pin installation for faux limestone repair

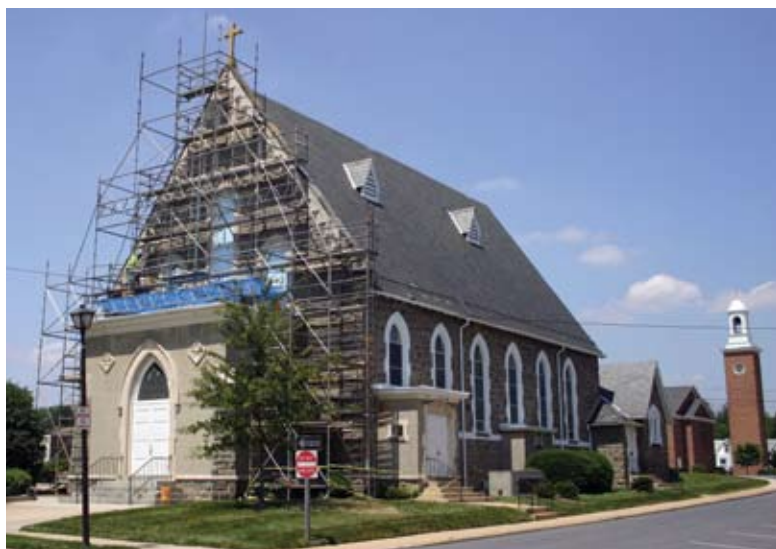
Fig. 5: Scaffolding erected to help ensure safety

The safety of the people using the structure on a daily basis was another key consideration. Specific safety concerns and methods for addressing these items were planned with the church pastor, the operations manager, and an Archdiocese representative at a preconstruction conference. Scaffolding was erected at the main entrance to the church in a manner that still allowed access to the structure during the work week (Fig. 5). Furthermore, there were times when the area had to be cleaned up in order to accommodate larger groups of people, such as a funeral. Throughout the project, communication with the church staff and the congregation was important not only for safety but also for the morale of the church family.

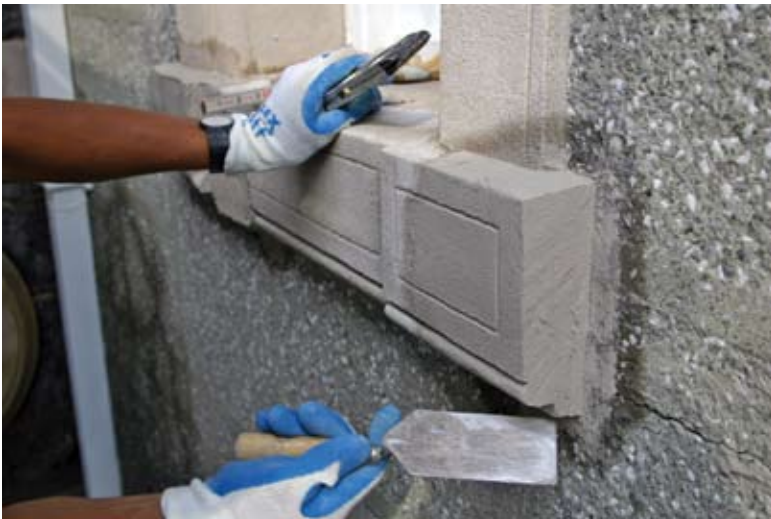
Fig. 6: Repaired sill prior to coating application

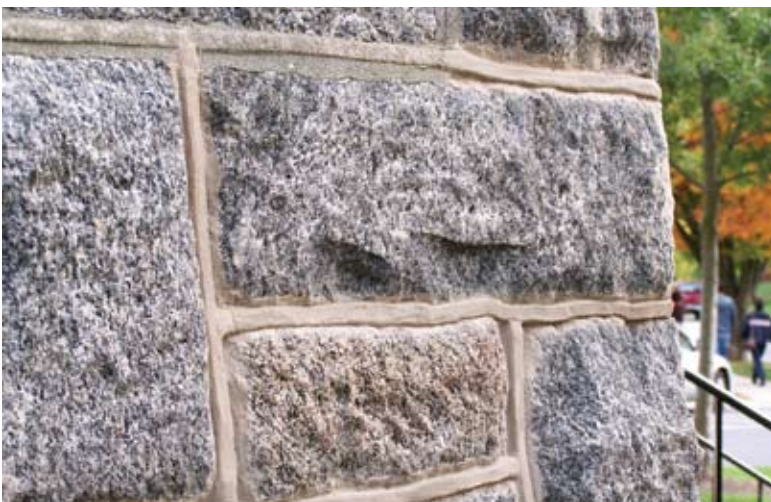
Fig. 7: Repaired pointed mortar joints with high-grade mortar material

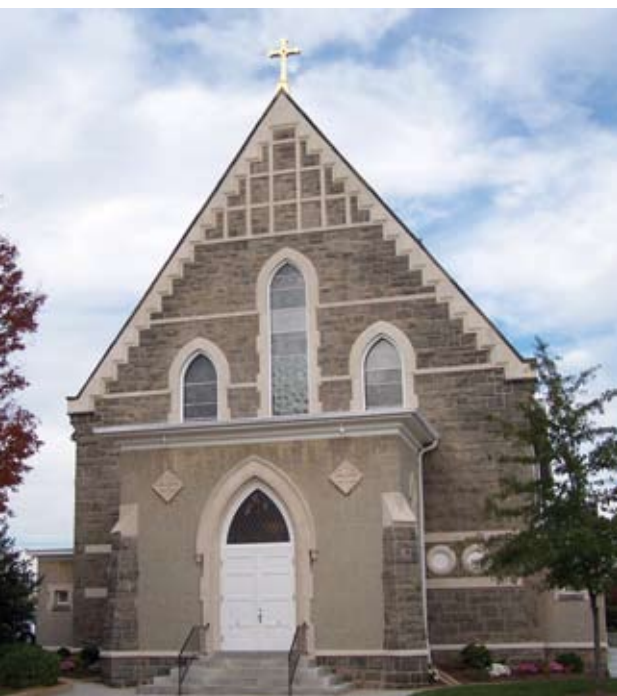
Fig. 8: Completed front façade of St. Mark's Church

Many involved in the repairs at St. Mark's Church share in their excitement of a project well done. Not only did the repair contractor provide the best solution for the owner through the rigorous selection of materials and methods, but they also helped ensure value to the owner by better defining a scope of work that would add the most value to the structure. Although not huge in terms of dollars, the restoration of St. Mark's Church was great in terms of the impact made on those that call St. Mark's home (Fig. 8).
