The La Mer Condominiums

Stucco and Concrete Repair

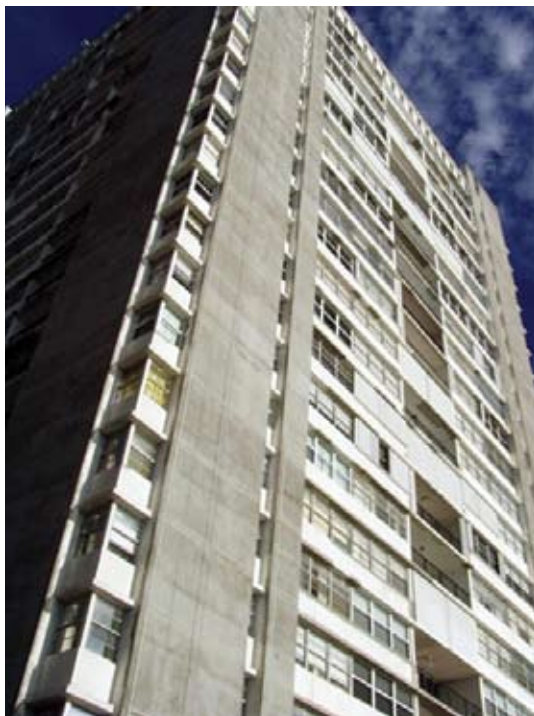
The buildings' conventionally reinforced concrete slabs suffered deterioration typical of the Florida environment. Concrete cracks in the slab surfaces allowed moisture penetration, causing the reinforcing steel within to rust. The high salt content of both air and rain accelerated the corrosion. The rust buildup on the reinforcing steel of the building floor slabs displaced the surrounding concrete, which eventually cracked and then spalled. Balcony slab edge deterioration was largely caused by embedded railings. Like the rusting reinforcing steel, rust buildup on embedded rail posts caused cracking and concrete spalls around the rail posts, damaging balcony slab edges.

Building with old finish and deterioration

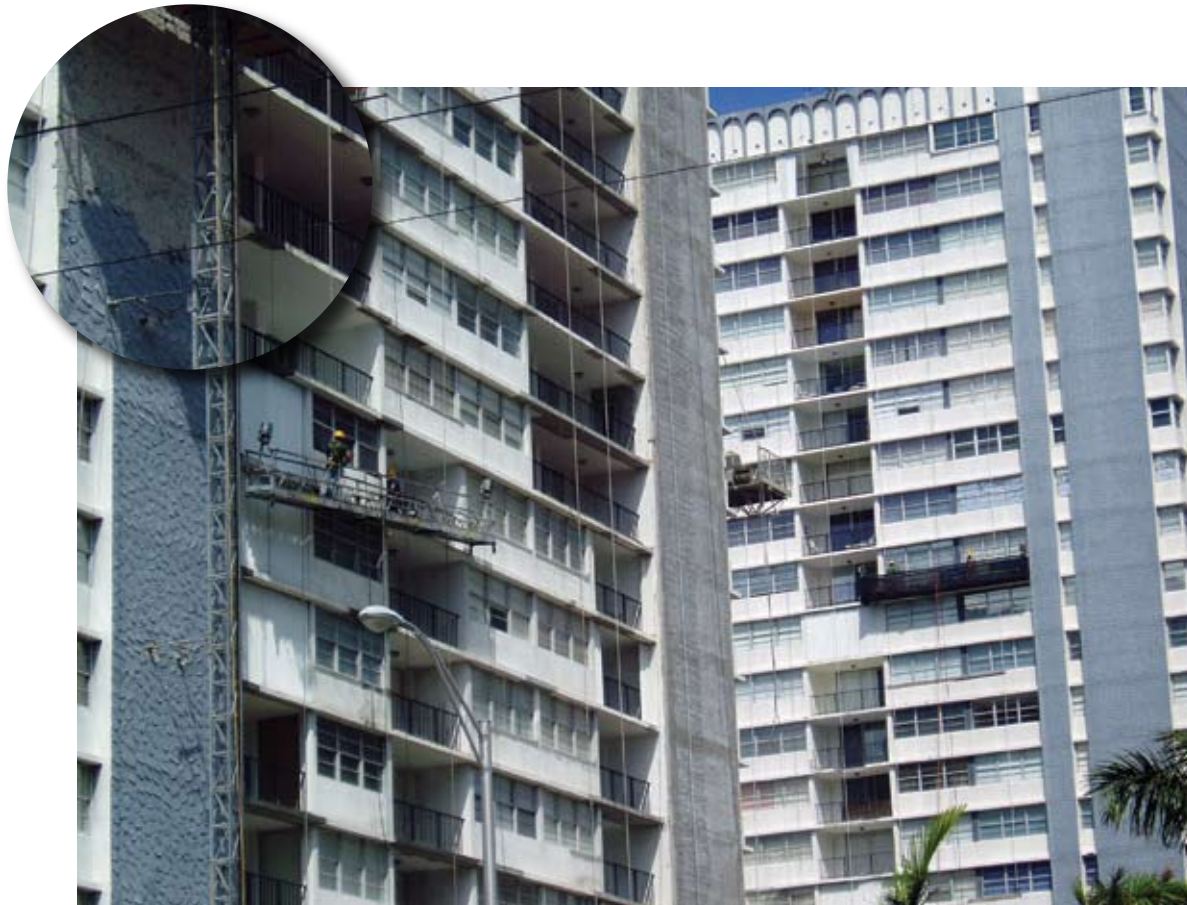
Removal of old stucco

The stucco was removed on each face of the building and the existing surfaces were prepared by means of mechanical preparation and high-pressure, low-volume power washing to remove all contaminants. Once preparation was complete, a base coat of new stucco was troweled on the building walls. The treatment was misted with water to stop too-rapid hydration of the base stucco coat materials. In the heat of South Florida,

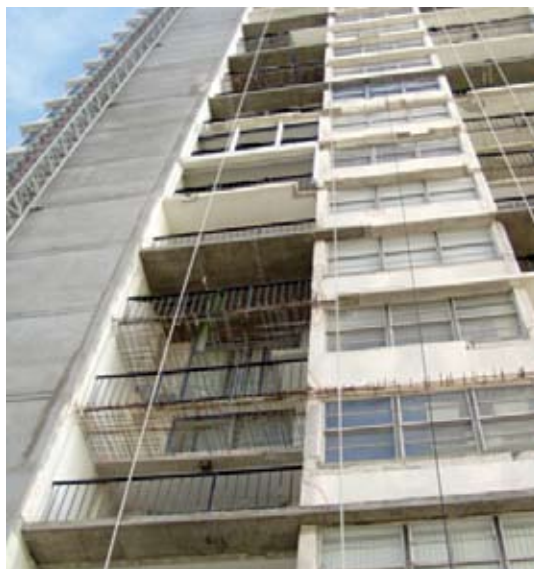
Repairing deteriorated balconies

Where railing post grout material had cracked, deteriorated, or was lower than the level of the surrounding balcony decks, the old grout material was removed and replaced with nonshrink grout to stop moisture intrusion. At all opportunities where grout pockets were opened, the exposed rail posts were cleaned of rust and coated with a rust-inhibitive prime paint. Where expanding rail posts had spalled slab edges, the failed concrete was demolished, the slabs prepped for repair per ICRI Technical Guidelines, and new concrete was placed to match the existing slab edge dimensions and geometry. The prepared balcony surfaces were then repaired using various techniques such as forming and placing ready mixed concrete pumped to the needed location (typically at the lower floors of the buildings), forming and placing bagged mixtures, or hand-troweling overhead repairs.

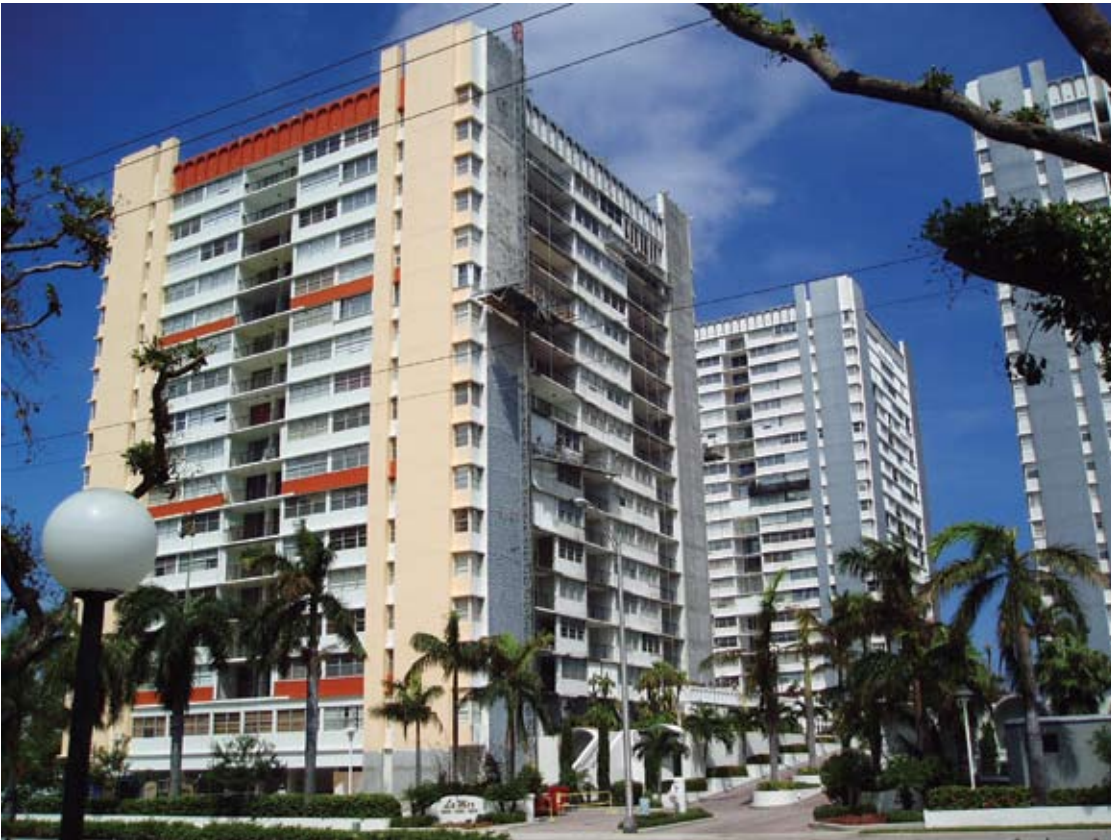
One side complete façade repaired with new appearance
