# NEW YORK MARRIOTT FINANCIAL CENTER FAÇADE REPAIRS

BY MATTHEW NACHMAN

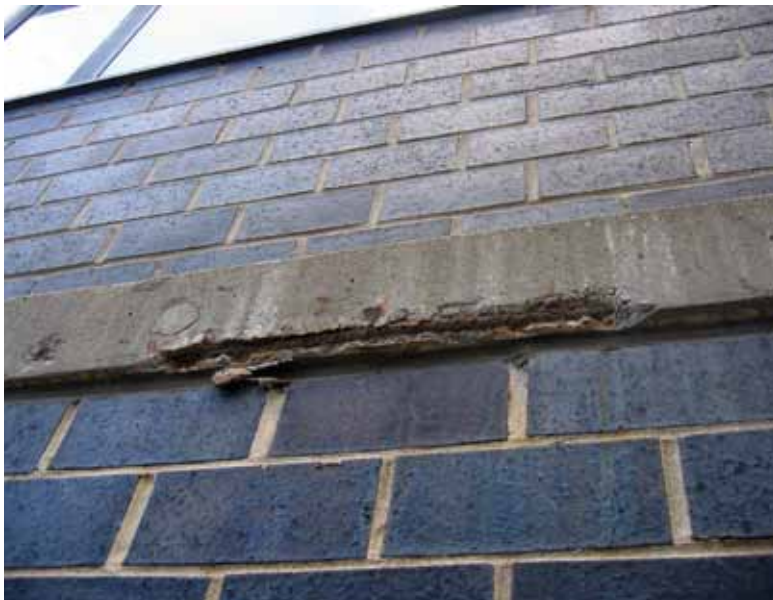
The primary condition of concern was corrosion-induced spalling of the concrete slab edges at each floor level. This high level of deterioration was particularly unique because the building has only been in service for 16 years and concrete spalling on the slab edges was first identified in 2002, only 12 years into the building's service life. Quality assurance during the reinforced concrete floor slab placement appeared to be deficient during original construction. The project engineer discovered numerous concrete spalls that had fallen to the lower roof levels from the upper floor levels of the hotel. This was also a major concern because of danger to pedestrians on the sidewalks below.

The concrete spalling was occurring due to a combination of carbonation of the concrete slab edges and very little (1/16 to 1/8 in. [0.16 to 3.2 mm] in many cases) concrete cover over the reinforcing steel at the edge and bottom edge of the slab. Exposure to moisture and the high levels of carbon dioxide in the Manhattan area caused spalling of over 35% of the exposed concrete slab edges. Corrosion-induced concrete spalling was also occurring on the north and east elevation exposed structural concrete shear walls that provide resistance against wind and seismic lateral forces for the entire building. In addition, numerous façade problems were also identified, including open and cracked mortar joints, cracked brick, failed façade sealants, corroding shelf angles, and failed spandrel glass gaskets that were allowing excessive air infiltration into the building.

*Exposed concrete slab edges as observed during engineering survey*

The project engineer prepared repair specifications and drawings and bid the project out to multiple repair contractors. The repair system specified for the concrete slab edge spalling included concrete demolition of the slab edge to expose all corroded reinforcing bars to a depth of 5 in. (130 mm). Repair specifications were based on ICRI Technical Guideline No. 03730, "Guide for Surface Preparation for the Repair of Deteriorated Concrete Resulting from Reinforcing Steel Corrosion." Concrete demolition was performed with electric chipping guns to minimize microcracking of the remaining concrete substrate. Sandblast surface preparation of the

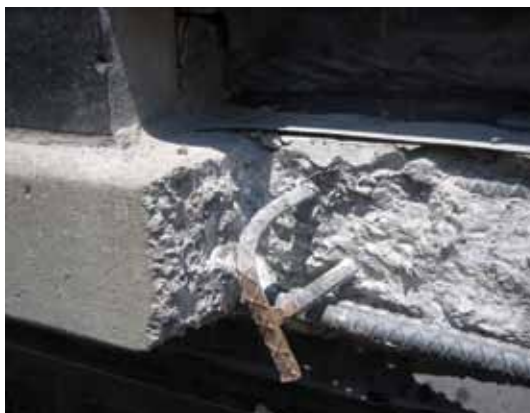
*Concrete demolition at exposed slab edge; demolition is nearly complete, surface preparation to follow*

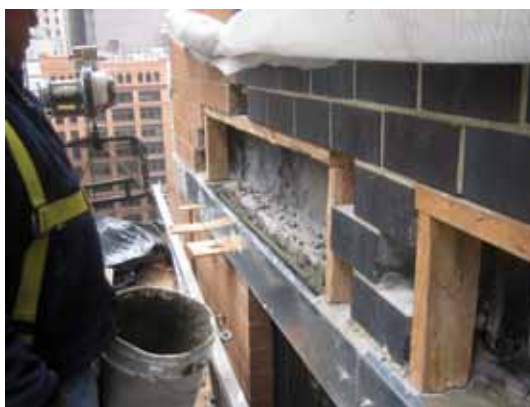
*Concrete placement at exposed slab edge. Note the galvanized metal forms fabricated by the repair contractor and shimmed to the brick below to optimize stripping and reforming operations*

The repair contractor devised a reusable galvanized steel form that slid between the bottom of the slab edge and the brick below. The forms were fabricated to match the existing slab thickness and chamfer features. This allowed for reduced forming time and minimized form material waste that is typical when forming with wood materials.

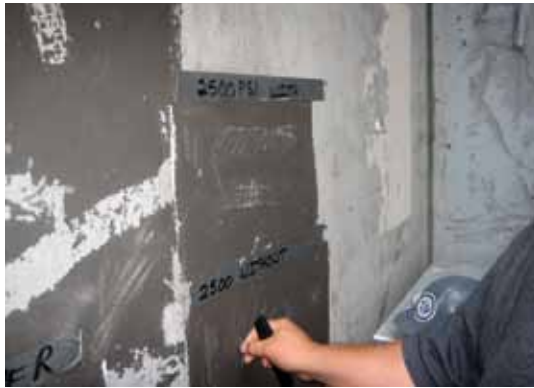
*Concrete shear wall coating surface preparation and bond test prototypes*

grinding. High-pressure water blasting at 3500 psi (24.1 MPa) was the selected surface preparation method for the coating and bond was verified by numerous bond tests performed by the coating manufacturer on the mockups. Testing continued throughout the construction process to verify bond.

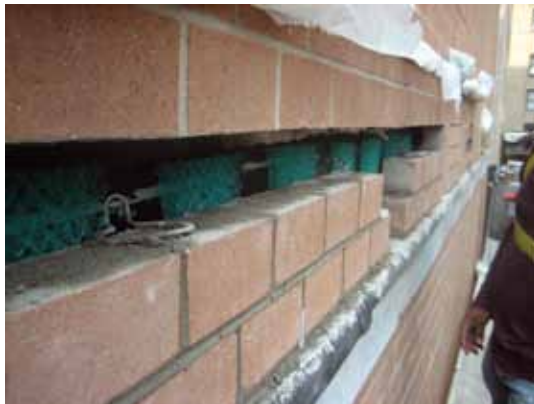
*Flashing installation is complete. Brick installation in progress along with cavity netting protecting brick ties and weeps*

A surface saturated dry (SSD) concrete substrate was specified prior to concrete placement. Existing through-wall flashing was adhered to the top of the slab edges, so repairs to the concrete also included removal and replacement of three courses of brick above the slab edge repair areas and installation of new through-wall flashing. A protective acrylic coating was specified by the project engineer to protect the slab edges and shear wall against moisture. The coating also had anti-carbonation qualities to provide protection to the steel reinforcing that had not yet corroded, but likely had less-than-desired concrete cover.

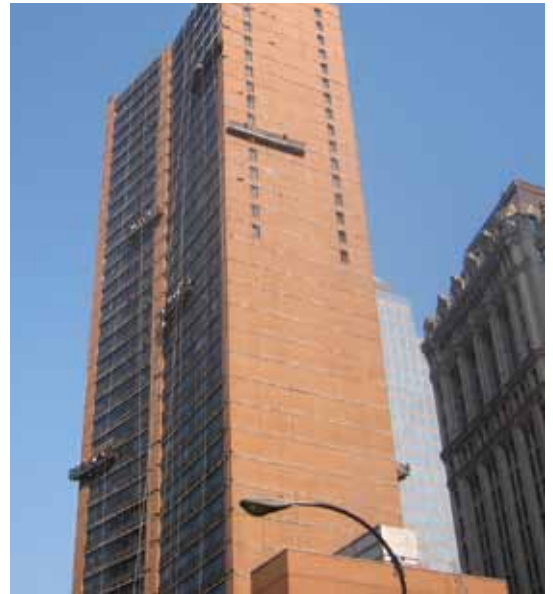
*East and south elevations of building under repair in August 2007. Up to 10 swing stages were used during the course of repairs*

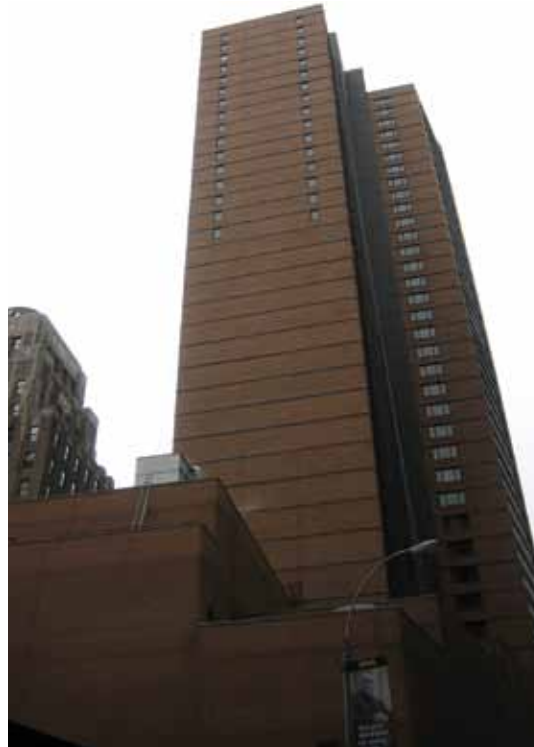
*East elevation and shear wall elevation after completion of repairs*
