REPAIR AND REHABILITATION OF THE PALACE OF AZIZA-FAHMY

BY REFAAT M. SALLAM

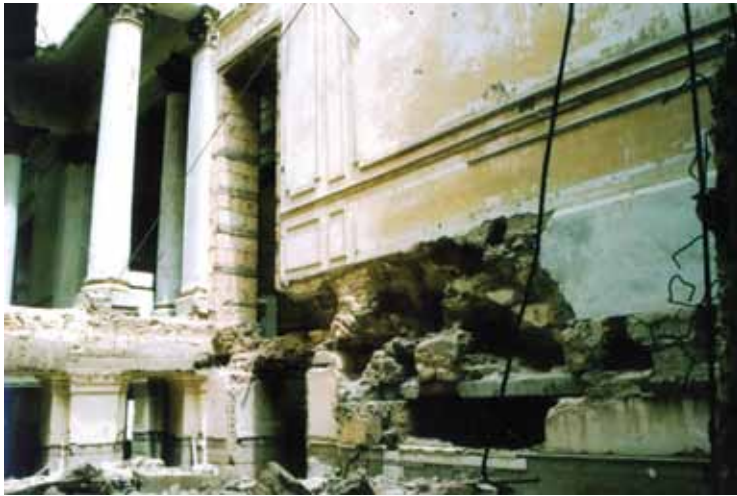
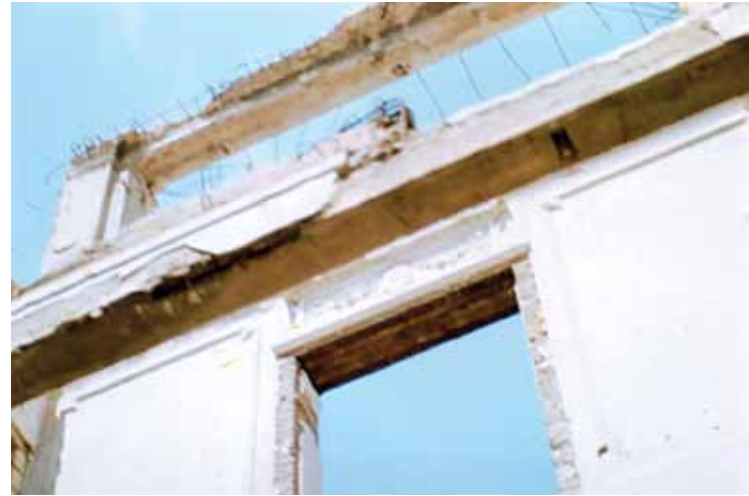
The damage included two main operations: 1) cutting the bearing walls at floor levels to nearly full length and full thickness with a height of 9.8 to 15.7 in. (250 to 400 mm), adding some small supports about every 6.5 ft (2 m) of wall length to avoid sudden collapse of the walls. The cutting operation was very severe and rough (refer to Fig. 2); and 2) completely removing the roofs, leaving the walls without any lateral horizontal support (refer to Fig. 3) for their full height of more than 46 ft (14 m). Also, the main staircase was removed by stripping the pure white Carrara marble stairs from the surrounding supporting walls.

Fig. 2: Photographs showing basement roof and top roof removed harshly

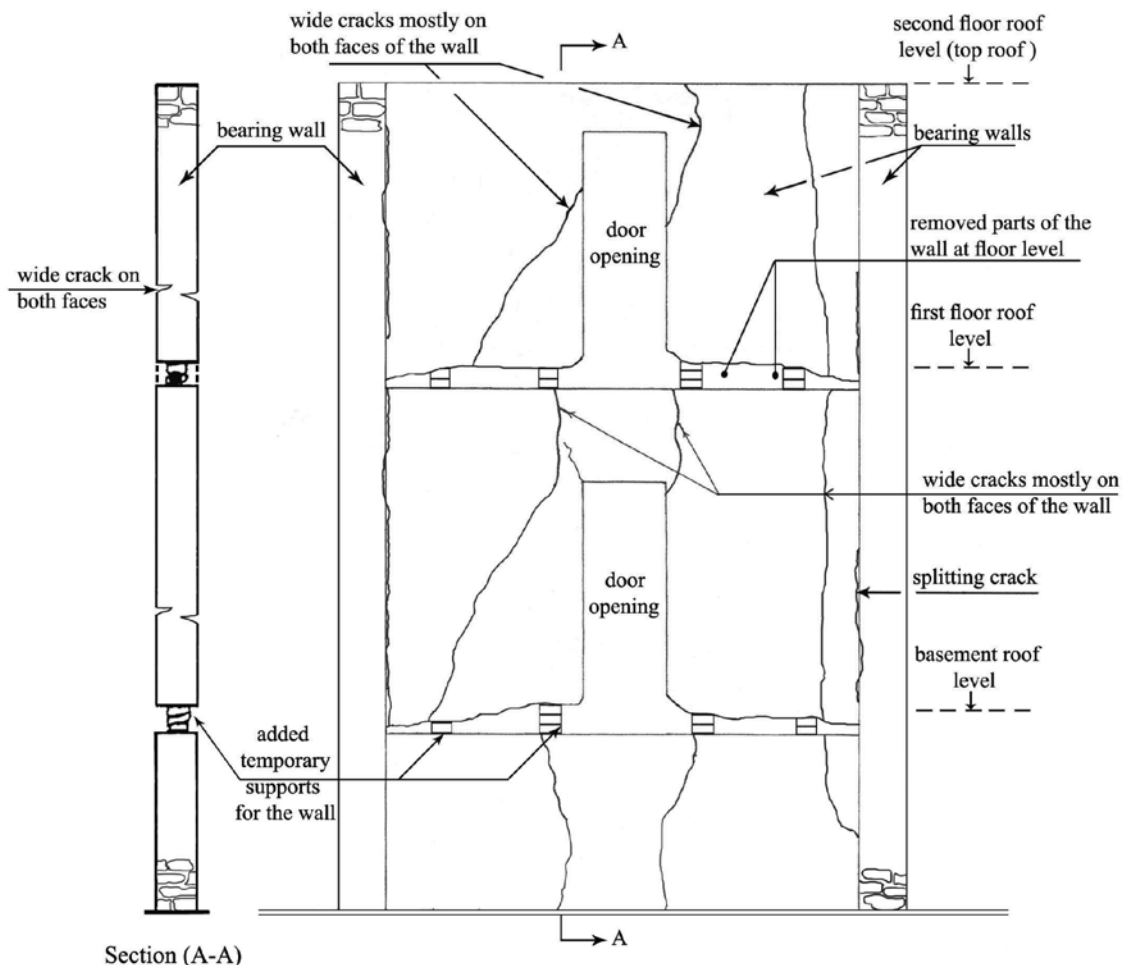
- Almost all of the bearing walls of the building suffered cracking in different directions, with the diagonal cracks being most notable. The diagonal cracks were wide (some of which exceeded 3/4 in. [20 mm] in width) and extended, in some cases, almost the full height of the wall.

- At the corners where perpendicular walls meet, vertical splits of nearly full height of the wall (between two roofs) appeared, in some cases, on both sides of a corner; and
- The only unremoved parts of the roofs were the six balconies on the first floor made of reinforced

Section (A-A)
Fig. 3: Location of damage in bearing walls

1. The bearing walls were structurally restored, that is, building the missing gaps at floor levels and repairing all cracks;
2. Reshaping of the restored walls at roof levels to accommodate the new roofs; and
3. Reconstruction of the three reinforced concrete roofs.

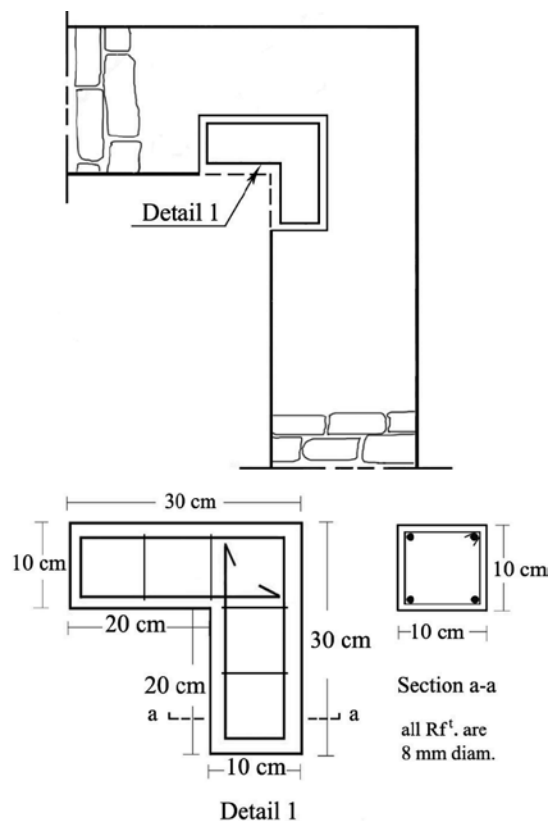
Fig. 4: Reinforced concrete corner pieces for tying perpendicular bearing walls (1 cm = 0.39 in.)

The second step dealt with the repair of the cracks in the bearing walls and at the corners where perpendicular walls meet. At the corners, where vertical long cracks on both sides seem to indicate the possibility of separation of the two walls, thus impairing their lateral stability, precast reinforced concrete L-shaped pieces at vertical distances of about 4.9 ft (1.5 m) were imbedded at some depth from the surface of the wall (as shown in Fig. 4). These pieces were connected to the masonry all around by masonry cement slurry and mortar. This operation was executed after the repair of the cracks in the bodies of the two walls under consideration has taken place.

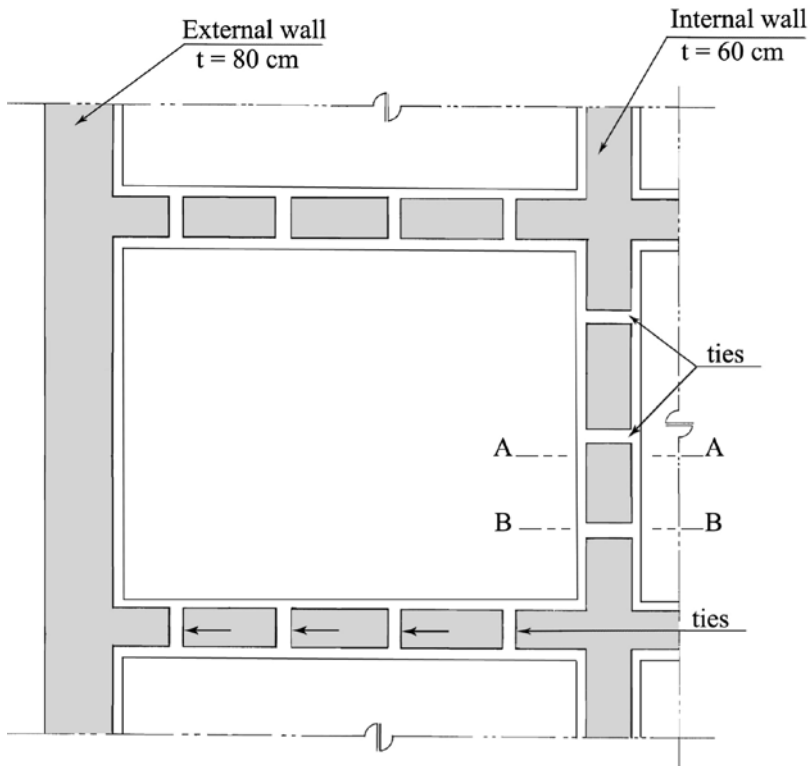
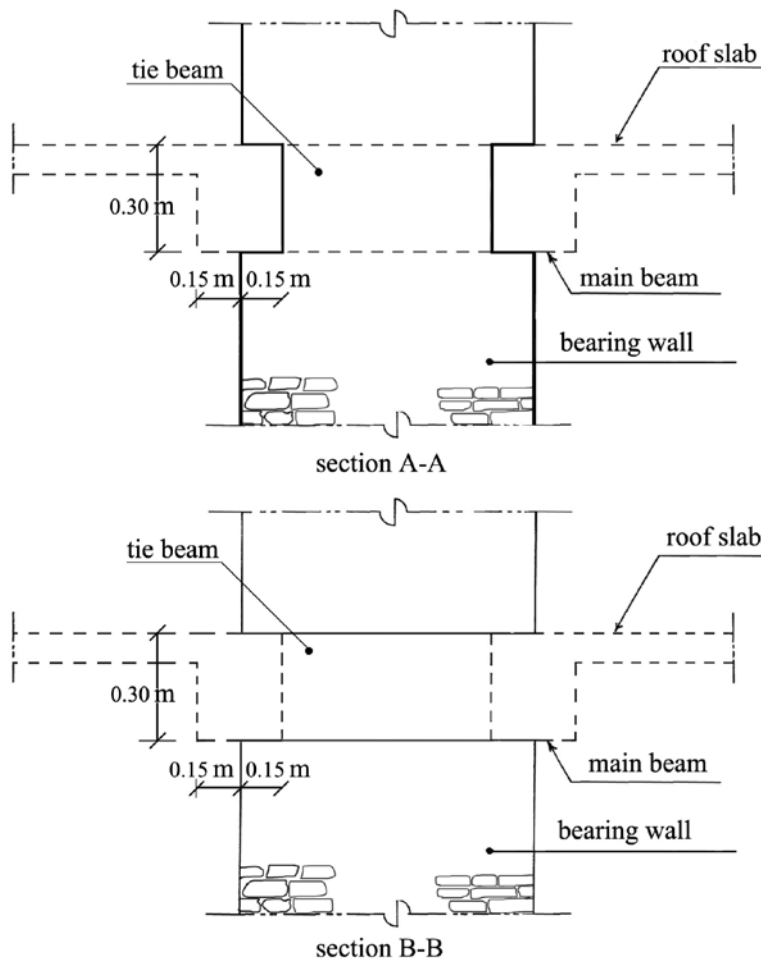
Fig. 5: Reshaping of bearing wall (cuts and drillings) (1 m = 3.3 ft)

The reshaping process is made up of two sets of cuts in these walls at roof levels (as shown in Fig. 5). The first set is the two longitudinal grooves on either side of the interior walls and on the interior side of exterior walls. The second set of cuts is the previously-mentioned holes drilled through the bearing walls to pass the reinforced concrete ties.

dimensions of the groove were 11.8 in. (300 mm) in height, exactly the height of the cross section of the abutting beam, and only 5.9 in. (150 mm) wide, that is, less than 11.8 in. (300 mm), which is the width of the abutting beam.

The two grooves on either side of a wall were not cut at the same time. The first groove was cut and, simultaneously on the other side, small holes were drilled to pass the dowels for the tie beam reinforcement. Stitch drilling of overlapping bore holes was used to make the holes with the required dimensions. The first beam and the tie beam were cast with concrete. The second beam groove was then made after casting the first beam for a period of 1 week. Local lateral supports were provided for the walls during the drilling operations.

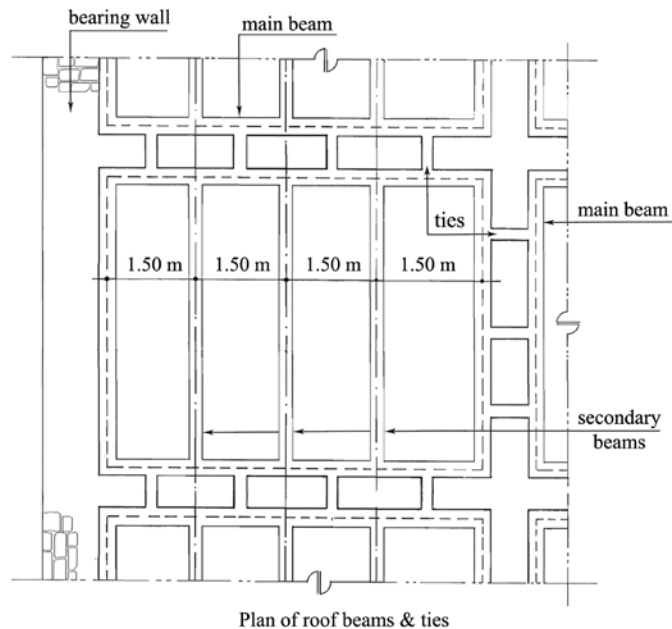
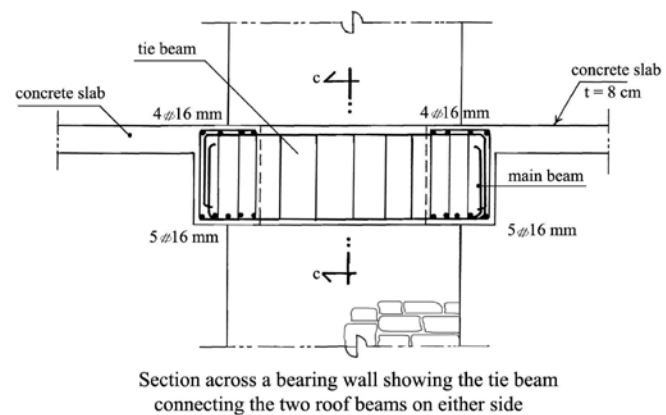
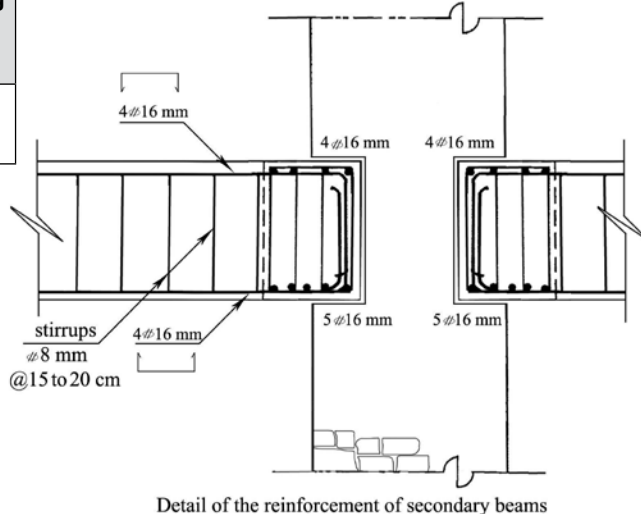
Fig. 6: Details of reinforcement of abutting main beams and ties (1 m = 39 in.; 1 cm = 0.39 in.; 1 mm = 0.039 in.)

The roof of each isolated panel was formed of four main beams abutting the four walls surrounding it, the secondary beams running in the short directions at a spacing of about 4.9 ft (1.5 m), with a slab thickness of 3.2 in. (80 mm). The ties connecting the main beams on either side of a wall were spaced at about 4.9 ft (1.5 m). Details of dimensions and reinforcement are shown in Fig. 6.

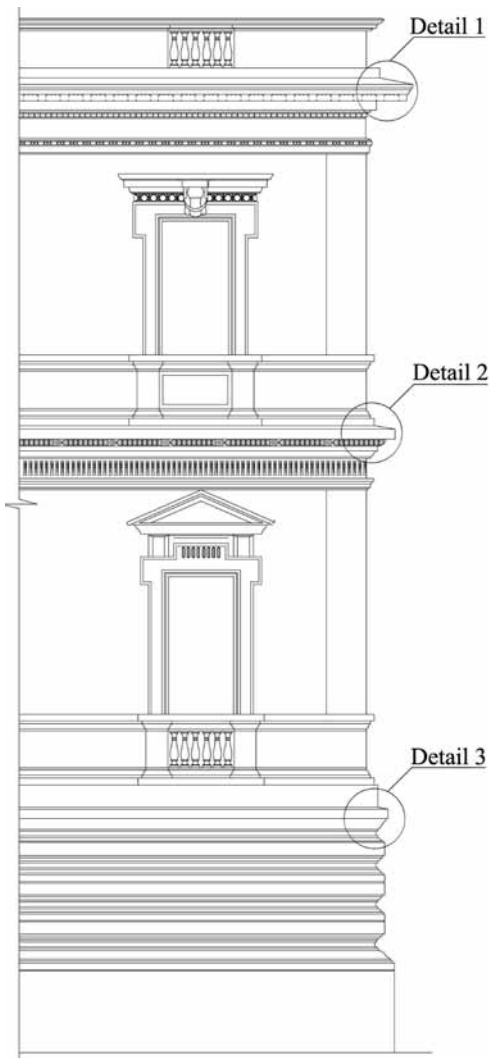
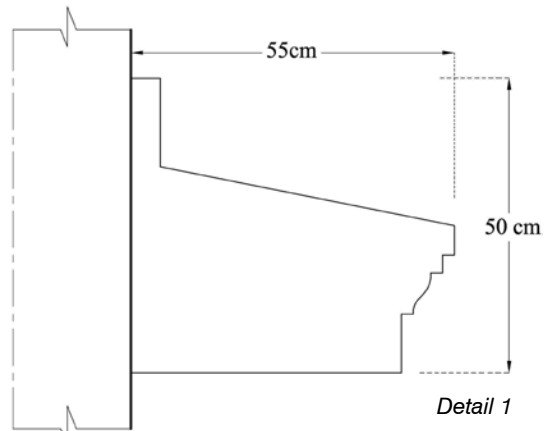
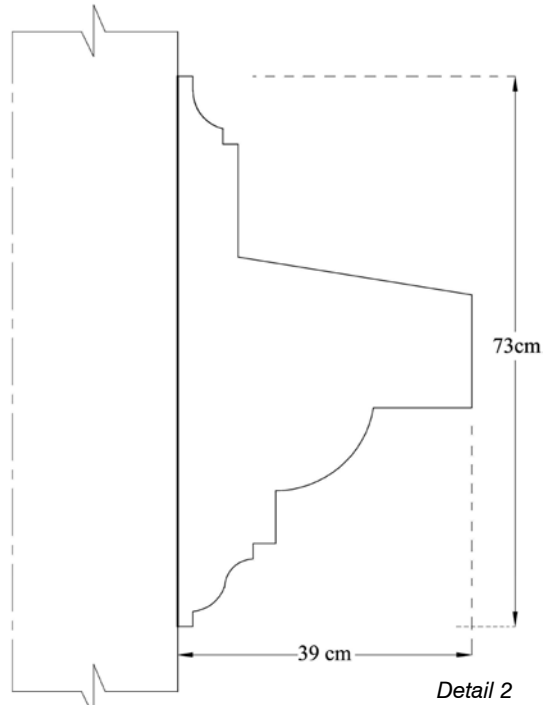
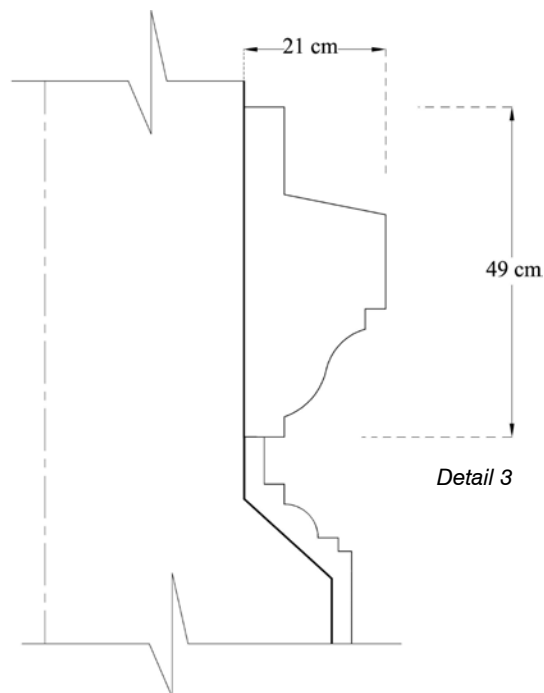
By mid-2006, another inspection of the building was carried out upon the request of the owner. The skeleton was intact, but some façade elements, especially cornices with big projections, suffered from edge spalling and cracks. Figure 8 shows details of façade cornices and relief elements with their sophisticated outlines. The reasons and proposed solutions for this problem are now under assessment.

Fig. 8: Section elevation showing typical relief ornaments in the façades of the palace (1 cm = 0.39 in.)
