ZORN PUMP STATION NO. 1 RESTORATION

BY MICHAEL BREETZ AND STEVEN ROYALTY

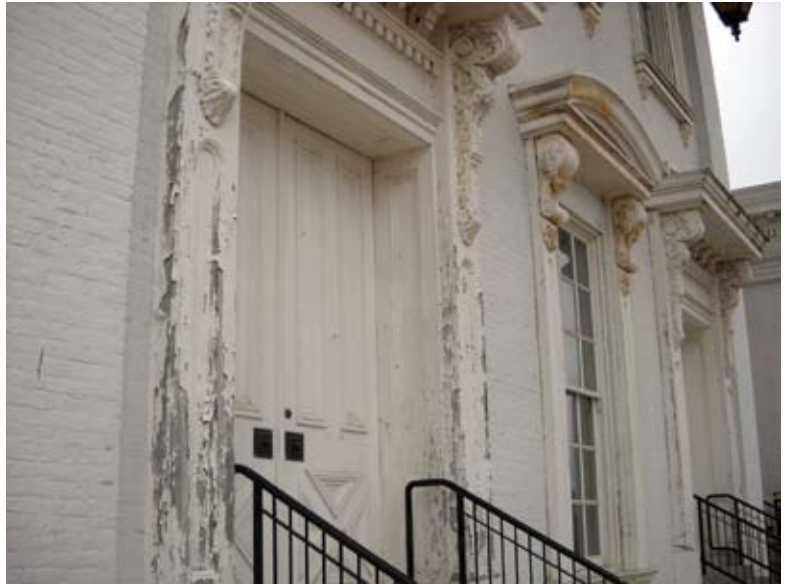
Typical deteriorated coating

Given the age of the building and all the detrimental environmental factors over the years, the historic pump station was very much in need of new protective coatings. A few of the building's existing coatings were never removed; they were simply scraped and recoated. Before the paint removal process began, the paint was tested and was found to contain high levels of lead. Once the coating removal process started, it was discovered that, in some areas, the lead-based coatings were up to 0.25 in. (6.4 mm) thick.

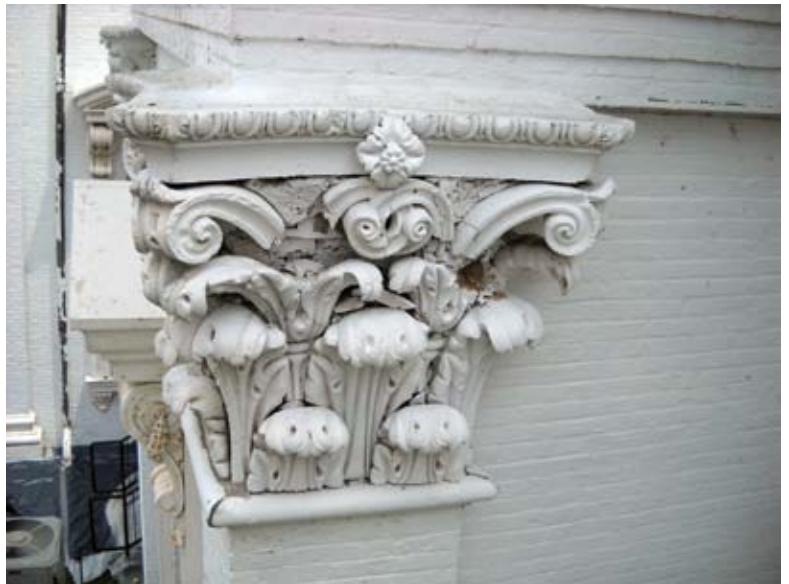
Before the restoration work began, several investigations had to take place—the most intensive was that of the extremely ornate terra cotta column capitals and modillions. The building includes two different sizes of capitals and six different sizes and profiles of modillions. Several weeks were spent inspecting, documenting, labeling, and numbering each individual column capital piece and each individual modillion. For each of the 792 capital's terra cotta pieces and 448 modillions, current condition notes were taken and repair recommendations were made for any terra cotta piece requiring more extensive restoration work. During the inspection and documentation, it was determined that the capitals and modillions were in far worse condition than anyone initially anticipated.

Typical deteriorated capital

To restore the terra cotta column capitals and modillions, many different methods and techniques were used, depending on the type of deterioration. If the terra cotta was spalled or deteriorated, a special repair mortar was used to reprofile the damaged area to match the existing texture. If the terra cotta piece was cracked, it was injected with a structural bonding epoxy. If the column capital piece was too deteriorated to be repaired on site or missing, it was replicated. Because of the historic nature of this project, standards and guidelines for restoring historic buildings set by the National Park Service were followed. To ensure an exact in-kind match of the terra cotta pieces, one of the large capitals, one of the small capitals, and one of each type of modillion in good condition was disassembled and shipped to a California terra cotta manufacturer that specializes in replicating historic terra cotta pieces. The terra cotta replica pieces had a 9-month lead time that really drove the project schedule.

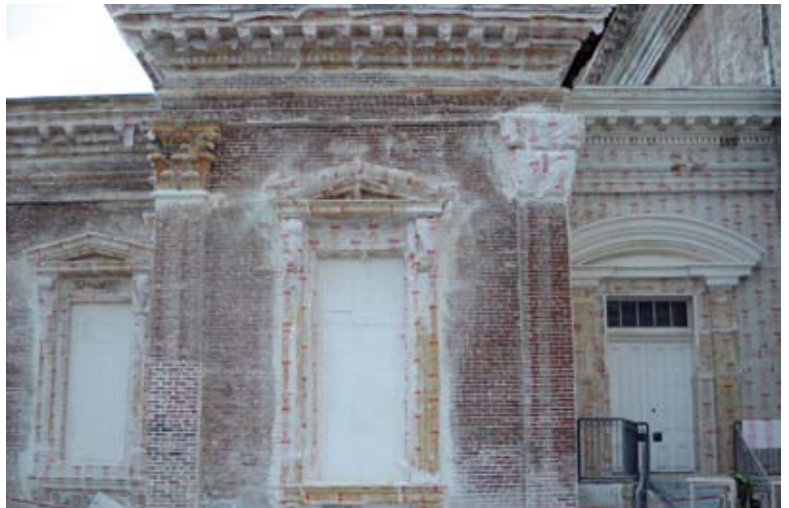
As doors and windows were removed to be repaired, openings were filled to prevent moisture infiltration

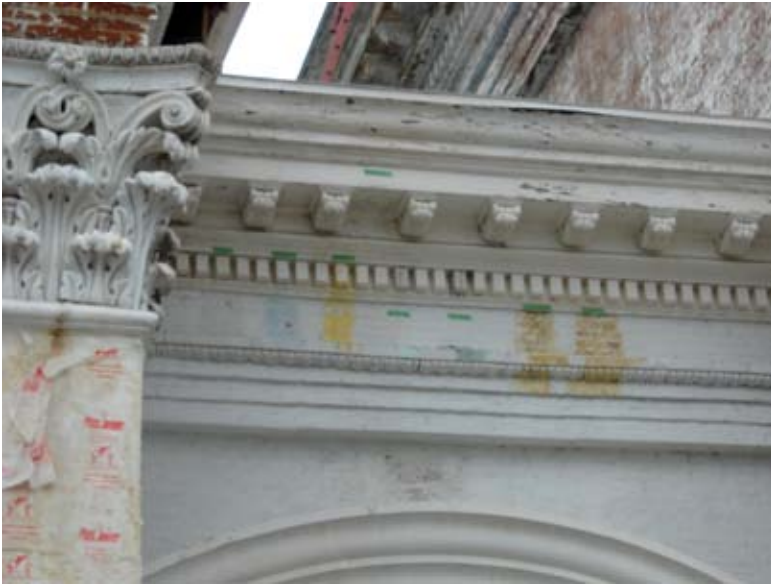
Different product mockups were tested to determine the most effective coating removal product

not damage the substrate. Following these guidelines determined the scope and methods of repair. The application methods employed and product selected to aid removal also changed after the mockups for the coating removal. The building had an unusually thick amount of existing coatings on a large variety of different materials. There were a variety of different substrate materials that complicated the process because what worked on the wood may not work as well on the masonry. Additional mockups were performed using around 15 different coating removal products until one product was selected that gave the most desirable results.

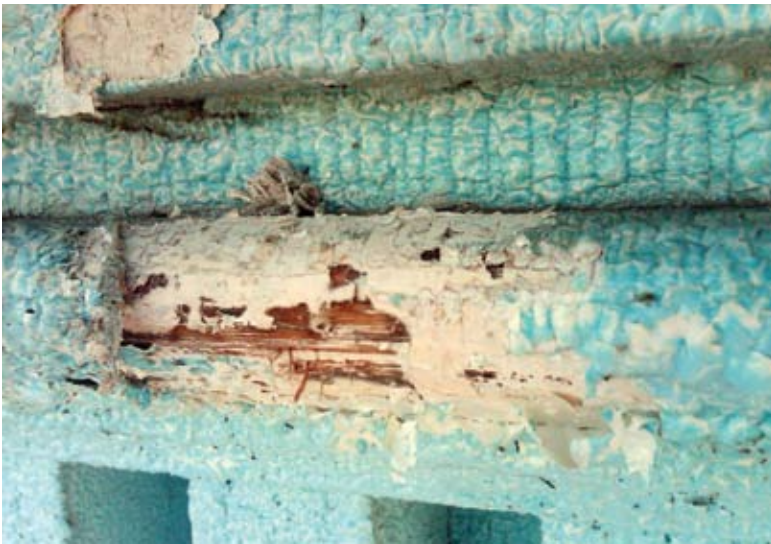
The specified paint removal product was ineffective against the unexpected 0.25 in. (6.4 mm) thick existing lead coatings

One of the things that makes restoration work so interesting is that with every project, you find something new and surprising that catches you off guard. This restoration project was no different. The biggest surprise here was discovering that the 0.25 in. (6.4 mm) thick coating material needed to be removed so that the new coatings would properly adhere. This thick coating also helped to hide a great

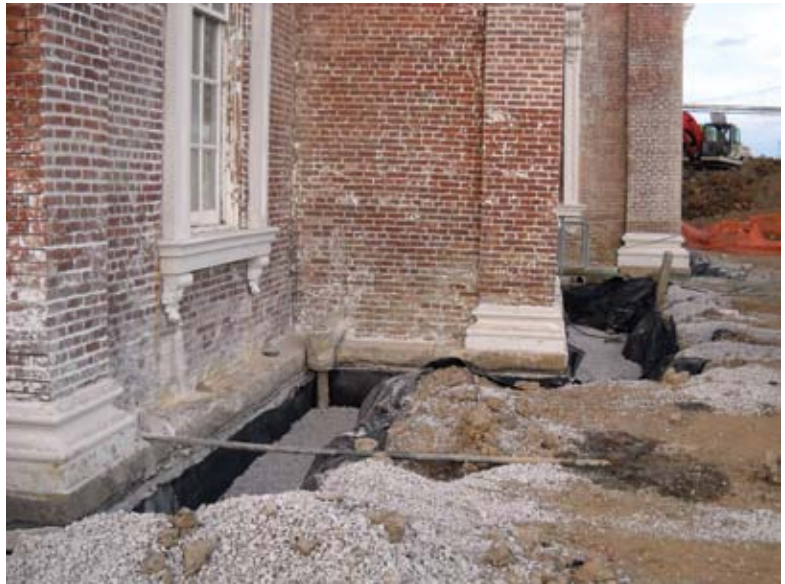
- The existing building continues a couple stories below grade—the floors have since then been infilled and are no longer accessible.
- With the building’s flood plain location and high water table, the building has had problems of wicking water up the masonry. An elaborate drainage system incorporating dry wells was installed.

West elevation waterproofing excavation and north elevation waterproofing installation

- The coating previously used on the building prevented the masonry from breathing and held water in the masonry. This helped deteriorate the masonry faster. To prevent this, 4 ft (1.2 m) of foundation waterproofing and five dry wells were added to promote proper drainage at the foundation. This was a challenging process at the perimeter because of the existing utilities around the building. It became more challenging at the west elevation, where the grade is higher on the building. At this point, the excavation was 16 ft (4.9 m) below grade in an already tight location.

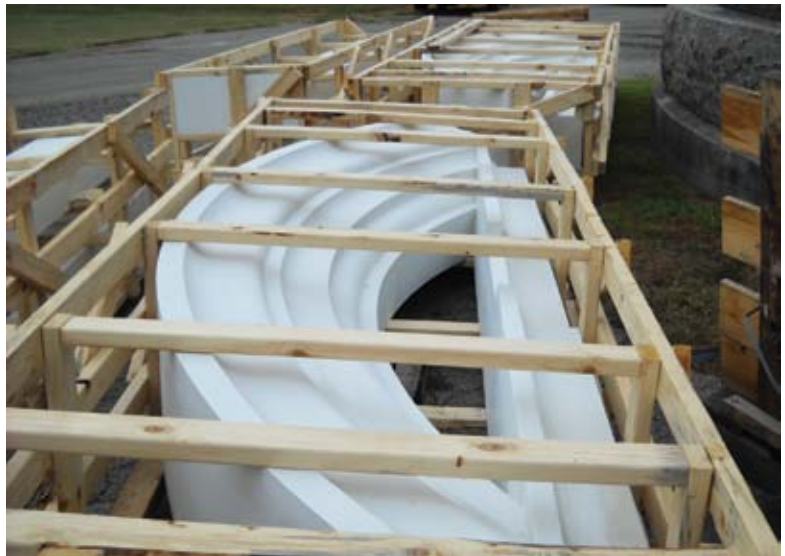
GFRC piece replicated to match the existing cast iron door surrounds

- At some point in the building’s history, the cast iron door surrounds were removed from the north elevation of the building. Glass fiber-reinforced concrete (GFRC) replicas were created to match these cast iron surrounds, and they were installed on the north elevation to bring the architecture details back to the building.
