REHABILITATION OF THE MONUMENT TO THE REVOLUTION IN MEXICO CITY

EDITED BY KELLY M. PAGE

Structure of the Monument to the Revolution

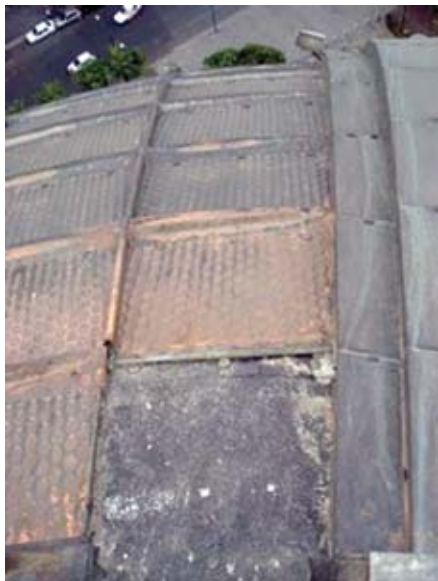
Copper roof cover removal

- Removing and salvaging the existing copper roofing plates;
- Removing unsound concrete in the cupola concrete lining and on the observation deck level;
- Restoring the damaged portions of the concrete section;
- Epoxy injection of cracks through the dome;
- Installation of a waterproofing system over the concrete dome and over the observation deck floor;
- Putting back the refurbished copper roof plates; and
- Repair and protection of the façade stones.

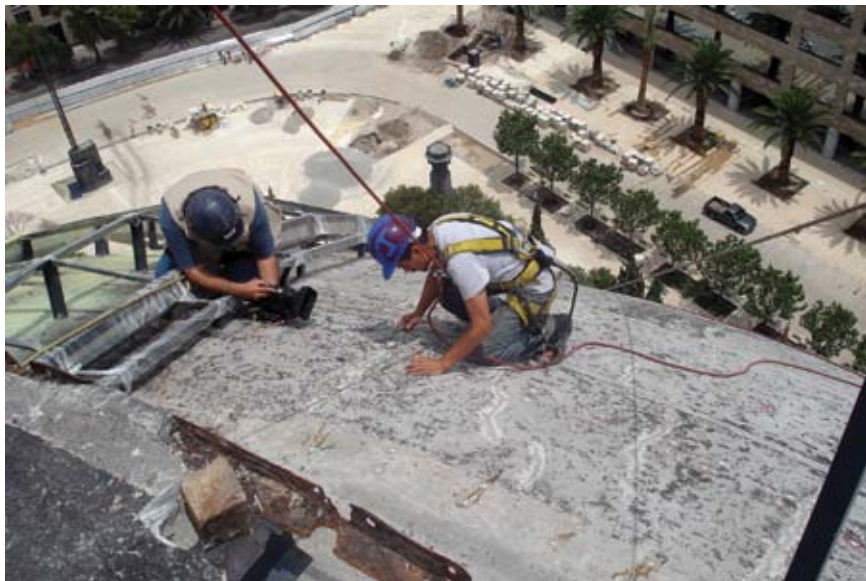
Crack injection

The concrete repairs, epoxy injection, and waterproofing on the top side of the dome all presented some unique challenges given the ever-changing slope of the domed roof. The unsound concrete was removed from the exterior of the dome and replaced with a prepackaged shrinkage-compensated repair mortar. Cracks were sealed and injected with a low-viscosity injection (LVI) epoxy. Once the repairs were complete, the surface of the dome was prepared to the appropriate profile to receive a waterproofing membrane. The membrane selected was a 100% solids, spray-applied polyurea. This material was selected in part because it could be readily placed on the sloping exterior of the dome, but it was also selected based on its temperature resistance. The membrane was required to resist service temperatures of 194°F (90°C) that were estimated to be present in summer months between the copper roofing plates and the concrete.

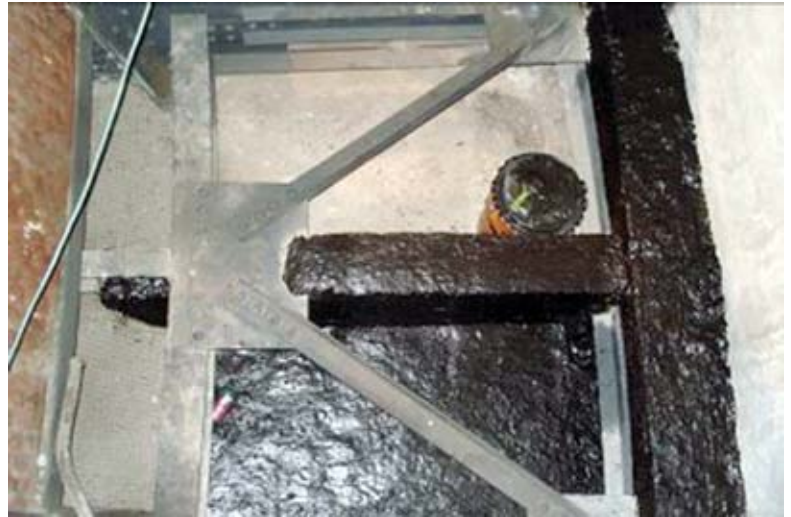
Waterproofing cupola's interior

In addition to the exterior repairs and waterproofing, the interior of the cupola received a cement-based acrylic coating and the joints were

sealed with a polyurethane asphalt-modified sealant. The copper plates that were removed were cleaned and polished before being reinstalled on the roof of the cupola.

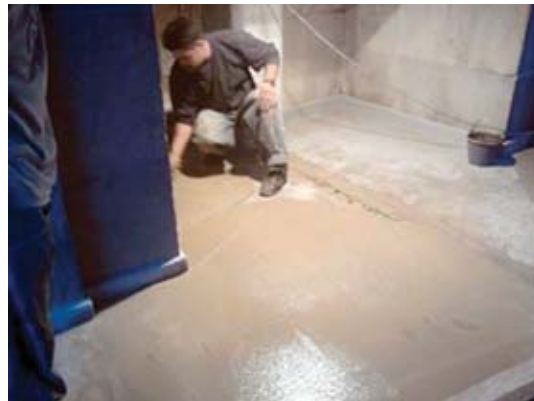
Leveling slopes with premix mortar

The concrete floor on the observation deck at the base of the cupola was also repaired with a leveling prepackaged mortar. The deck was properly sloped

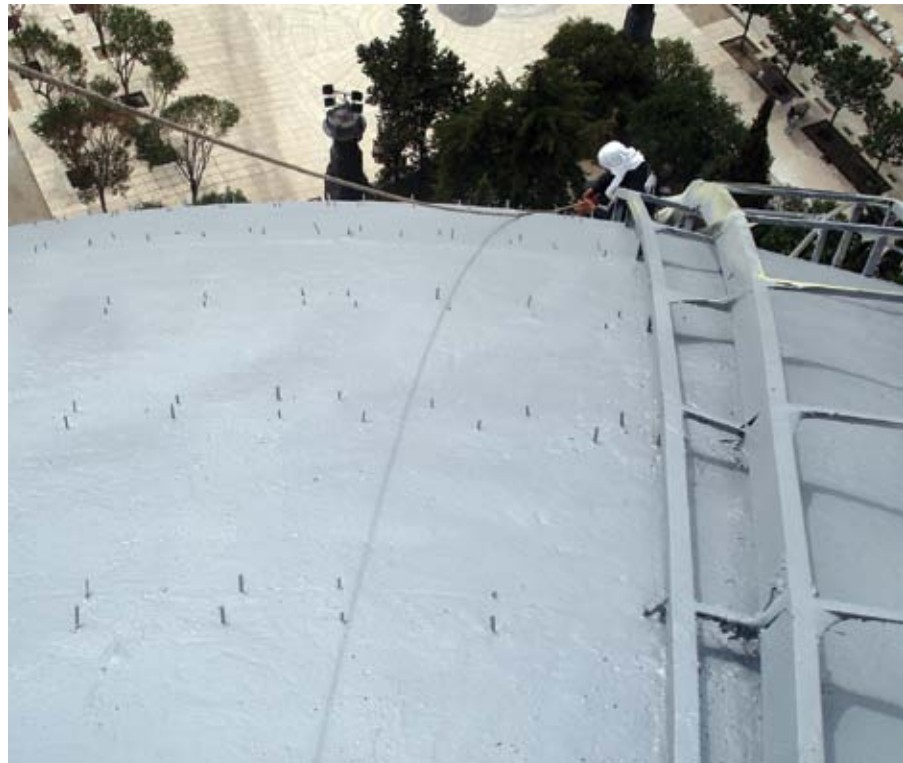
Waterproofing application of the cupola

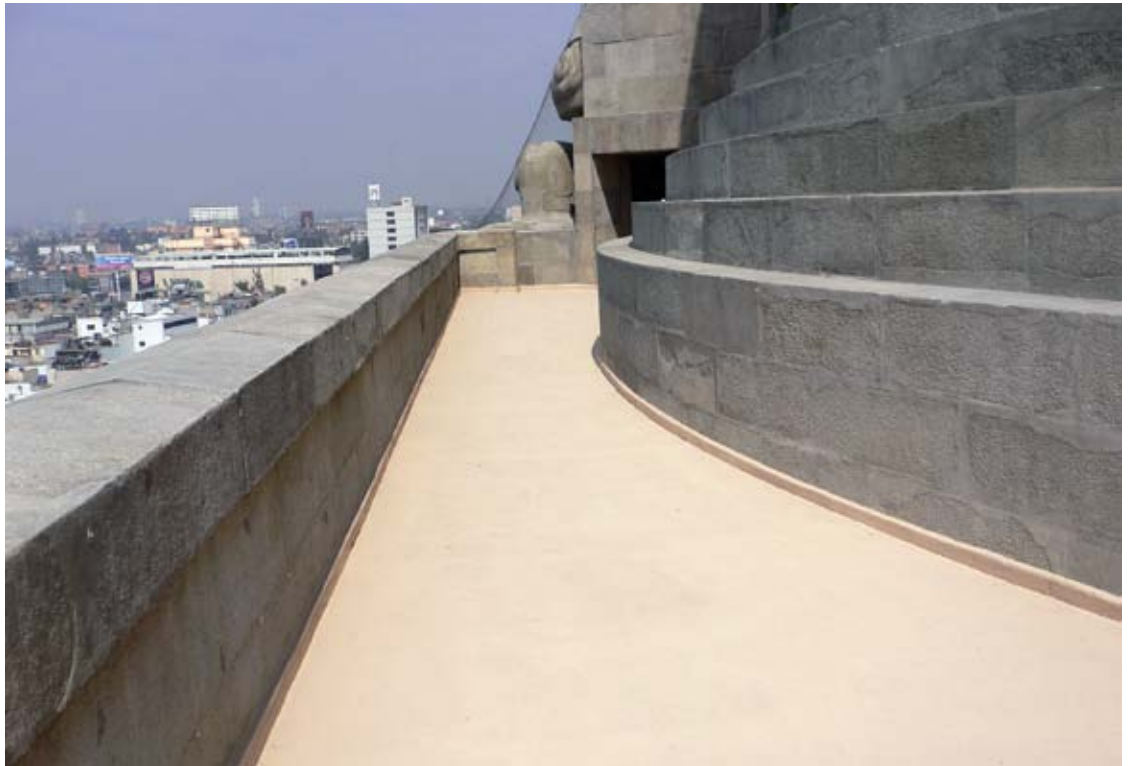
Waterproofing membrane on observation deck

and coated with a polyurethane waterproofing membrane system.
