EMERGENCY MASONRY REPAIRS TO SAM H. WHITLEY HALL

TEXAS A&M UNIVERSITY AT COMMERCE

BY MARK LEMAY

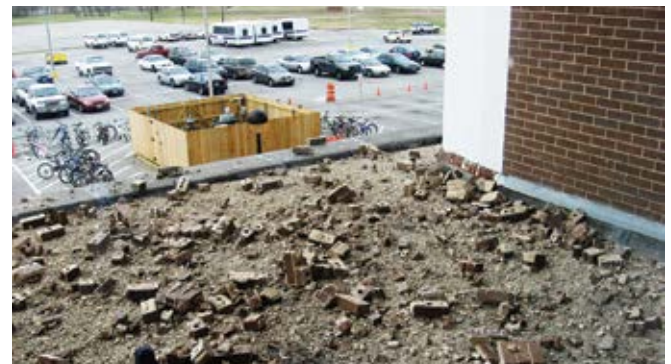
Fig. 2

In January 2012, 2 days prior to the start of the spring semester, an unusually severe wind storm resulted in a potentially life-threatening situation at Whitley Hall. Winds in excess of 60 mph (97 kph) caused a 10 x 12 ft (3 x 3.7 m) section of brick veneer to become dislodged from the southeast face of the Penthouse level (Fig. 1), falling 140 ft (43 m) onto the adjacent parking lot and first-floor roof of the resident assistant's apartment below (Fig. 2). Fortunately, no injuries resulted from this unexpected failure.

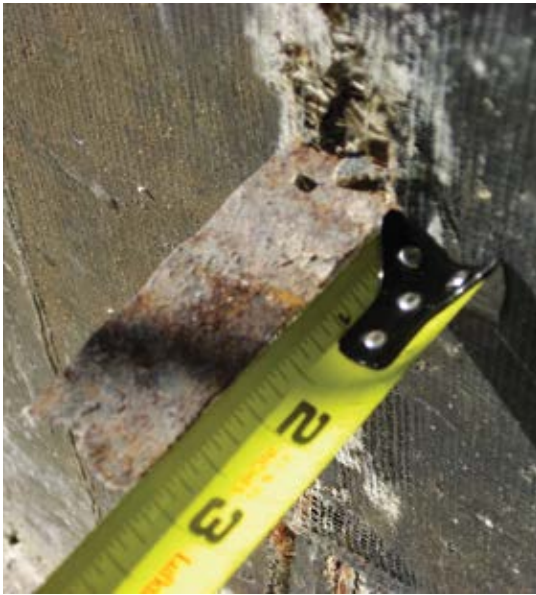
Fig. 3

1. Dovetail anchor slots were cast into the reinforced concrete backup wall.
2. Asphaltic damp-proofing was applied over the concrete backup wall.
3. Moderately to severely corroded corrugated metal wall ties occurred in some random portions of the failed sections of brick (Fig. 3).
4. Locations where the metal wall ties had been pulled out of the dovetail anchor slots were

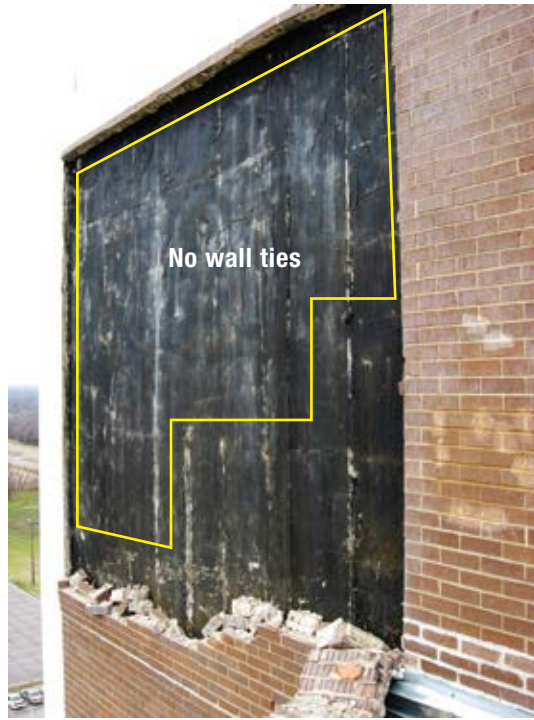
Fig. 4

observed only in the lower portions of the failed section—no such locations were observed in the upper two-thirds of the detached section of brick (Fig. 4).

Preliminary findings pointed to the absence of corrugated metal wall ties in the upper portion of the failed section of brick. Despite having remained in place for 43 years, the unique wind conditions that January evening most likely produced a vacuum effect that essentially sucked the untied brick veneer off the face of the building. The degree of corrosion observed on the metal wall ties also created a significant degree of uncertainty regarding the integrity of the remaining ties. Immediate plans were made to review original drawings and further investigate the condition of the metal ties in other sections of the exterior walls.

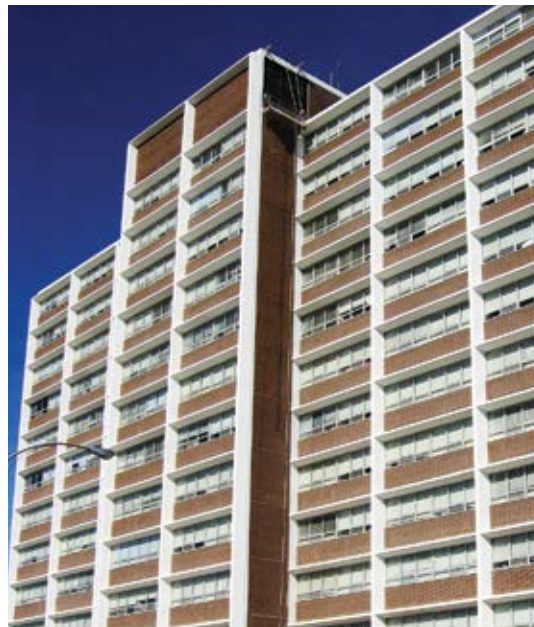
Fig. 5

Immediately following the initial evaluation performed the day following the event, the university recognized the severity of the situation and took swift and decisive measures to authorize emergency action. A contractor was hired and a swing stage scaffold was put into place at the location of the dislodged section (Fig. 5).

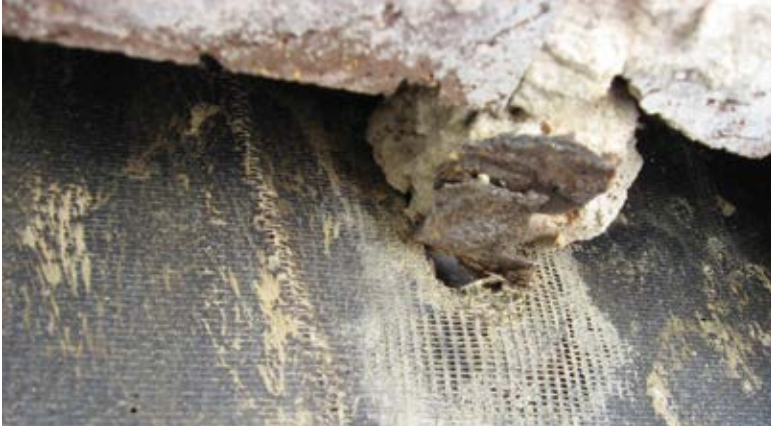
Fig. 6

The remaining brick veneer was removed from the failed section and close-up inspections commenced. The existing corrugated metal wall ties were located using nondestructive methods. At all locations, the spacing of the wall ties was found to be extremely variable, and not in conformance with the project requirements. Random sections of the brick veneer were removed to examine the condition of the ties. Corrosion on the corrugated, galvanized ties ranged from mild to severe. A few of the ties were observed to be completely severed, thereby providing no anchorage to the backup wall (Fig. 6).

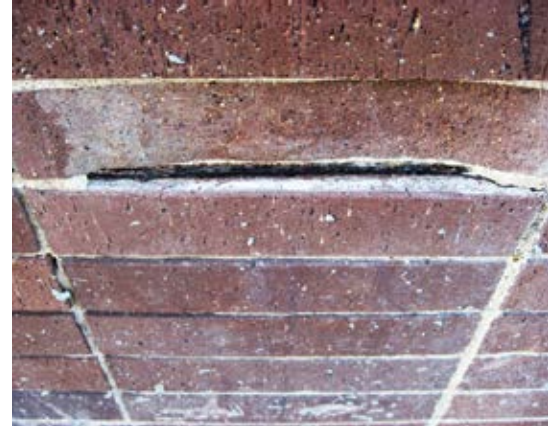
Fig. 8

mortar were exhibited. Ladder-type reinforcement installed too close to the exterior surface of the joint resulted in significant corrosion of the steel and spalling of the mortar (Fig. 8). Investigation of the metal wall ties in the stacked bond veneer revealed the same random spacing and mild-to-severe corrosion found in other locations.
