REPAIR OF DRAPED MESH CONCRETE SLABS

BY KIRK M. STAUFFER AND KEVIN C. POULIN

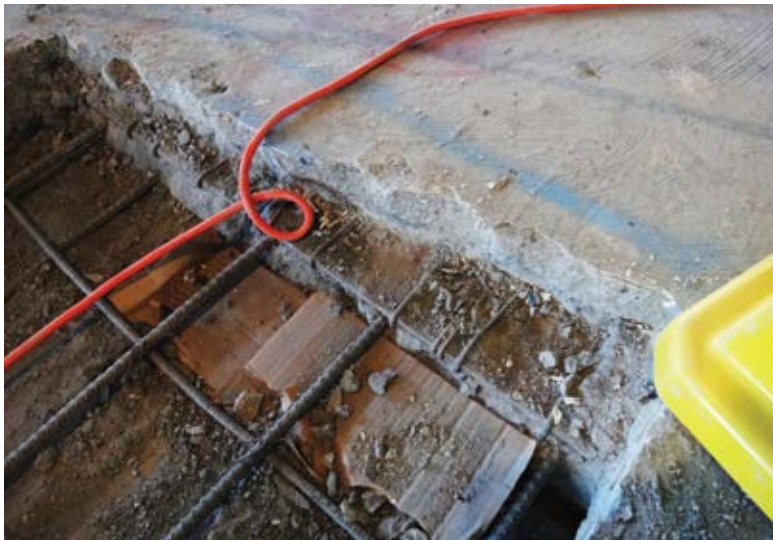
Fig. 1: Typical method of mesh anchorage where welded wire reinforcement is bent and hooked around beam flange

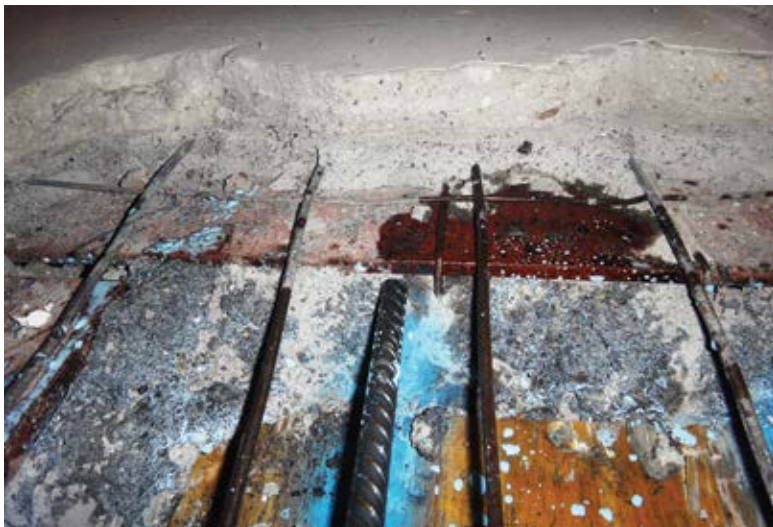
Fig. 2: Perimeter of repair where existing reinforcement extends uninterrupted through repair area

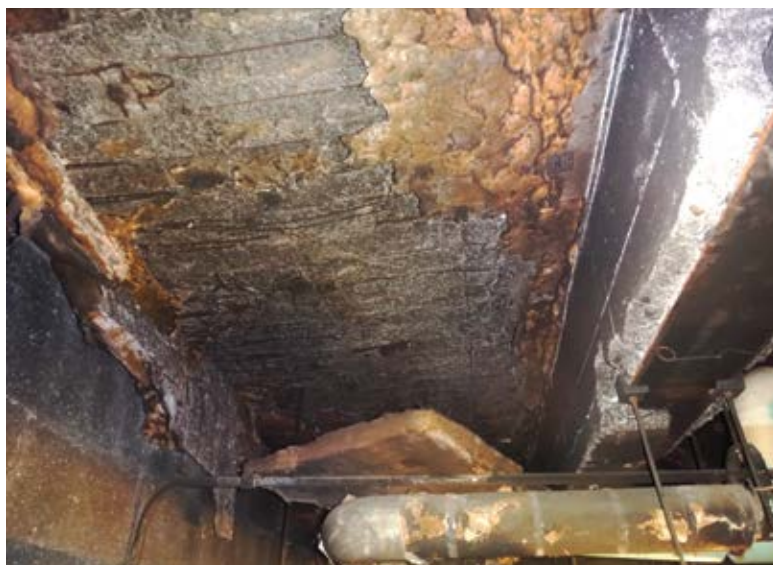
Draped mesh cinder-concrete slabs have been repaired or strengthened due to deterioration (corrosion of the reinforcement and deterioration of the concrete resulting from exposure to water/moisture over time) (Fig. 3 and 4); due to damage (physical

Fig. 3: Deterioration of slab due to corroded reinforcement at slab underside

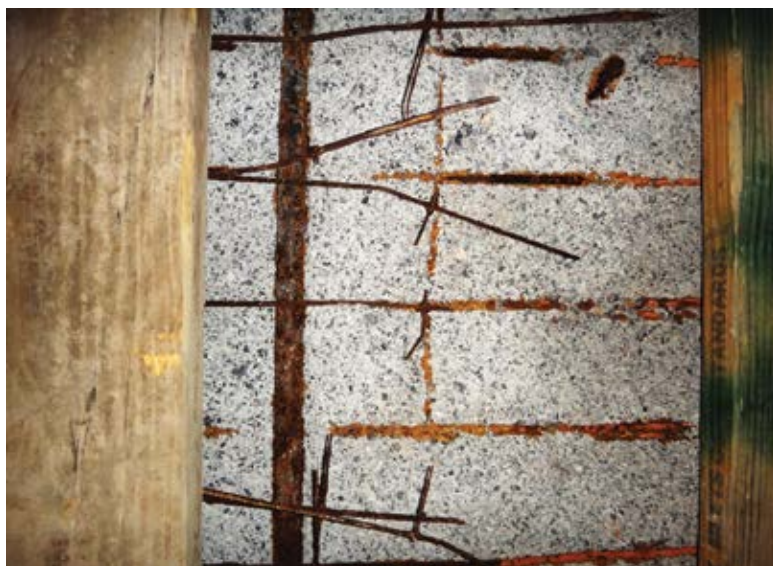
Fig. 4: Close-up view of corroded reinforcement at slab underside

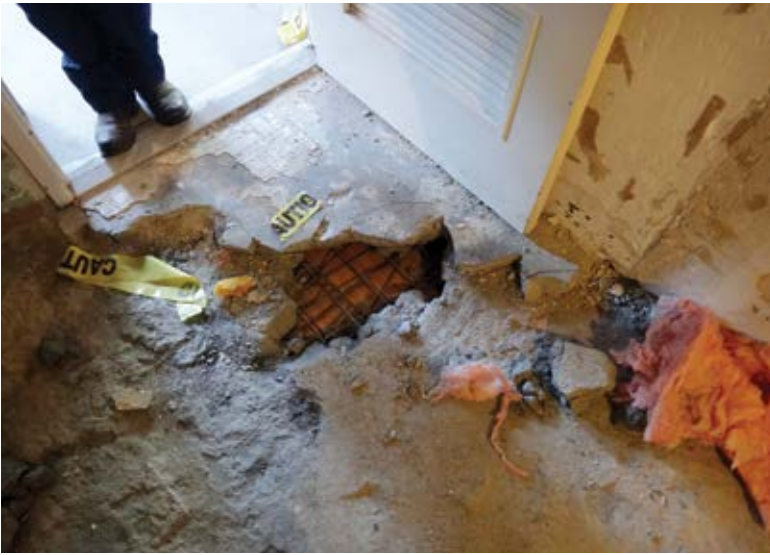
Fig. 5: Partial-depth and full-depth slab damage from finish removal during a tenant fit-out

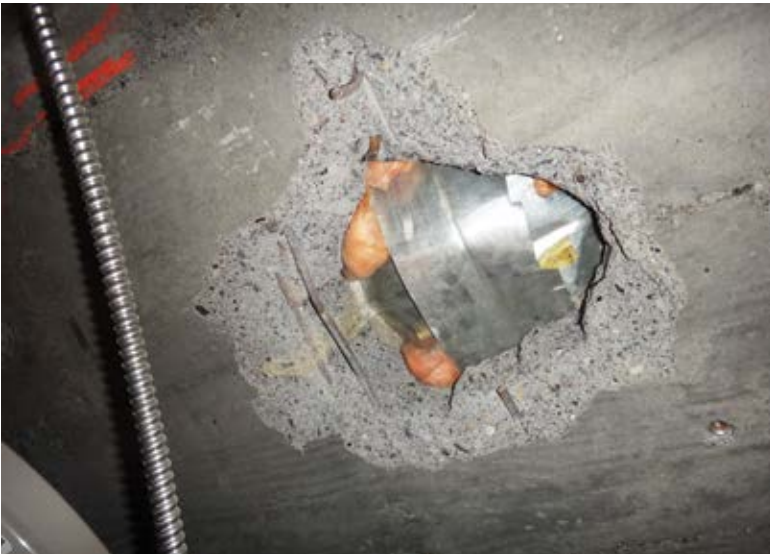
Fig. 6: Existing poorly executed repair made at a full-depth penetration

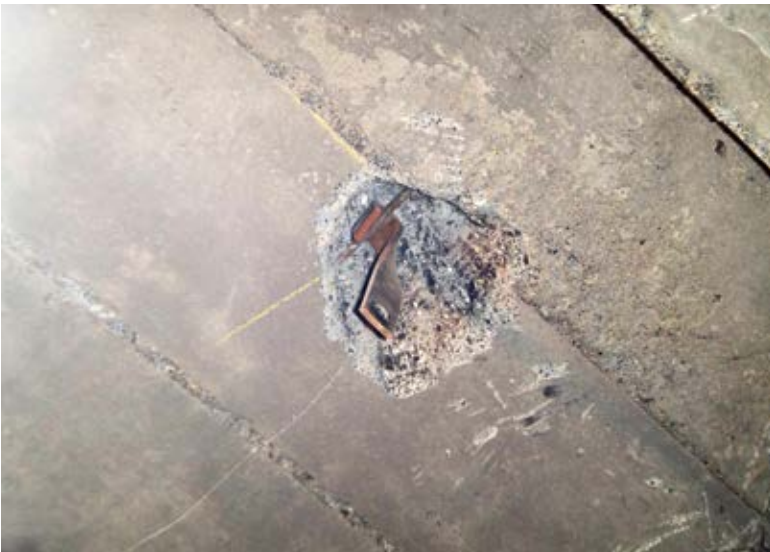
Fig. 7: Partial-depth slab damage where a wire of the reinforcement was exposed and used for supporting a hanger

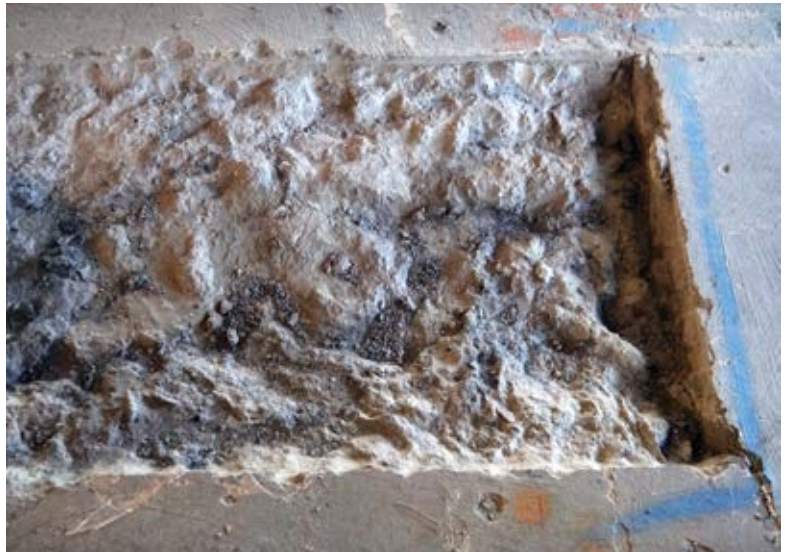
Fig. 8: Selectively demolished partial-depth repair area at top of slab

Partial-depth repairs typically start with carefully removing the compromised cinder concrete, using hand methods, to expose the welded wire reinforcement and prepare the substrate. Power tools are not recommended for this work because of the brittle and unpredictable nature of cinder concrete. Furthermore, care should be taken during selective demolition to avoid loosening the reinforcement from the underside of the cinder concrete, and to avoid disturbing the bearing of cinder concrete onto the reinforcement. In every case, exposed reinforcement should be cleaned, examined for section loss, and coated with a corrosion inhibitor. In smaller areas where an individual wire of the reinforcement is exposed locally, the most common approach is to repair the area with a suitable trowel-applied overhead repair material. At locations where the corrosion of the reinforcement is widespread but the remaining cross section is still sufficient and the bearing of the cinder concrete on the reinforcement is not compromised, a new layer of expanded metal lath can be mechanically anchored to the underside of the slab and a new layer of repair material (troweled, shot, or formed and pumped), for fire and corrosion protection, can be applied. At locations where the cross section of the reinforcement is

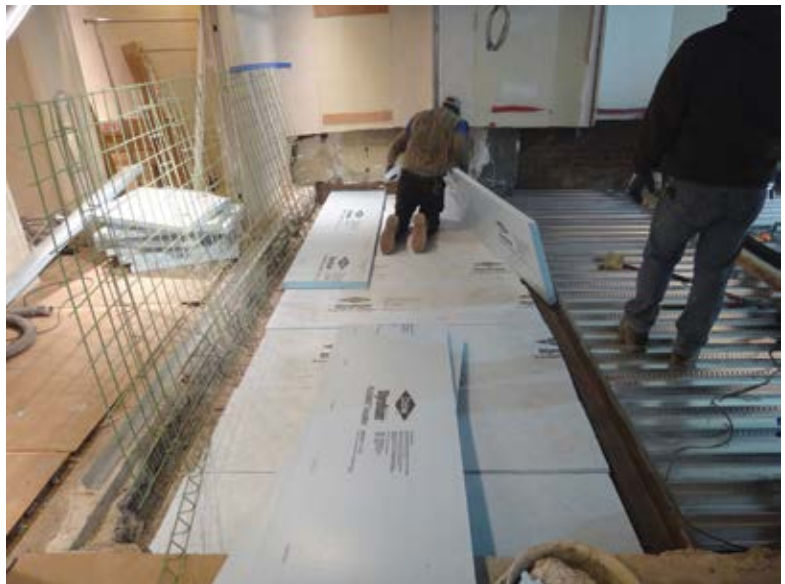
Fig. 9: Unbonded topping slab repair area (with foam filler) adjacent to full-depth repair area on composite metal deck

vided that it can support its self-weight unreinforced. Less-deteriorated slabs can typically remain in place. In most instances, existing finishes, previous toppings, and cinder fill are removed for an unbonded topping slab. If the thickness of cinder fill is greater than the thickness of the topping slab, layers of rigid polystyrene can be installed to act as lightweight filler and to achieve the desirable finished-floor elevation (Fig. 9).

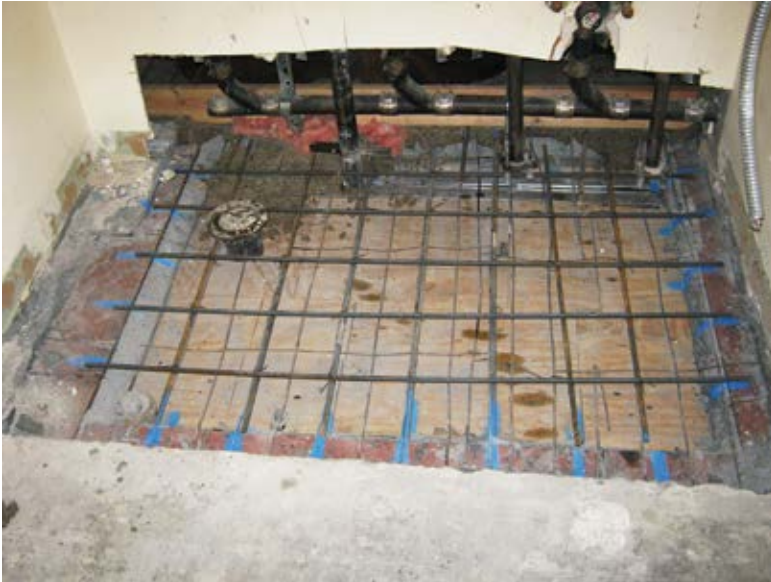
Fig. 10: Full-depth repair area with existing reinforcement and new additional reinforcement placed on wood formwork

bays, placed as a precaution until the wire reinforcement can be properly anchored. Additional shoring, placed in the bays designated for replacement, is used as a work platform for demolition and to assist with formwork installation. Demolition proceeds with a saw cut at the repair perimeter, typically located over the centerlines of beams and girders. The depth of saw cut should not cut or damage the welded wire reinforcement and/or beam flange. Initially, demolition with small electric rotary or pneumatic hammers can remove the bulk of the cinder concrete at the center of the slab. Finally, selective demolition with hand tools is performed to remove the remaining cinder concrete within about one foot of the saw-cut perimeter. The extent of demolition and condition of the remaining cinder concrete, beams, and reinforcement are reviewed, and further action taken if necessary, prior to proceeding with installation of the new slab reinforcement. Once the new reinforcement is installed, ready mixed concrete or prepackaged repair material (typically extended with aggregate) is placed.

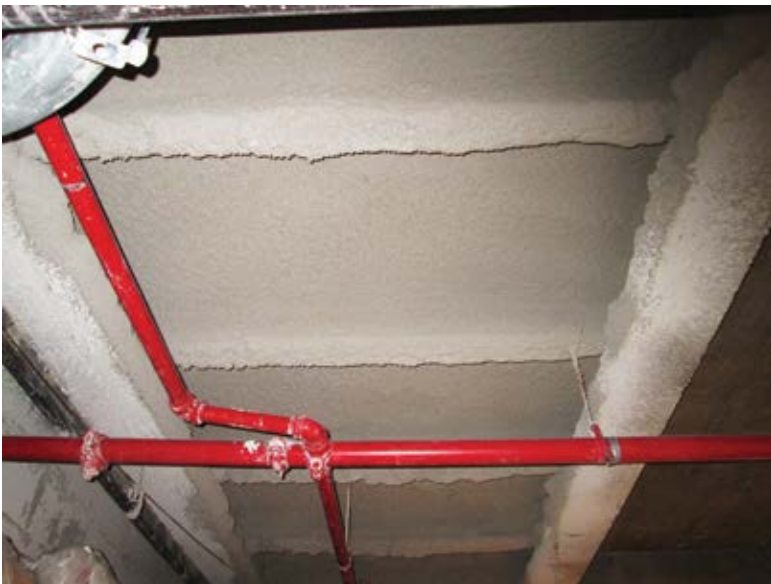
Fig. 11: Closely spaced channels of supplemental support repair (shown after spray-on fireproofing was applied)

At locations where a full-depth repair is performed but the reinforcement in an adjacent span cannot be properly anchored, it may be necessary to support the adjacent spans by providing supplemental supports (Fig. 11). In situations where the reinforcement's ability to carry load in tension through catenary action is interrupted due to lack of anchorage, closely spaced steel channels can be installed at the underside of the slab, parallel to its span, and connected to the existing steel beams. These new channels are sized and spaced to carry the self-weight of the slab and any superimposed loads. The slab can then be analyzed to span as plain concrete perpendicular to the new channels (parallel to the beams) using conservative material strength assumptions. In some cases, steel plates can be installed directly below that slab to act as a deck between the new channels. After the new steel is installed, the space between the underside of the slab and the top of the new steel is pumped or dry-packed with a nonshrink grout.
