HICKAM AIR FORCE BASE HEADQUARTERS

CRAWL-SPACE COLUMN REPAIRS AND CORROSION MITIGATION

BY TORE O. ARNESEN AND J. CHRISTOPHER BALL

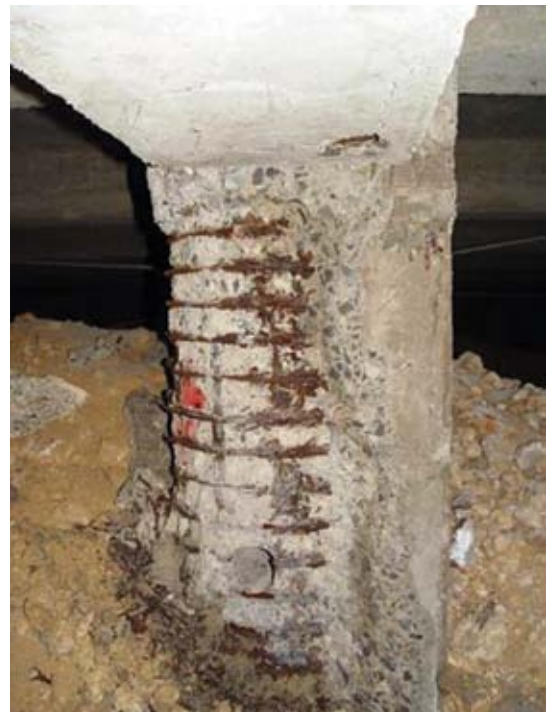
Fig. 3: Corrosion damage to the crawl-space columns

Concrete damage and reinforcement corrosion were observed in a substantial number of crawl-space columns (refer to Fig. 3), typically at or near the interface with surrounding soils. In particular, significant corrosion damage was visible at the chamfered edges where there was less concrete cover over the reinforcing steel.

Based on the field survey and test results, it was determined that the observed problems were caused by chloride-induced corrosion of the rein-

forcing steel. In sufficient quantities, chloride ions destroy the normal passive oxide protection that encases the reinforcing steel, leaving the structure vulnerable to corrosion. The corrosion by-product is expansive in nature and leads to concrete cracks, delaminations, and spalling.

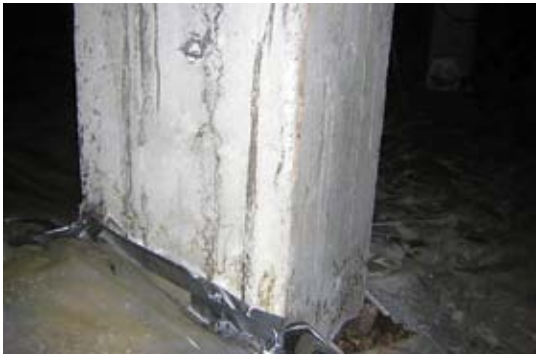
Fig. 4: Column with no damage (green condition)

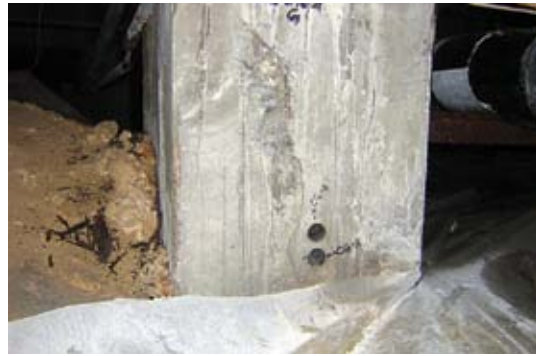
Fig. 5: Column with minor damage (yellow condition)

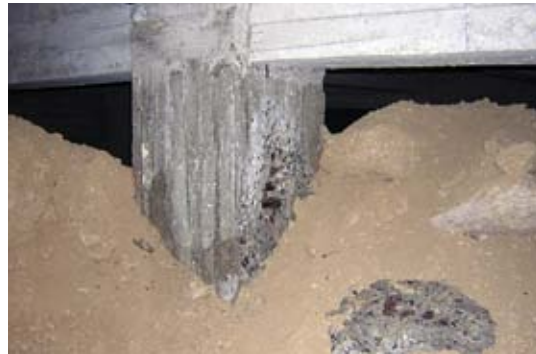
Fig. 6: Column with intermediate damage (blue condition)

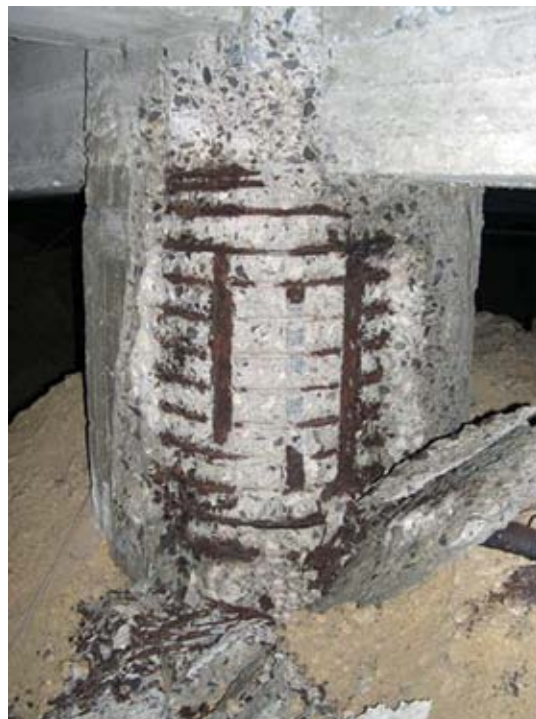
Fig. 7: Column with severe damage (red condition)

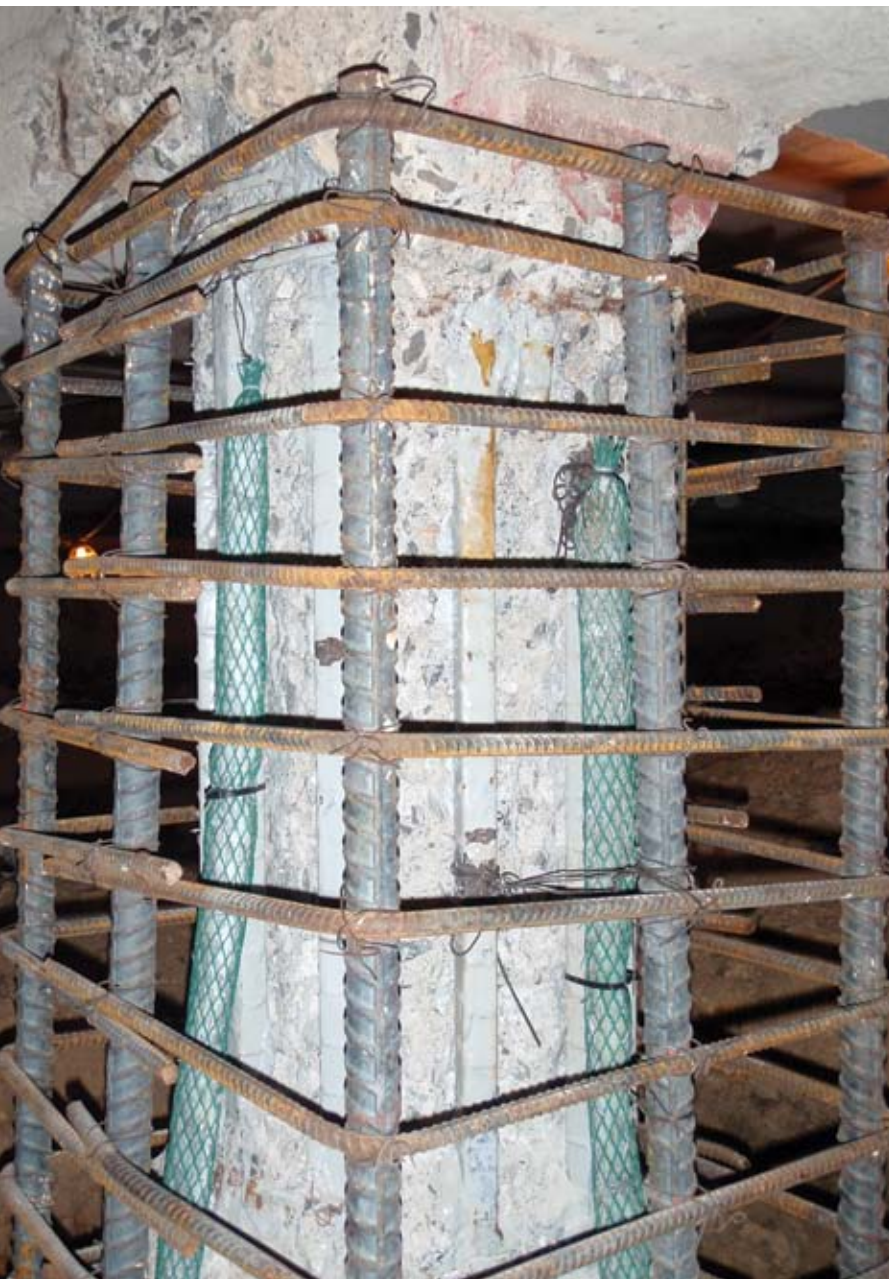
Fig. 8: Galvanic encasement protects and strengthens severely damaged columns

At the most severely damaged columns (blue/red), the columns were overbuilt on all four sides and encapsulated with a new reinforced concrete jacket approximately 6 to 8 ft (1.8 to 2.4 m) in height. Both the existing and new reinforcing steel were protected by embedded galvanic anodes, which were 5.5 to 7.5 ft (1.7 to 2.3 m) in length (refer to Fig. 8). The repairs included the following work:

- Soil around the column was removed to expose the footer;
- All loose, spalled, and delaminated concrete was removed using small handheld chipping hammers;
- A new reinforcing bar cage was constructed around the columns;
- Embedded alkali-activated strip anodes were placed on each side of these columns, electrically connected to new and existing reinforcement, and then secured to the inside of the reinforcing bar cage; and
- The columns were then formed and poured with new concrete.

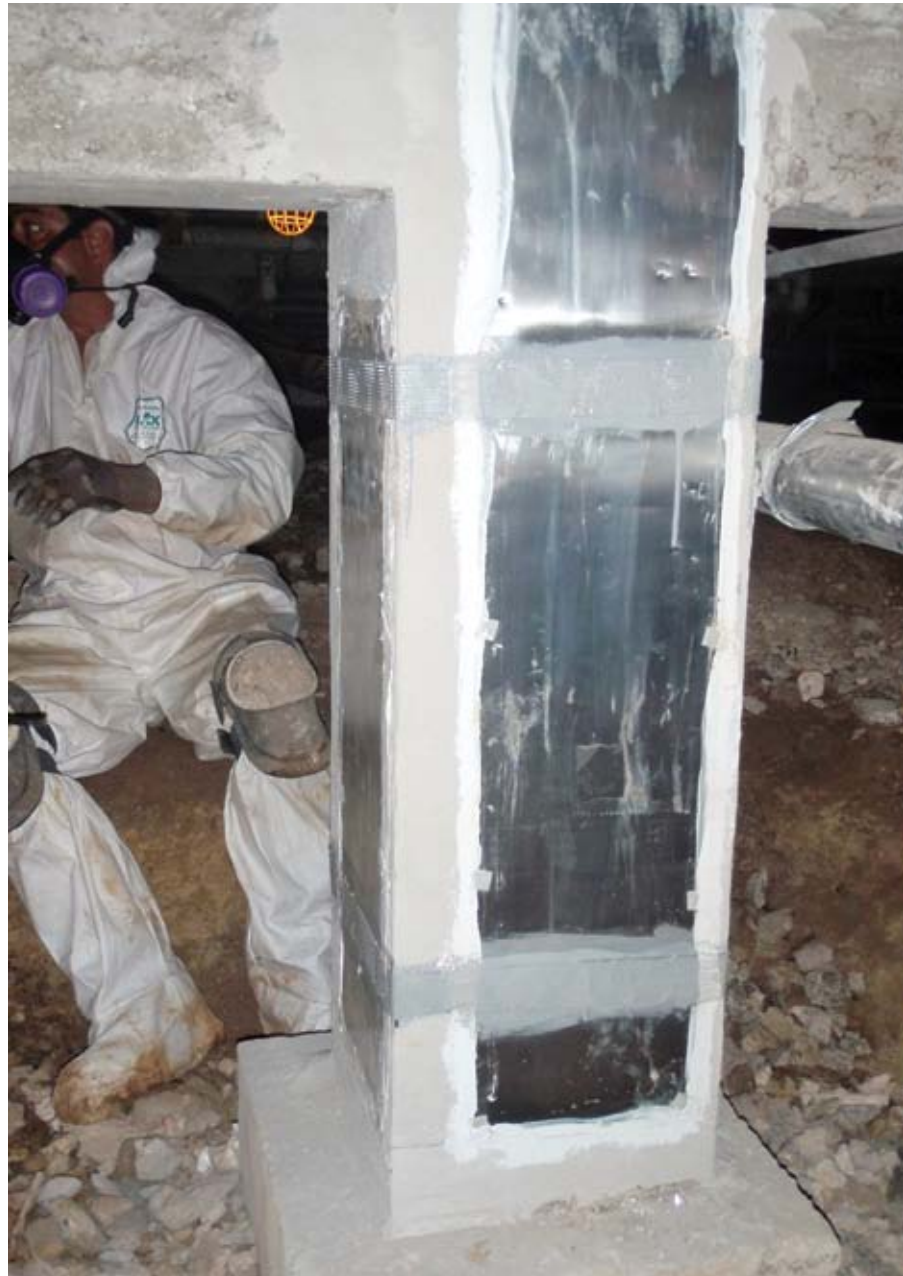
Fig. 9: Surface applied zinc sheet anodes prior to final coating

At the columns with little or no existing deterioration (green/yellow), zinc sheet anodes were surface-applied to all faces of the columns after the repairs were completed (refer to Fig. 6). The zinc sheet anodes use a preformed conductive adhesive that bonds the anode to the concrete surface while allowing ionic current flow between the anode and the reinforcing steel. These repairs included the following work:

- Soil around the column was removed to expose the footer;
- Electrical connections were made to the reinforcing steel;
- Concrete patch repairs were completed using ICRI guidelines and cured for 28 days;
- After surface preparation was completed and just immediately prior to installing the zinc sheet anodes, the columns were blown clean and free of dust;
- The zinc sheet anodes were installed in a vertical orientation;

- The zinc sheet anodes were interconnected by soldering zinc foil to each individual anode and connecting it to the electrical connectors;
- Nylon pins were installed at 2 ft (0.6 m) intervals along each edge of the zinc sheet anodes for supplemental anchoring; and
- Protection of the zinc sheet anode consisted of the use of a polyurethane adhesive along the zinc sheet edges with a final waterproof topcoat applied to the entire column (refer to Fig. 9).

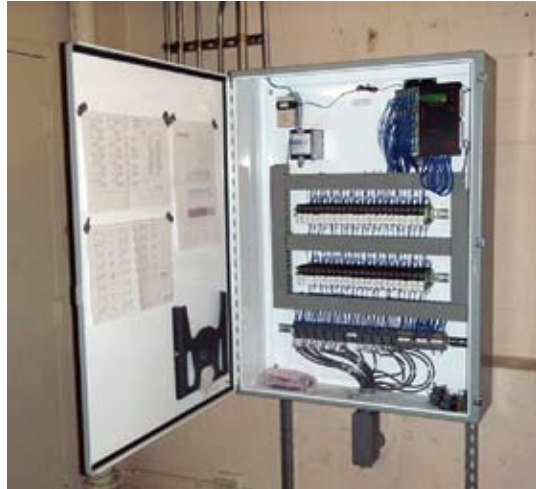
Fig. 10: Monitoring cabinet in central location

Although a galvanic system was selected, the USAF still wanted the capability to monitor a sample of the repaired columns. Remote monitoring of the protection system (refer to Fig. 10) was important to the owner because access into the crawl space is very difficult and, as a result, rarely done. Instead of requiring every column to be instru-

mented, a representative sample from each wing was selected. The instrumented sample locations included columns from each damage state.
