RENOVATION OF THE PURI ADHIMELATI OFFICE BUILDING AND FACILITIES (EXIM MELATI)

BY DAVID WHITE, HARI M. SANTOSA, AND HARTONO HIOE

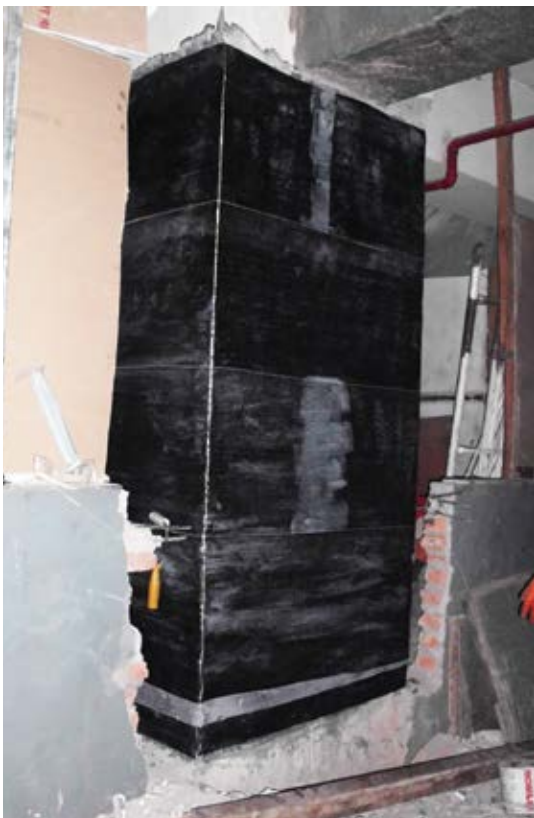
Fig. 3: Columns strengthened with carbon wrap

- **Foundation:** The capacity of the foundation still met the criteria of loading, so it did not need to be strengthened.
- **Columns:** The strengthening of columns was necessary on the basement floor and ground floor. A total of 18 columns were upgraded in confinement using CFRP wrap (Fig. 3).
- **Beams:** Shear capacity in almost every beam (approximately 231 beams) did not fulfill the loading criteria, so shear strengthening with carbon wrap was necessary. The CFRP wrap was applied from one to three layers onto three sides of the beam for a U-wrap application (Fig. 4). In addition, flexural strengthening was done on six beams located on the ground floor using carbon plates (Fig. 5).
- **Slab:** Slab capacity still met the loading criteria, so it did not need to be strengthened.

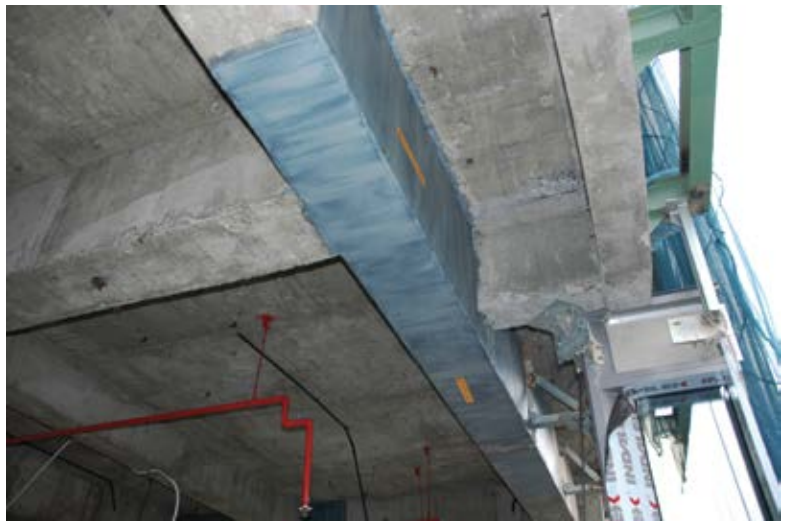
Fig. 4: Reinforcement of beam with CFRP

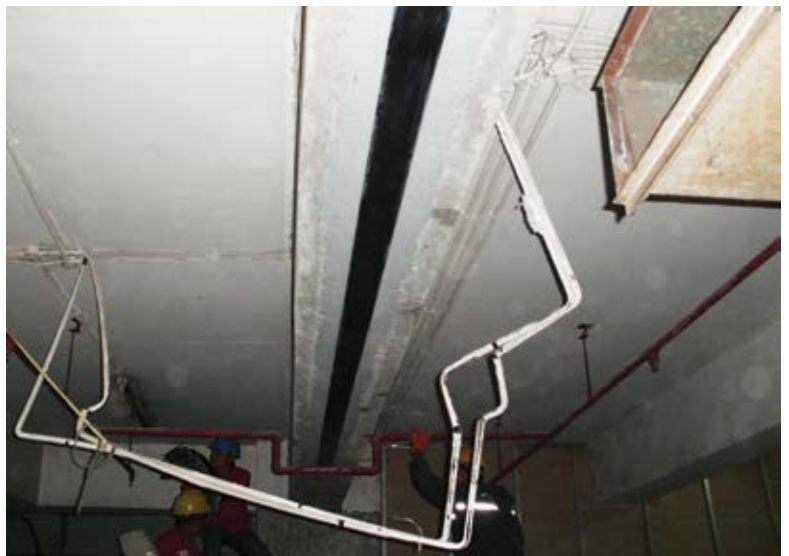
Fig. 5: Reinforcement of beam with carbon plate

The concrete surfaces were prepared by hand with a chisel and epoxy adhesive was then applied onto the cleaned carbon plate and prepared concrete substrate with a special “dome”-shaped spatula. The carbon plate was then placed onto the prepared substrate with both epoxy layers facing each other and the plate was pressed into place with a rubber roller until the epoxy was forced out on both sides of the plate; the excess adhesive was then removed.

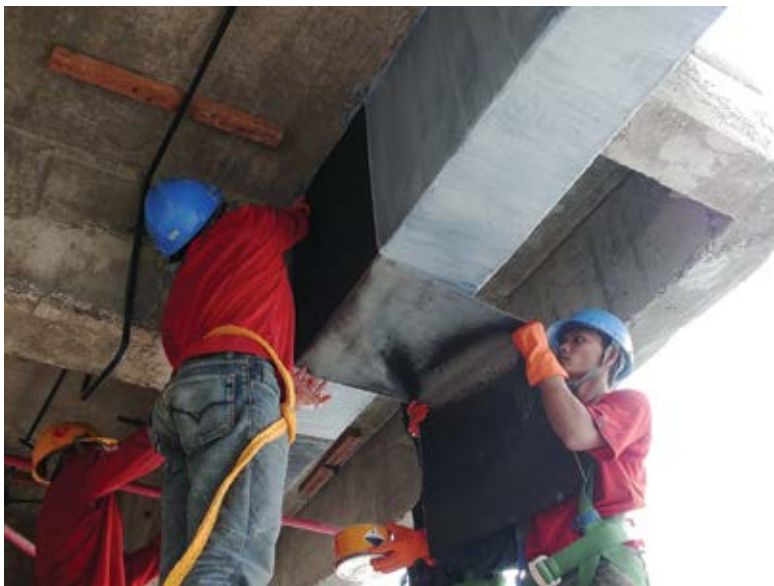
Fig. 6: CFRP being placed on adhesive

required direction (Fig. 6) onto the epoxy adhesive and then pressed with a plastic impregnation roller. The carbon wrap was rolled parallel to the fiber direction until the resin was squeezed out and distributed evenly over the entire wrap surface. For additional layers of carbon wrap, epoxy adhesive was applied onto the previously placed layer (Fig. 7) and the wrap application procedure was repeated.

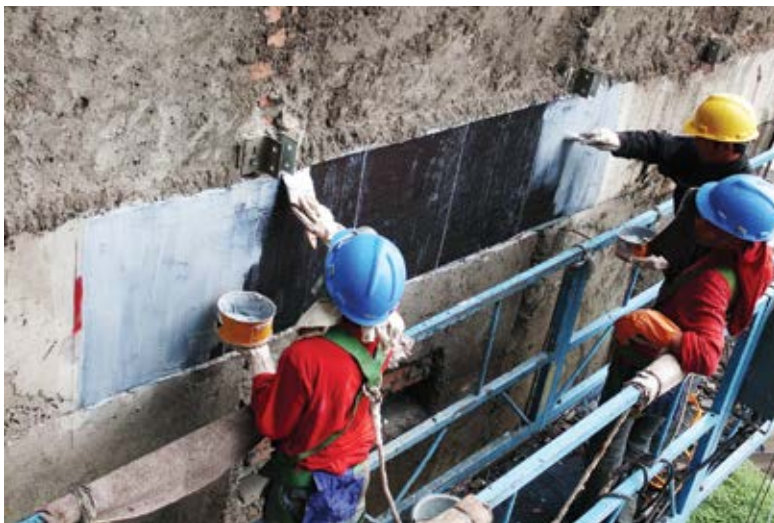
Fig. 7: Application of adhesive to previous CFRP layer

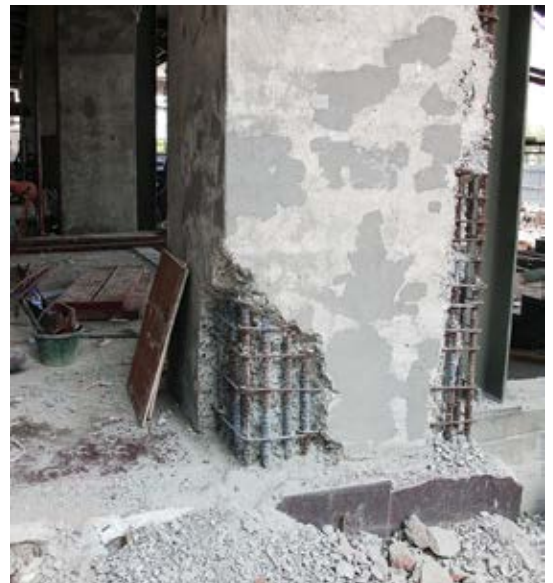
- Poorly consolidated concrete with voids was found at the corner of one column, which was not anticipated (Fig. 8). The column was repaired prior to the strengthening operation by using the form-and-pour method with nonshrink cementitious repair materials (Fig. 9).
- After surface preparation of beam members, numerous small air bubble voids were found. They were repaired by using an epoxy patching adhesive prior to strengthening (Fig. 10).
- Existing walls underneath beams around the elevator core wall and at external locations could not be removed. In these cases, the carbon wrap was not able to be applied onto the three sides of the beams to achieve a U-wrap (Fig. 11). After the engineer reevaluated the loads in accordance

Fig. 8: Poorly consolidated concrete found on column

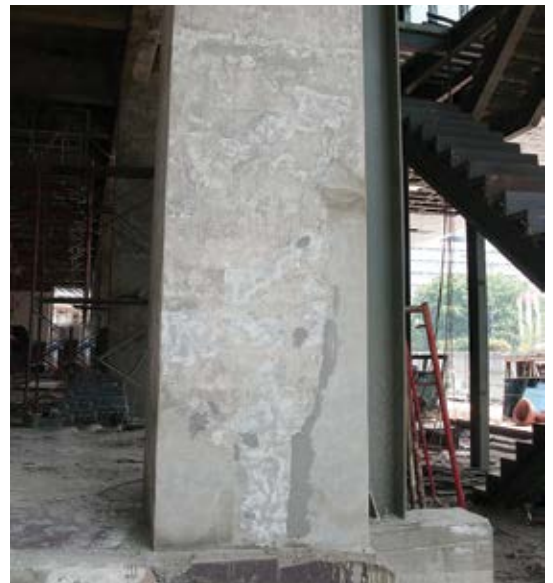
Fig. 9: Patched column section

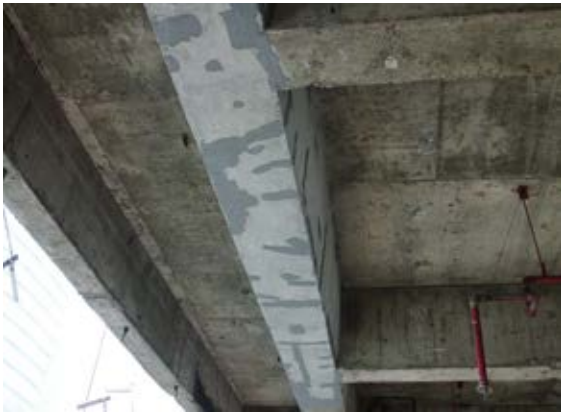
Fig. 10: Patched air voids on beam

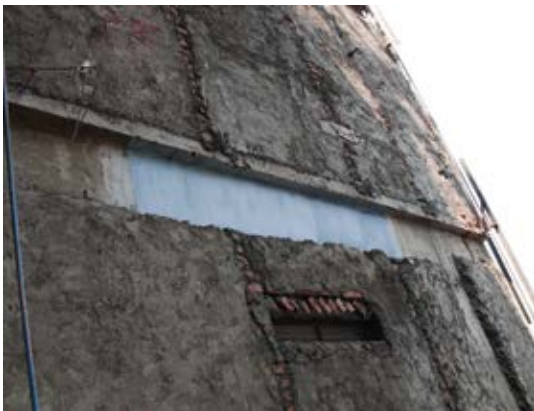
with ACI 440.2R, a two-sided application was found to have enough strength to handle the expected shear loads.

Fig. 11: Beam strengthened without removing wall

Because of the lightweight and high-strength capacity of the carbon wrap and carbon plate, the strengthening materials did not affect the loading of the building. In addition, the inability to remove the existing walls at specific locations was solved by the two-sided application of the carbon wrap solved.

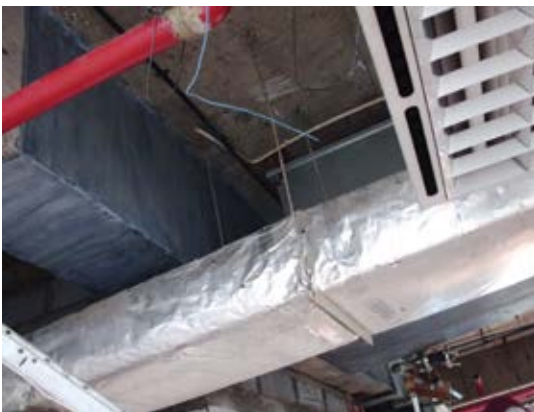
Fig. 12: CFRP installed around existing obstacles

The project successfully strengthened existing building elements with minimal demolition needed to apply the strengthening materials (Fig. 12).
