DOWNTOWN PARKING REVITALIZED

FIRST & JASPER PARKING DECK FLOOR SLAB REPLACEMENT

BY DARYL PREFONTAINE

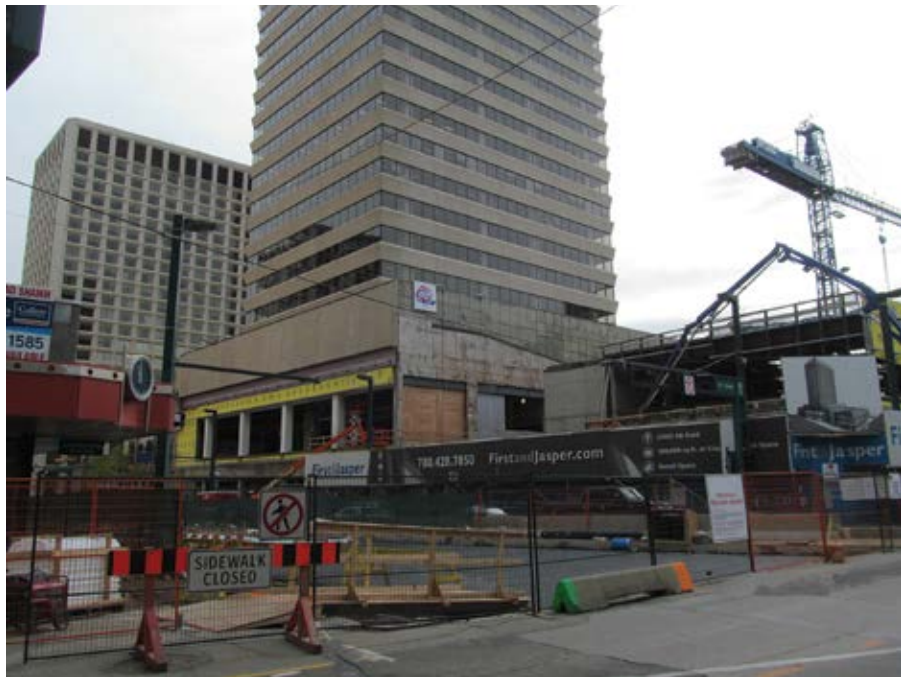
Fig. 1: Overall view of project site during construction

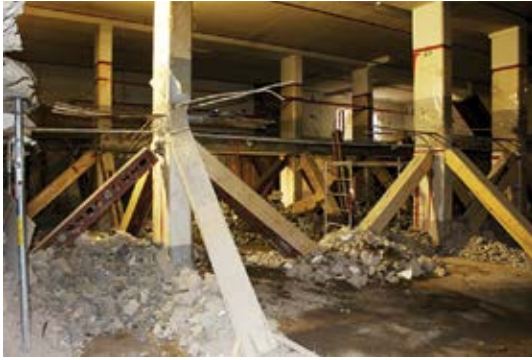
Fig. 2: Steel bracing members installed prior to concrete removal at core walls, columns, and perimeter walls. Plywood sheathing was applied to protect steel members from damage during the construction demolition process

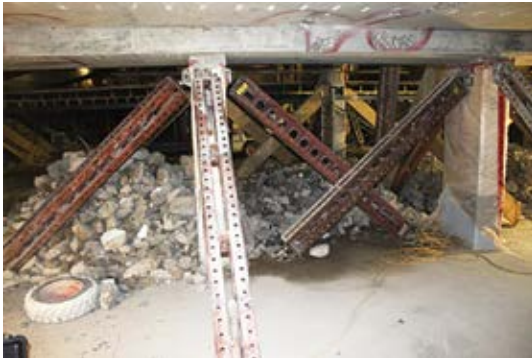
Fig. 3: Typical column bracing along demolition phasing boundary. Demolition debris was stockpiled on slab-on-ground during some phases of work

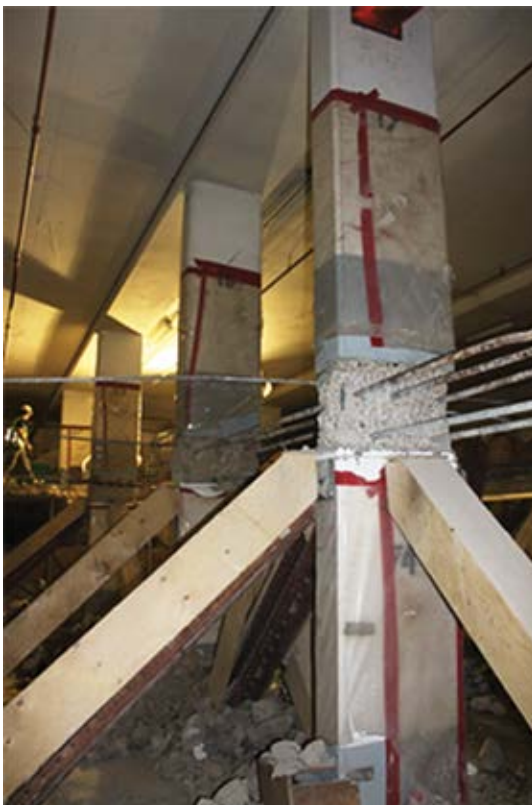
Fig. 4: Interior concrete columns braced to maintain load-carrying capacity

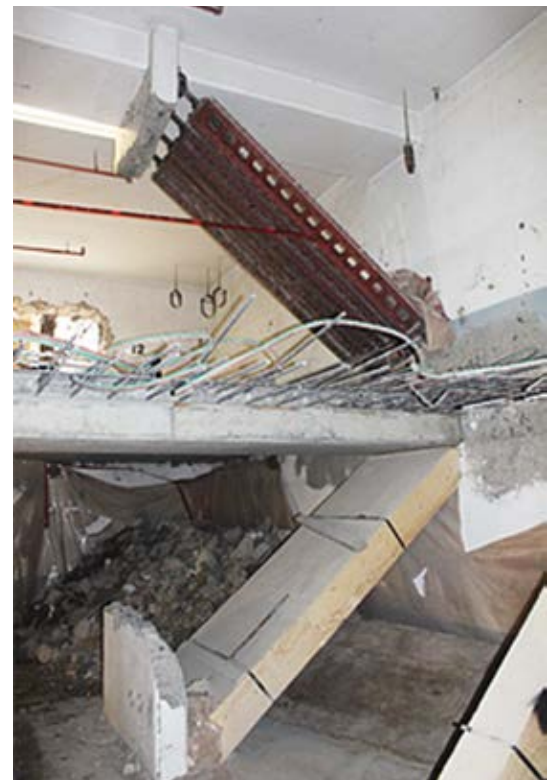
Fig. 5: Significant bracing was required at the north interior wall to ensure the stability of an adjacent LRT Pedway tunnel cantilevered from the building structure

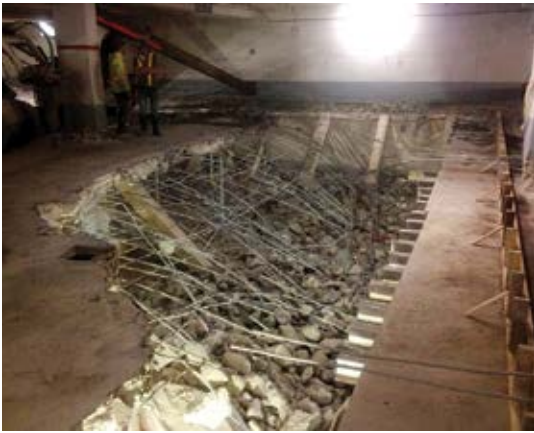
Fig. 6: Slab demolition in progress

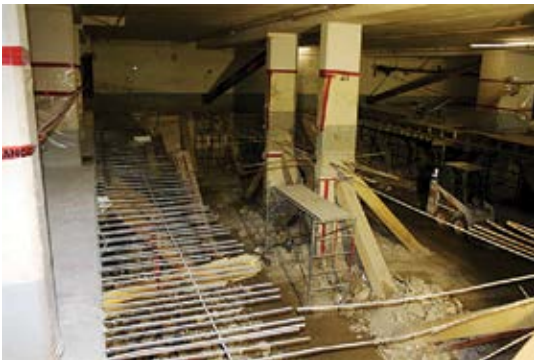
Fig. 7: Slab removal and replacement operations were carefully sequenced over several phases to maintain lateral support for the building walls and columns, while minimizing bracing and shoring requirements

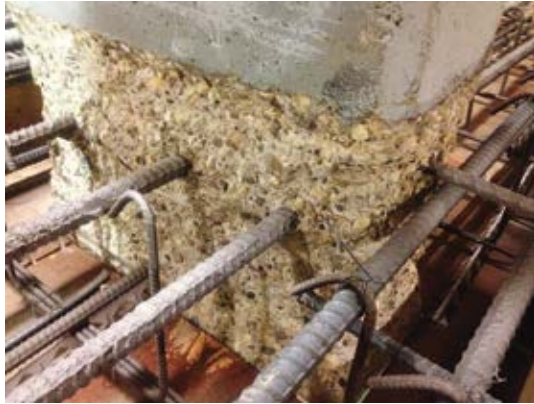
Fig. 8: Existing slab and slab-band reinforcing steel were maintained, abrasive-blast cleaned, and reincorporated into the new work at the perimeter walls, core walls, and interior columns

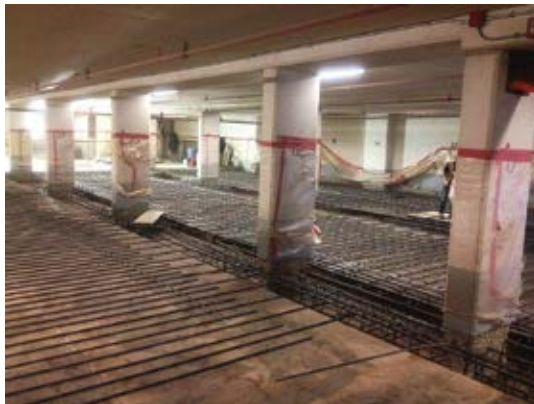
Fig. 9: Forming and placement of new reinforced parking deck floor slab prior to concrete placement

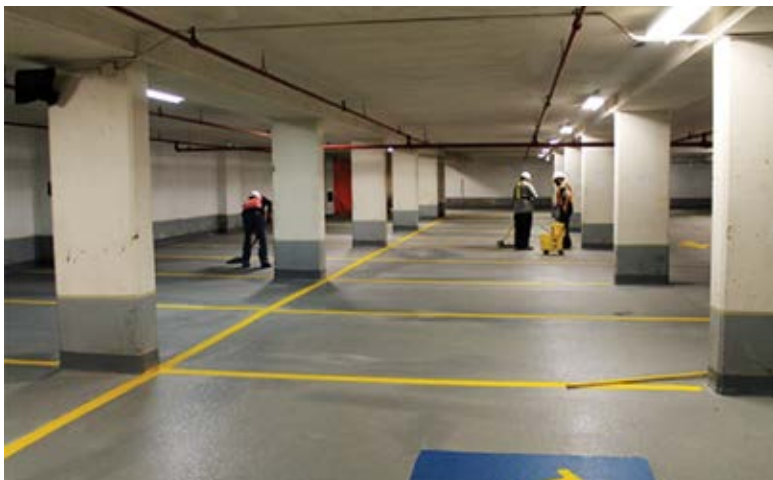
Fig. 10: Highly durable protective coating and sealant materials were used on the new parking deck floor slab surface
