# Post-Tensioned Concrete Structure Evaluation

By Michael Tabassi

## Case Study

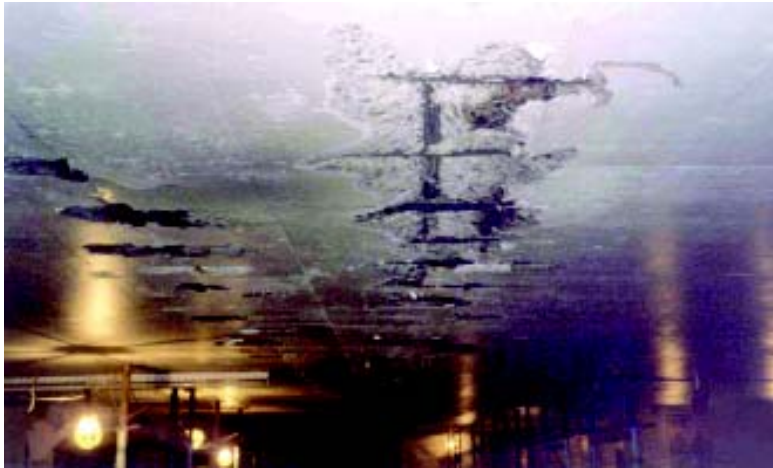
*Severely deteriorated concrete soffit*

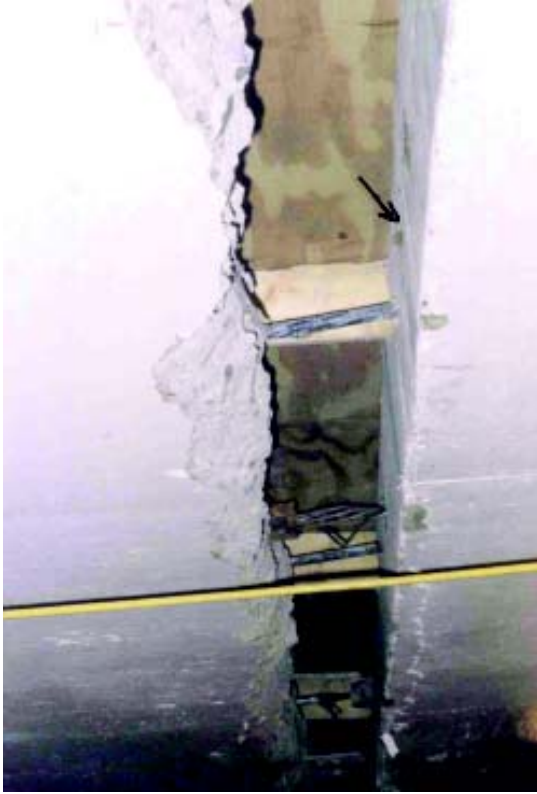
In addition, water can penetrate into the porous concrete and enter the protective post-tensioning sheathing through the exposed ends. This water can emulsify the protective grease and produce embrittlement of the strands. Corrosion and embrittlement of the PT strand can cause the strand to reach its ultimate strength and eventually break. When breakage occurs, it can be explosive, resulting in collapse of the released strand upon itself, and, in some cases, exploding out of the structure at the ends or at locations where shallow concrete covers exist.

*Severely corroded and/or broken PT cables at intermediate stressing location*

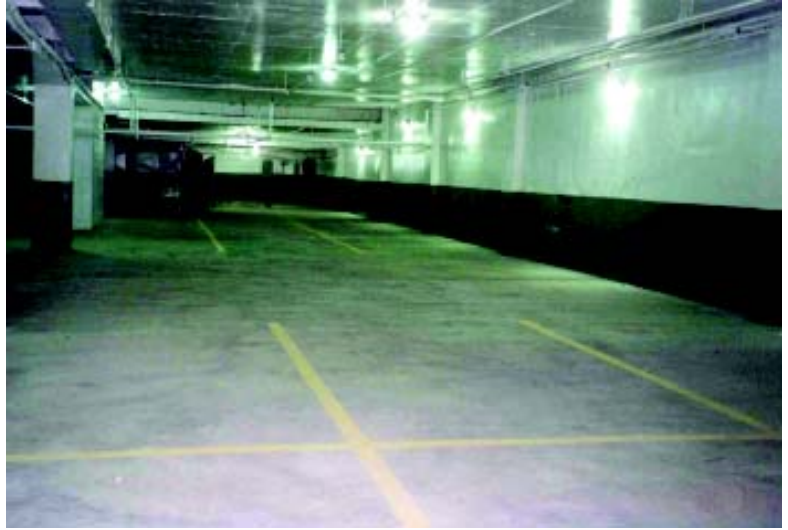
*Photo shows replace concrete slab with striping and freshly painted walls and columns*

slab was removed in 3 weeks. The total cost of removal and replacement of the slab in addition to installing new lights, sprinkler system, and painting of the garage was \$1,127,000.
