Concrete Repair of Hangar Building 340

Naval Air Station, North Island, San Diego, California

By Roy Becker and Adriano "A. B." Bortolin

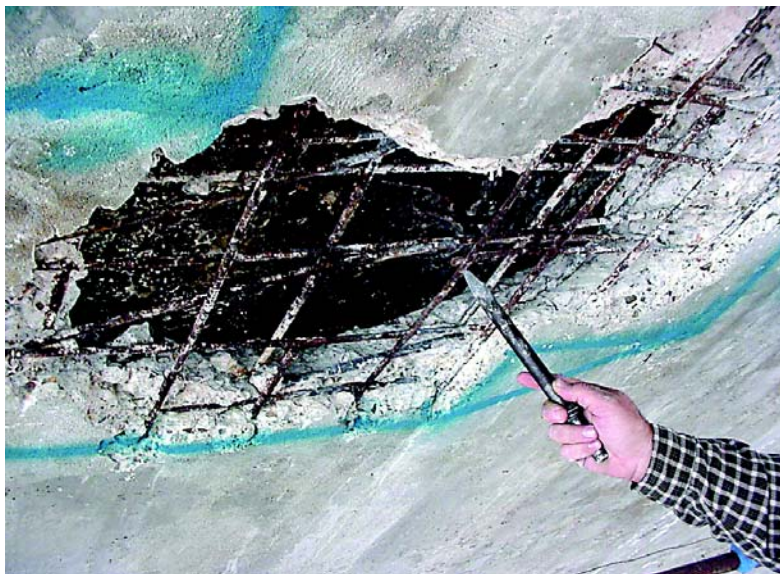
Typical spall on underside of thin shell

- The proximity of Hangar Building 340 to salt water;
- Insufficient concrete cover of the reinforcing steel, especially in the exterior arches, and carbonation of the concrete;
- Localized poor consolidation and segregation of the concrete mix; and
- The age of the structure (62 years).

1. Removing spalled concrete by hand methods;
2. Applying high-strength polymer repair mortar to spalls by hand methods;

3. Applying a penetrating, corrosion inhibiting impregnation to all exposed concrete surfaces; and
4. Applying a protective, anticarbonation acrylic coating to all exposed concrete surfaces.

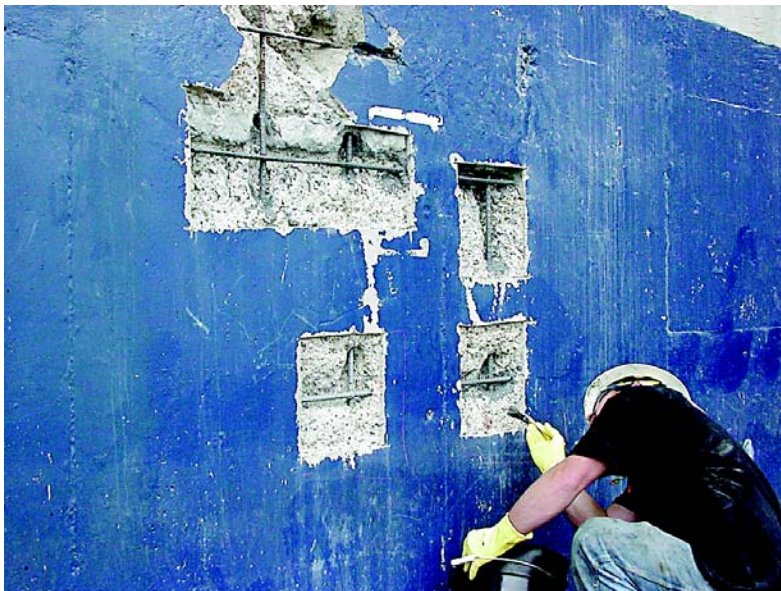
Cleaning spalled areas prior to repair

The spalled areas were removed to a geometrically regular configuration by sawcutting to a depth of 1/2 in. (1.2 cm) around the perimeter of the spalled areas. Then, 15 lb chipping hammers were used to remove all unsound concrete and expose the reinforcing steel.

Reinforcing steel was then cleaned to white metal by abrasive bead blasting. Reinforcing steel that was badly corroded was replaced with new reinforcement (this occurred infrequently).

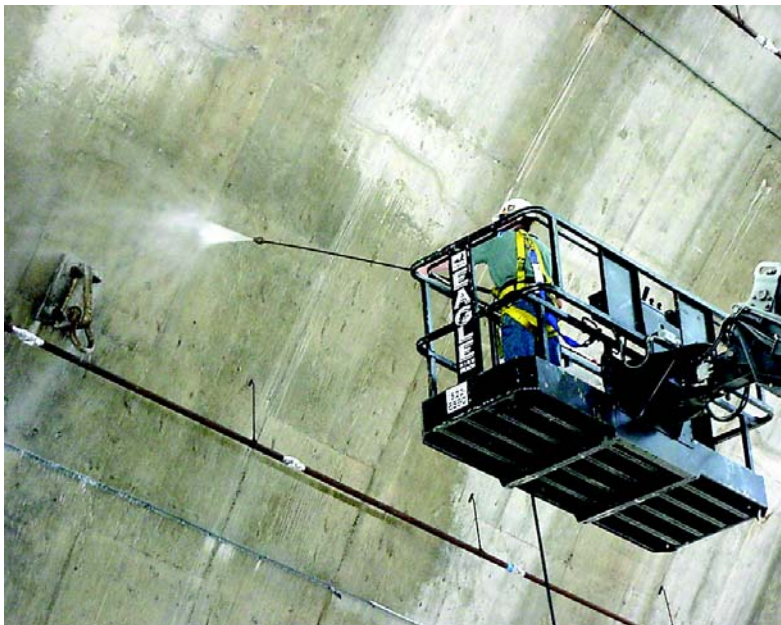
Surface preparation by hydroblasting

To thoroughly determine the extent of the concrete deterioration, all exposed concrete surfaces were hydroblasted using pressure of 4000 to 6000 psi (27 to 41 MPa), and then any suspected surfaces were carefully visually and impact hammer inspected to determine which additional areas should be repaired.

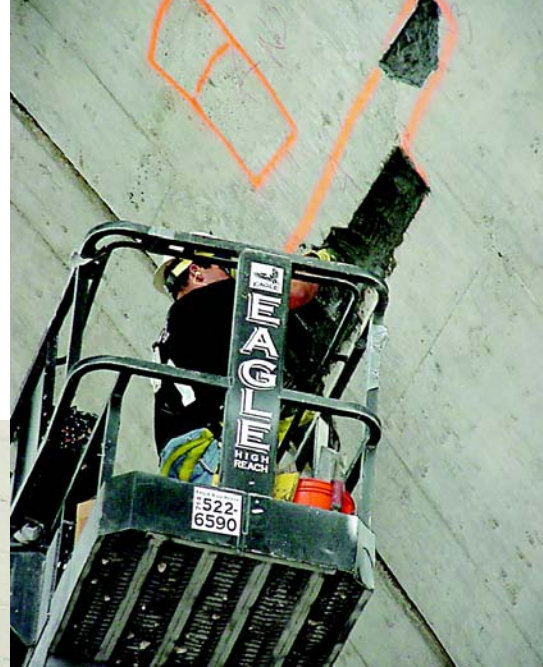
Repairing spalls

1. Application of a bonding agent and reinforcement protection to the prepared concrete and reinforcing steel surfaces;
2. Application of a high-strength polymer repair mortar for all spall repairs;
3. Application of a penetrating, corrosion-inhibiting impregnation to all concrete surfaces; and
4. Application of a protective, acrylic-based, anticarbonation coating to all concrete surfaces.

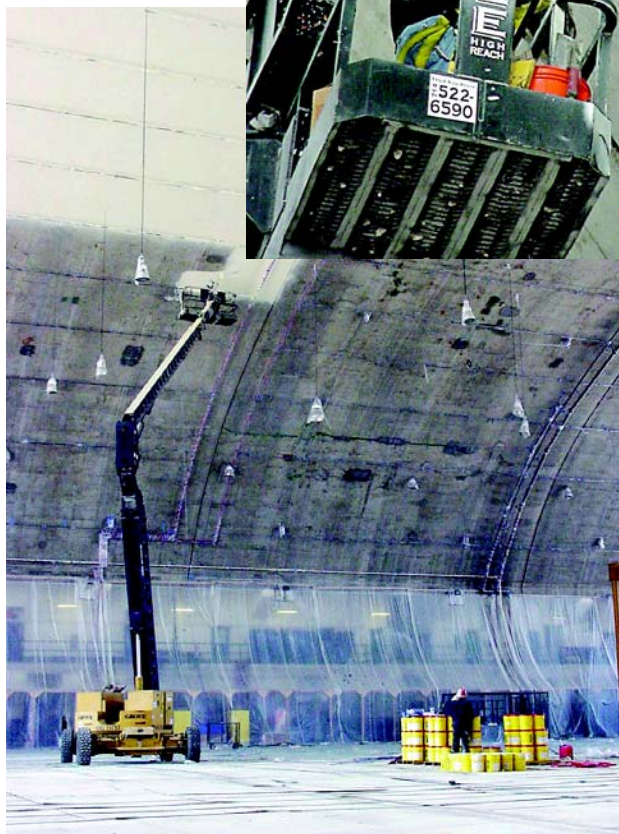
Applying coating to exposed concrete surfaces

Because the hangar bays are as high as 80 ft (24 m), seven high lifts were used to expedite the construction process and to eliminate scaffolding. The high-strength polymer repair mortar was hand applied and hand finished. The corrosion-inhibiting impregnation and the anticarbonation acrylic coating were applied by air-actuated spray guns.
