Strong Communication Key to Successful Garage Repair

By Craig Kobza and Ron Petsch

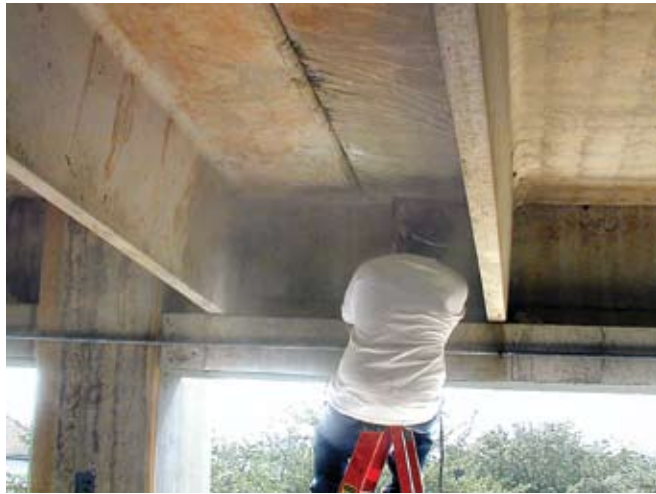
Fig. 1: Expansion joint requiring repair

The contractor prepared a schedule that required development of a well-designed work and traffic control plan. Repairs were orchestrated in such a manner as to provide the maximum number of parking spaces with minimal closure during the construction process. Partitioning of the garage was accomplished by grouping methods of repair such as spall repair, crack injection, CFRP installation, bearing pad replacement, and the application of coatings and sealants. Extensive amounts of tee beam stem and flange restoration were required, and the primary expansion joint was repaired using an epoxy nosing and flexible sealant allowing both horizontal and vertical movements.

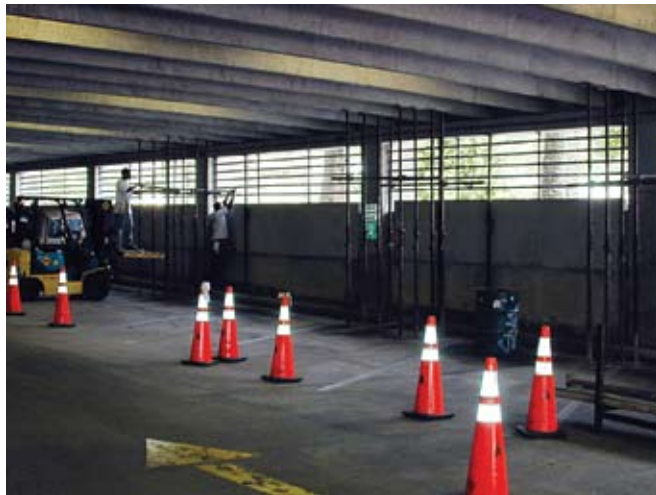
Concrete damage, especially at many of the tee stem bearing locations, was noted. Several factors contributed to the corrosion and deterioration, such as inadequate concrete cover, exposure to the elements, embedded conduit, and inadequate maintenance. Core sampling and testing of the in-place concrete were performed to allow the engineer to provide the most cost-effective methods of repair.

Fig. 2: Shoring of damaged double tee beams

An issue of great concern was the amount of jacking and shoring that was required while the garage was still in use. To remain on schedule, the contractor had to work in multiple areas concurrently, using innovative techniques of jacking and shoring while vehicles and people traveled in and out of

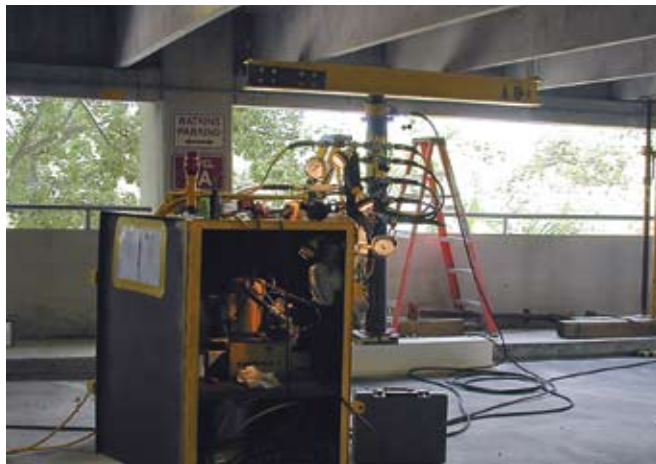
Fig. 3: Jacking equipment used to raise double tee beams during bearing pad replacement

the work zone. This addressed safety as well as logistical concerns. The contractor used sophisticated hydraulic jacking equipment to incrementally raise the precast concrete to allow repair of the tee stem bearing locations and replacement of the deteriorated bearing pads. The loads exerted by the hydraulic jacks induced forces in the members that could be monitored allowing a safer and more controlled system. The system was continuously monitored by the engineer during this process to ensure that overloading and subsequent cracking of the precast members did not occur. New bearing pads were designed to accommodate the loading and allow movement and rotation at the ends of the tee members. Many of the precast members required the release of welded connections prior to jacking. Extensive amounts of effort by the contractor ensured the facility was safe for users during the construction process.

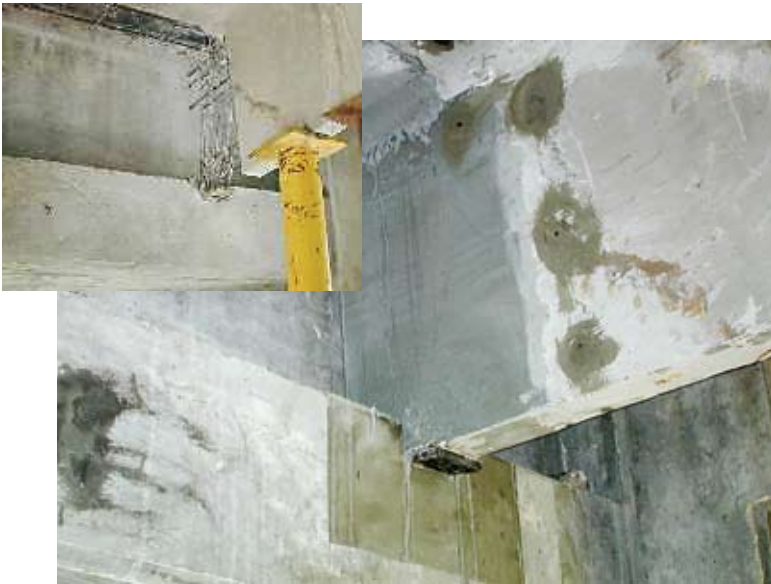
Due to severely spalled stems caused by inadequate reinforcing steel at the bearing locations of the double tee beams coupled with the existing cracks, carbon fiber-reinforced polymer (CFRP) reinforcement was used to strengthen the deficient areas. After the engineer performed an analysis of the bearing conditions for shear considerations of the existing members, a CFRP wrap system was designed to strengthen approximately 20 tee stems. The surface of the area receiving the CFRP was prepared per the manufacturer's requirements and all cracks were epoxy injected prior to installation of the CFRP. The CFRP was applied in multiple layers that wrapped the stem in the vicinity of the bearing points. This system provided the retrofit necessary to accommodate the stresses at the bearing locations due to the loading conditions and allowed an economical solution to an otherwise costly repair.

Fig. 4 (top inset): Beam repair in progress

Fig. 5: Completed beam repair

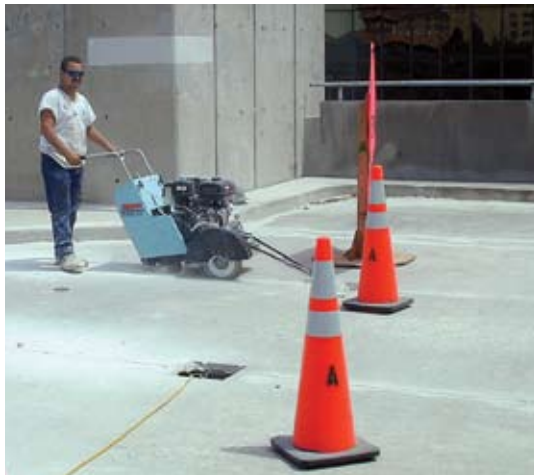
Fig. 6: Concrete cutting and removal at top level
