# Precast Concrete Façade Investigation

By Mike Hoglund

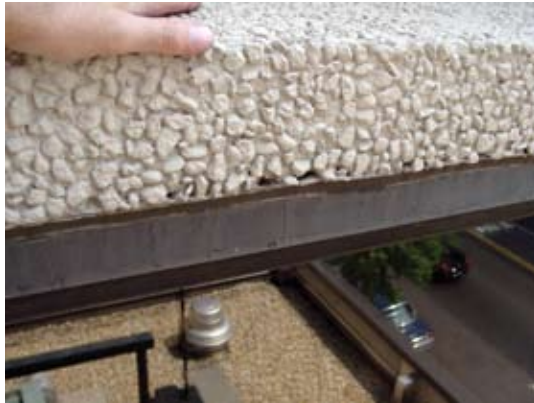
Fig. 1: Horizontal joint with gaps in aggregate

If there are gaps in the aggregate, such as shown in Fig. 1 and 2, consideration has to be given to grinding of the joints to produce an effective water seal with the caulk. Additionally, consideration should be given to sequential water testing of the joint:

1. Water test as is to establish the joint leaks;
2. Replace the caulk, leaving the joint as is and water test; and
3. Grind the joint, caulk the joint, and water test.

If it does not leak during Step 2, grinding of the joints is not needed; if it leaks during Step 2, grinding will be needed. Water testing such as this will help the building owner to understand that grinding of the joints may be a necessary work item and construction cost to effectively seal the precast façade panel joints against water intrusion.

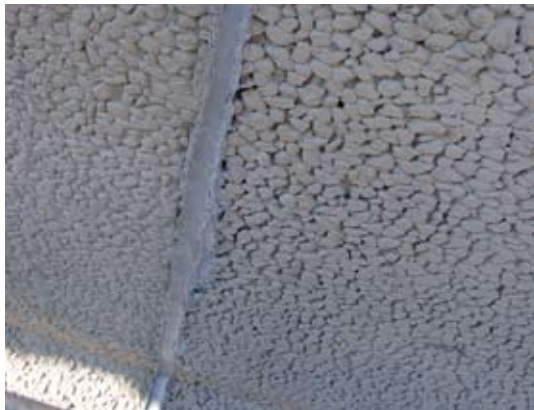
Fig. 2: Vertical joint with gaps in aggregate

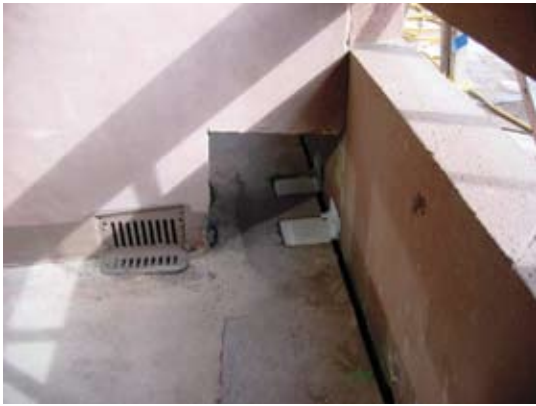
Figure 4 shows a repaired precast connection at a precast balcony wall panel that required a simple steel angle bolted to the slab and back of precast panel for temporary support. Figure 5 shows a repaired precast connection at a precast column cladding panel at a balcony that required temporary steel frame support. In both cases, the slab concrete at the embedded plates was delaminated and the

Fig. 4: Repaired precast wall connection on slab

exposed steel connections were cleaned and primed. Removal and replacement of the concrete masonry unit divider wall was necessary to expose the connections shown.

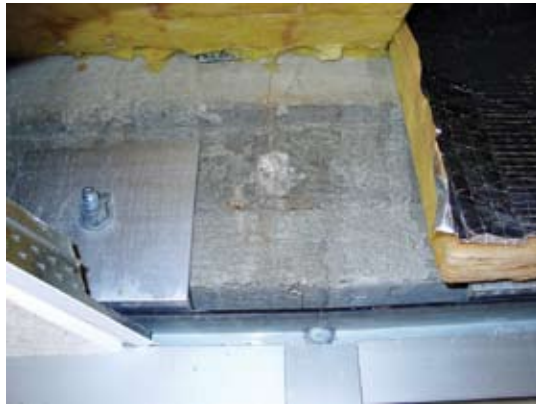
Fig. 6: Vertical crack at connection constraint

Figure 6 shows cracked precast concrete at a connection, viewed from the interior of the building. The crack is vertical, indicating lateral movement caused the crack, most likely from thermal expansion of the precast panel in the lateral direction. It is difficult to construct an absolutely restraint-free slotted connection and constraint within the slotted connection resulted in the crack shown. Figure 7 shows that water testing of the same crack revealed that the crack is a leaking crack, meaning it is a full-depth crack, and will most likely leak during wind-driven rain. Because the crack leaks, there will mostly likely be corrosion damage to embedded

steel in the precast concrete from water intrusion—if not now, then sometime in the future. Therefore, the designer must consider structural repair and water tightness of the repair along with the aesthetic appearance of the repair in the exterior precast concrete face.

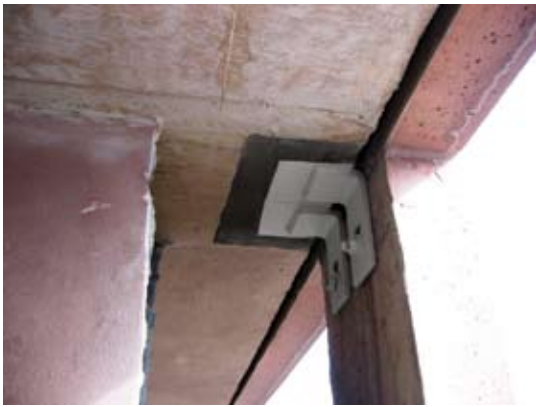
Fig. 5: Repaired precast column connection

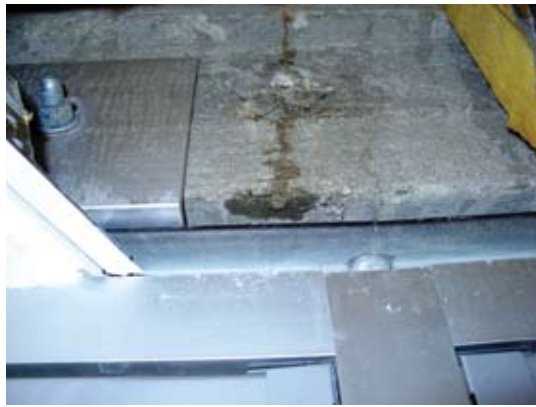
Fig. 7: Same crack leaks
