Lifeline Foods Mill Building Renovation

Lifeline Foods Dry Mill

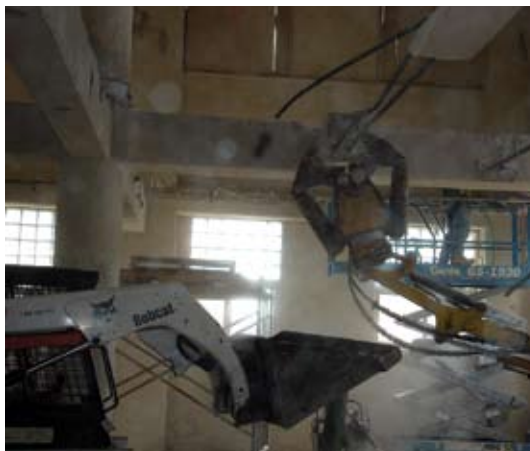
Demolition of interior beams

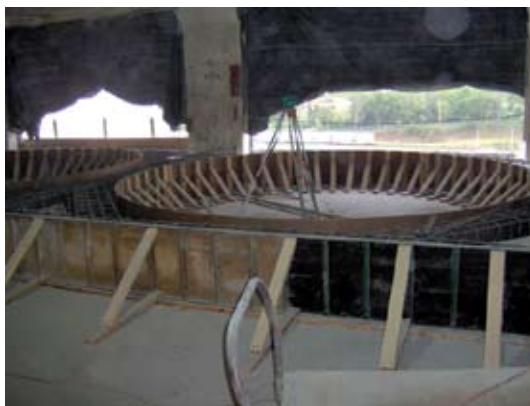
Large diameter tank supports

Areas that were to receive very heavy tanks were dealt with by building cast-in-place beams over the existing slab (up-turned beams) that resulted in a clean surface to mount the tanks and prevent vermin hiding locations. The ends of the slabs were tied into the columns.

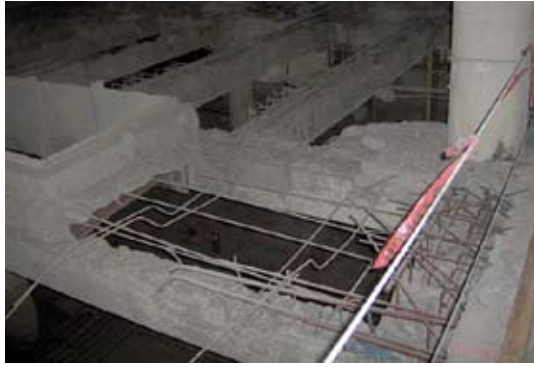
Floor perforations being built

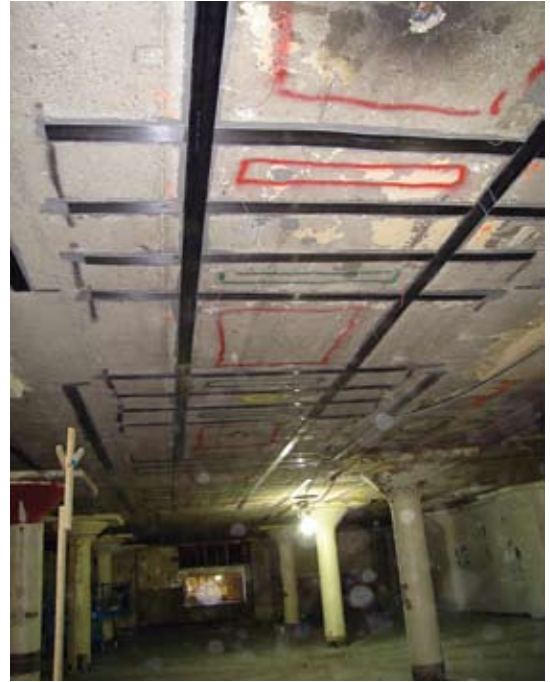
CFRP installed in ceiling

15,000 ft (4472 m) of new CFRP was eventually installed to repair the slabs. Over 600 floor perforations from 8 in. to 17.5 ft (20 cm to 5.3 m) in diameter were added. Approximately 80,000 ft² (7432 m²) of new bonded concrete topping was added. Over 8000 ft² (745 m²) of reinforced concrete full-depth floor repair was constructed. Approximately 145,000 ft² (13,471 m²) of new epoxy wall and ceiling coatings were installed. Three 17.5 ft (5.3 m) diameter reinforced concrete upturned

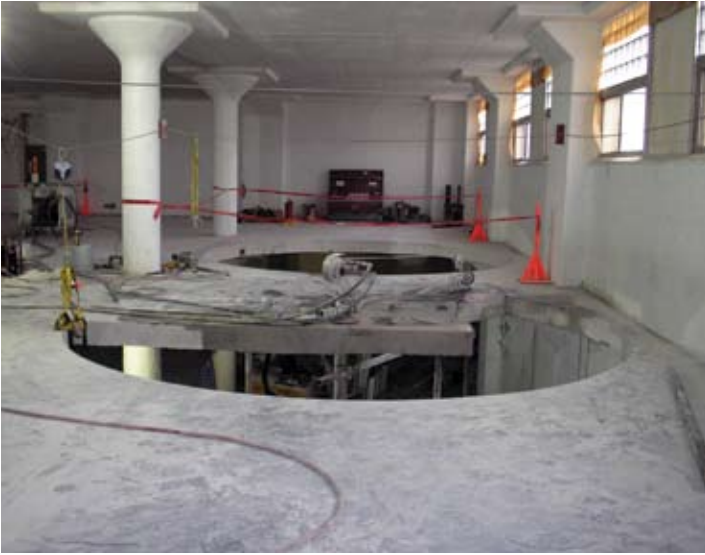
New floor with perforations ready for equipment

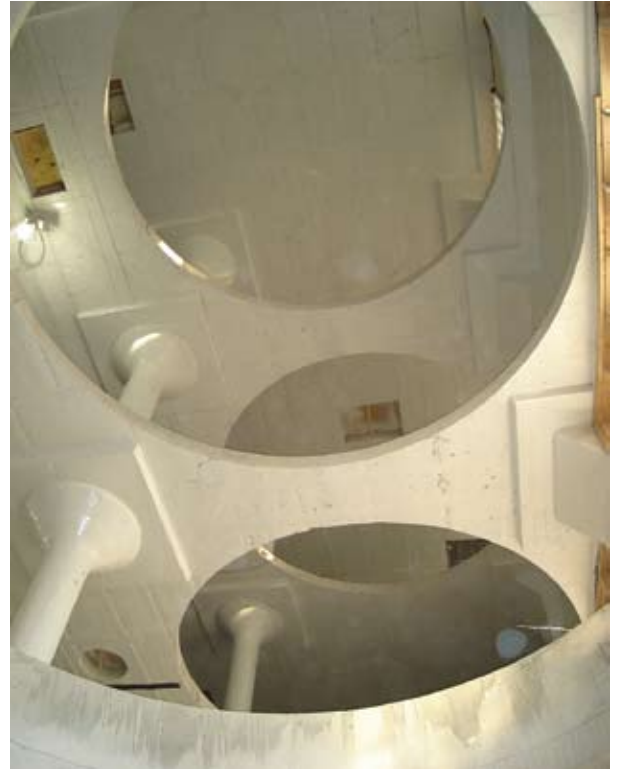
Looking up through bin holes in new floor slabs
