DUQUESNE UNIVERSITY BROTTIER HALL GARAGE REPAIRS—PHASES I AND II

BY PHILLIP ELGIN

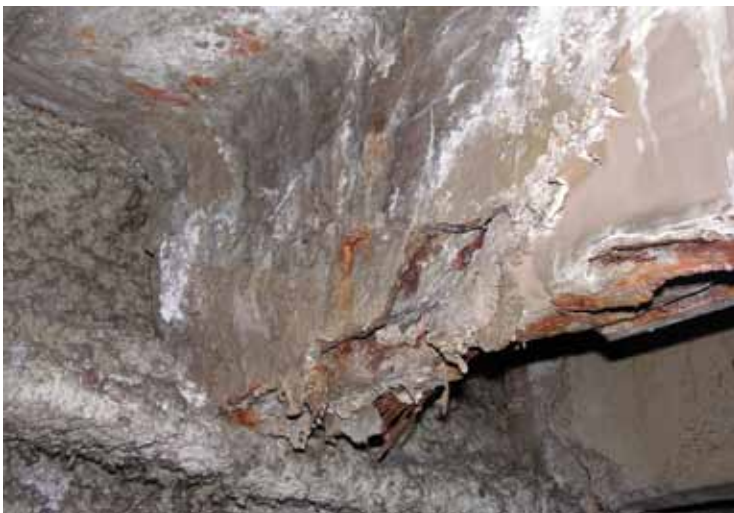
The assessment determined that the observed deterioration along the central girder line was rather extensive. Evaluation of over 210 precast double-tee stems revealed that approximately 40% of the stems were cracked at the support. In addition, 24 stems indicated signs of bearing failure and a large number of top flanges were also deteriorated. Some locations of steel beam corrosion were found with laminations exceeding 2 in. (50 mm), and large portions of the steel angle used for precast member bearing were deteriorated.

Fig. 1: Double-tee stem deterioration

2. Demolition and repair of deteriorated double-tee flanges and stems;
3. Replacement of severely corroded structural steel angle and WT-members;
4. Reinforcement and repair of hollow-core plank;
5. Removal of concrete and asphalt topping materials;
6. Installation of new topping slab with sealed control joints; and
7. Installation of new traffic-bearing coating.

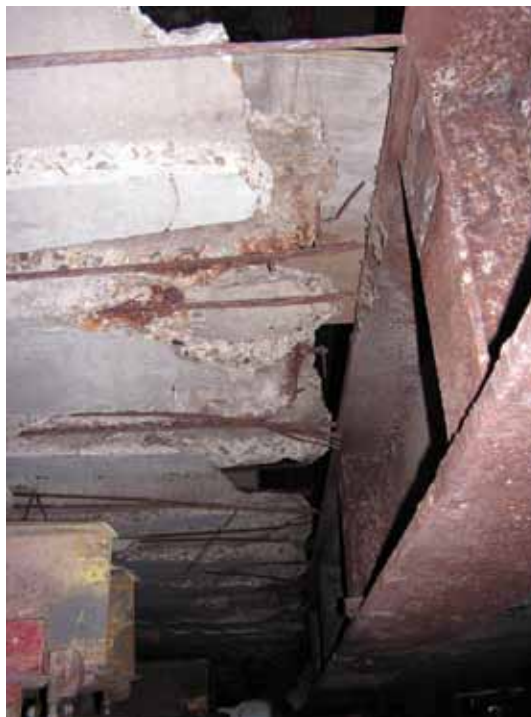
Construction repair details incorporated double-tee, hollow-core, and topping concrete repairs as well as steel reinforcing details. Phase I of the project included the removal and replacement of deteriorated construction along the central girder line (Fig. 2 and 3). Two full levels of temporary shoring were required at both sides of the central girder for the entire length of the garage. In addition, a permanent steel shoring beam was needed to facilitate repairs made within a congested mechanical room. Phase II of the project included concrete topping slab removal and replacement, precast double-tee flange repairs, repairs to the ramp areas, and replacement of concrete encasements around structural steel building columns.

Fig. 2: Double-tee end demolition (from below)

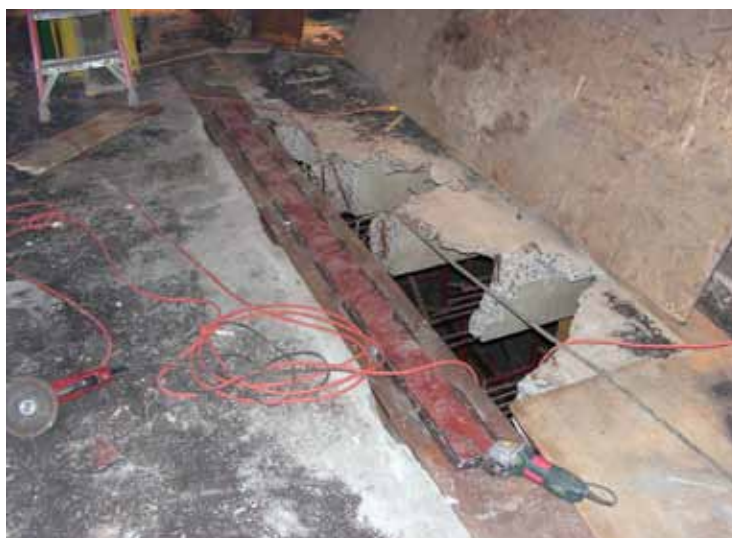
Fig. 3: Double-tee end demolition (from above)

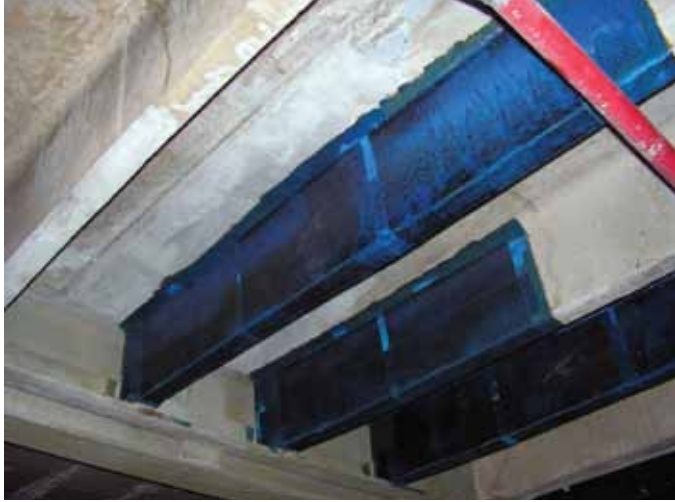
Fig. 4: Carbon fiber mesh installation

Original repair details showed a concrete “shoe” to strengthen the deteriorated precast double-tee bearing ends. During the bidding process, it was suggested to include an alternate detail using carbon fiber mesh to reinforce the bearing ends instead of the concrete “shoe”. The repairs were completed using the carbon fiber mesh approach (Fig. 4), as carbon fiber mesh proved to be a cost-effective and less cumbersome repair alternative.

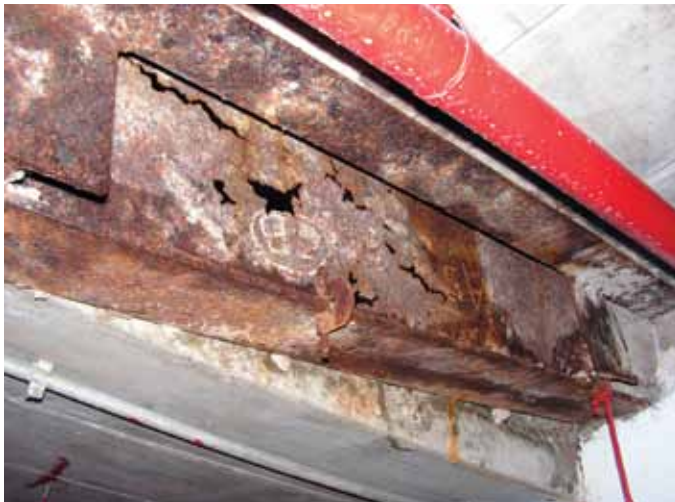
During the repairs for the single-lane ramp topping slab, additional unforeseen conditions were discovered, which included extensive deterioration of structural steel members (Fig. 5). Corrective repairs included partial steel beam replacement and steel beam reinforcing prior to repairing the ends of the precast planks and placement of the concrete topping (Fig. 6).

Fig. 5: Steel beam deterioration at ramp

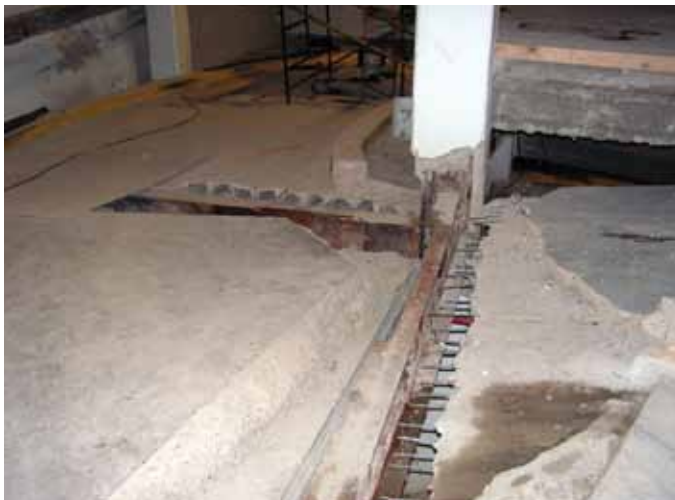
Fig. 6: Steel beam replacement/repair
