CASE STUDY

VAN NESS EAST CONDOMINIUM GARAGE AND PLAZA REHABILITATION

Van Ness East Condominium Garage and Plaza Rehabilitation

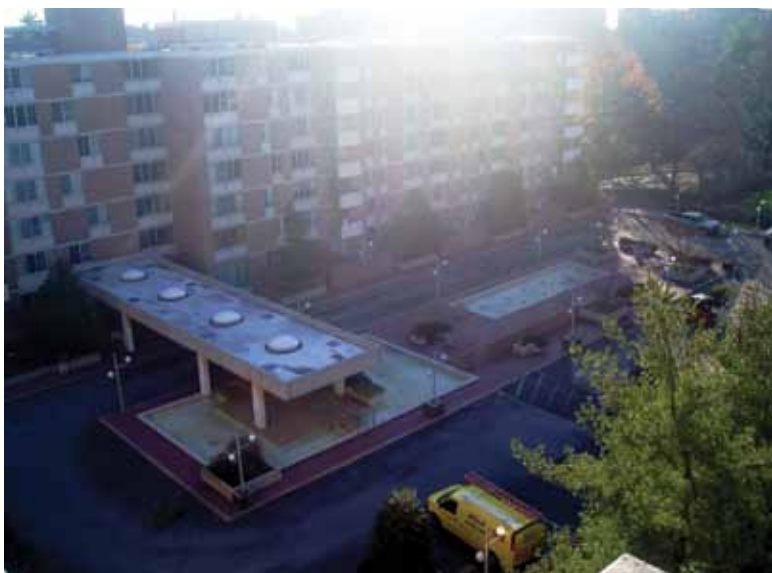
Plaza and landscaping before rehabilitation

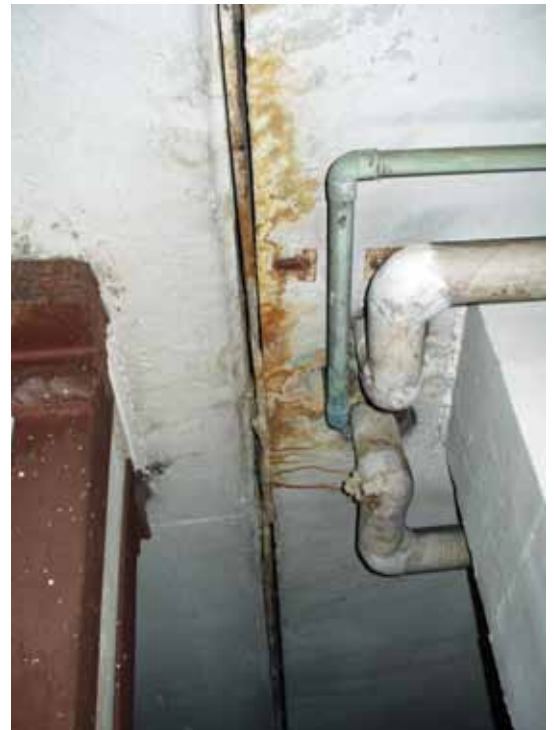
Deterioration and staining due to failure of existing expansion joint

type flashing that spanned the opening. Due to years of thermal movement and improper detailing, the joint failed systemically. Severe concrete deterioration of the slab edges along the building-to-garage/plaza transition and severe staining was noted.

- A new waterproof expansion joint system was installed between the plaza level and the building;
- A new waterproof vehicular traffic-bearing expansion joint system was installed between the upper garage level and the building where appropriate; and
- The entire plaza was water tested for 24 hours to meet the plaza waterproofing manufacturer's warranty requirements. Due to varying elevations, a multi-tiered and phased water test with bulkheads was required to affect the various water tests. The expansion joint at the plaza level was water tested separately for 48 hours to achieve the joint manufacturer's warranty requirements.

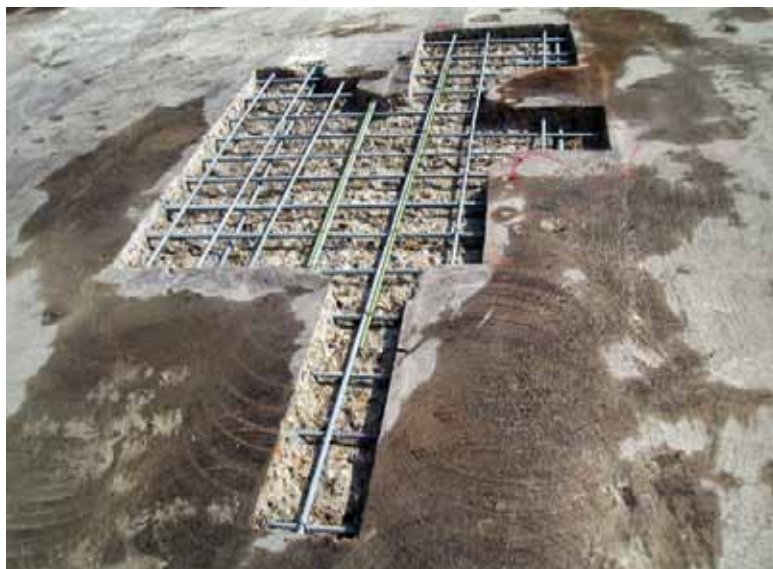
- A predemolition survey was performed to identify all areas of deteriorated concrete. The contractor removed all of the deteriorated concrete in general conformance with project specifications, ICRI guidelines, and ACI requirements. The exposed reinforcement showed signs of substantial corrosion resulting in locations where the reinforcement had lost more than 25% of its cross-sectional area. Supplemental steel reinforcing was installed at those locations;
- Abrasive blast cleaning (SSPC-10) was performed to remove laitance and to clean and prepare the reinforcing steel. The cleaned reinforcement was then coated with a zinc-rich primer;
- Formwork and shoring was erected. The contractor used ready mix concrete as well as bag mix concrete, depending on the application. The repair patches were wet-cured;

Exposed reinforcement during the predemolition survey and concrete preparation

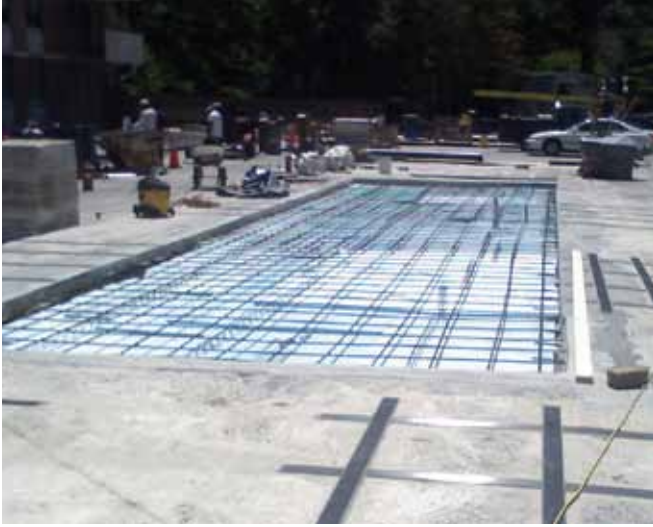
Existing fountain areas were filled in

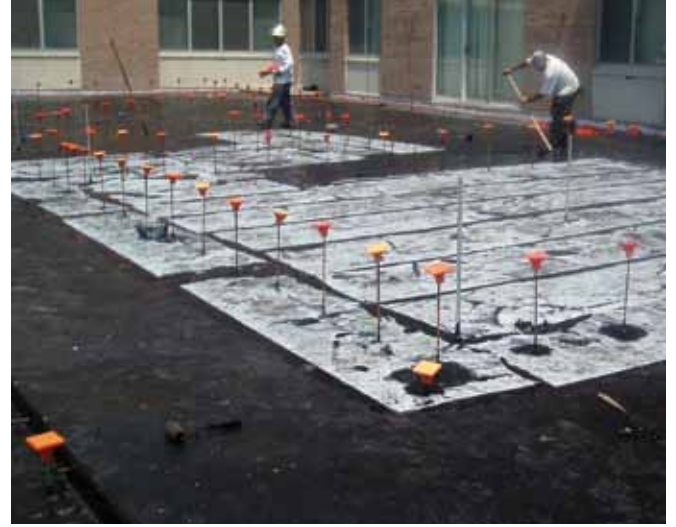
A hot-applied rubberized asphalt membrane was installed on the plaza deck

- At the existing fountain and canopy areas where the GPR investigation and subsequent analysis had revealed inadequate structural capacities, new carbon-fiber reinforcement was installed at both negative- and positive-moment locations;
- A high-density, lightweight extruded polystyrene board was used to fill the existing fountain areas and the fountains were capped with a concrete topping slab;
- A vehicular traffic-bearing membrane coating was applied to the upper-level garage. The coating was applied to help reduce the water intrusion into the porous concrete substrate, thereby better protecting the steel reinforcement and extending the serviceable life of the garage;
- A hot-applied rubberized asphalt membrane was installed on the plaza deck. The rubberized membrane included a polyester reinforcing

fabric sandwiched between two layers of hot rubber. A perimeter turndown and trench drain was installed in certain areas along the driveway transition to help manage storm-water runoff;

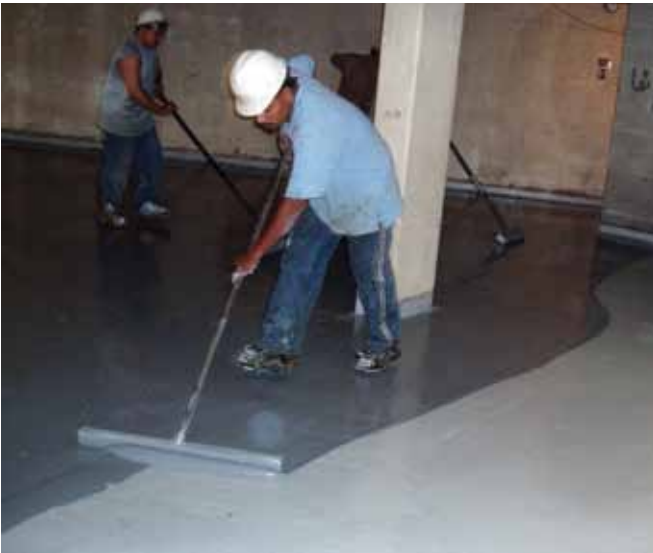
A vehicular traffic-bearing membrane coating was applied to the upper-level garage

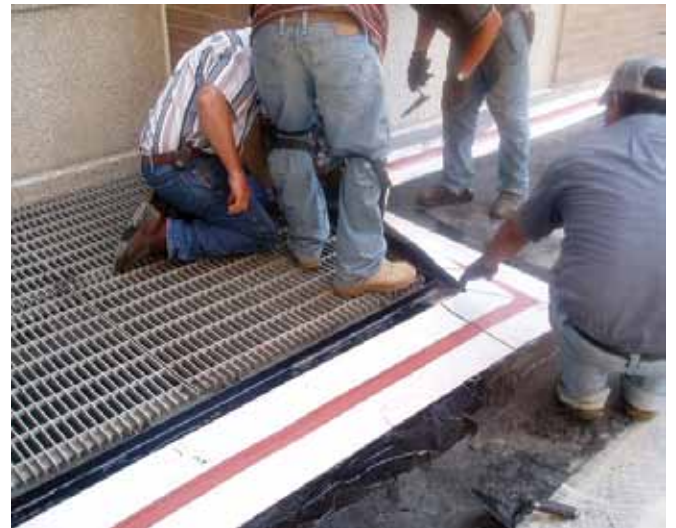
A new waterproof expansion joint system was installed between the plaza level and the building

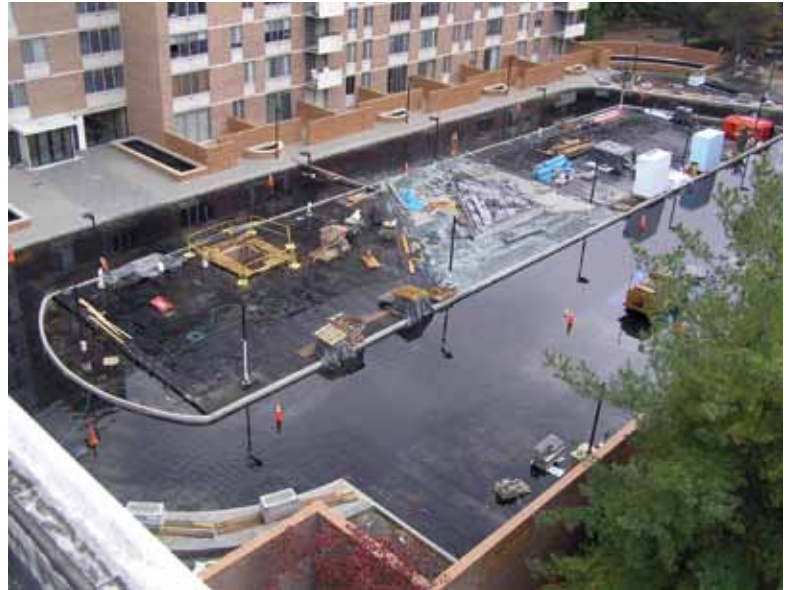
The entire plaza was water tested for 24 hours

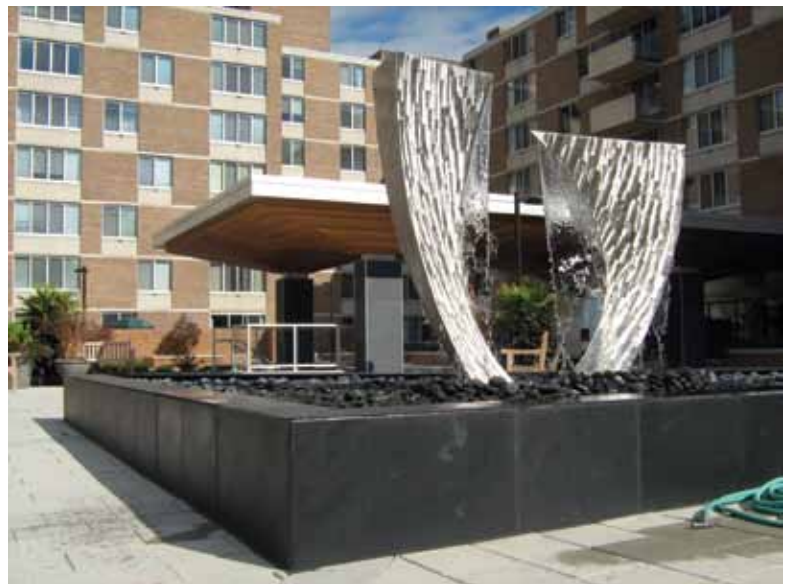
A sculpture/water feature was designed, built, and installed in the new fountain

The owner retained an artist to design and build a sculpture/water feature to be installed in the new fountain. During the design of the fountain sculpture, it was determined that the new sculpture would introduce additional point loads to the structural deck, which also required strengthening. The fountain also required installation of several water supply and drainage openings to accommodate the plumbing work associated with the fountain/sculpture. Further analysis of the plaza structural deck was performed and additional carbon-fiber reinforcement was designed. The carbon-fiber reinforcement strip layout was coordinated with the location of the core holes through the slab for the plumbing installation.

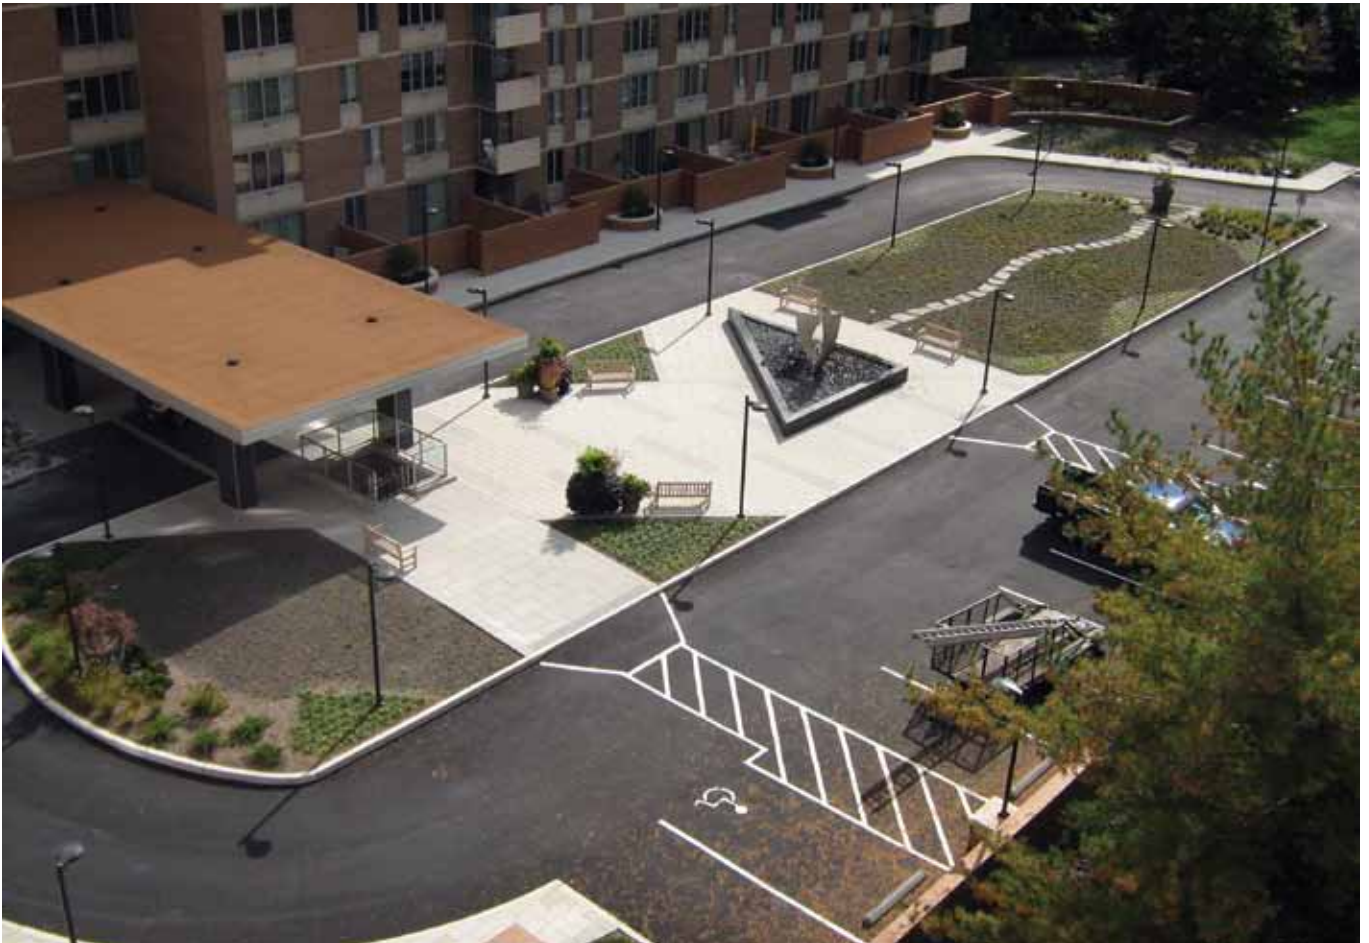
Plaza and landscaping after the rehabilitation was complete
