# MIAMI BUILDING FIRST TO BENEFIT FROM INNOVATIVE PILE JACKET

BY MO EHSANI AND ABHI TIPNIS

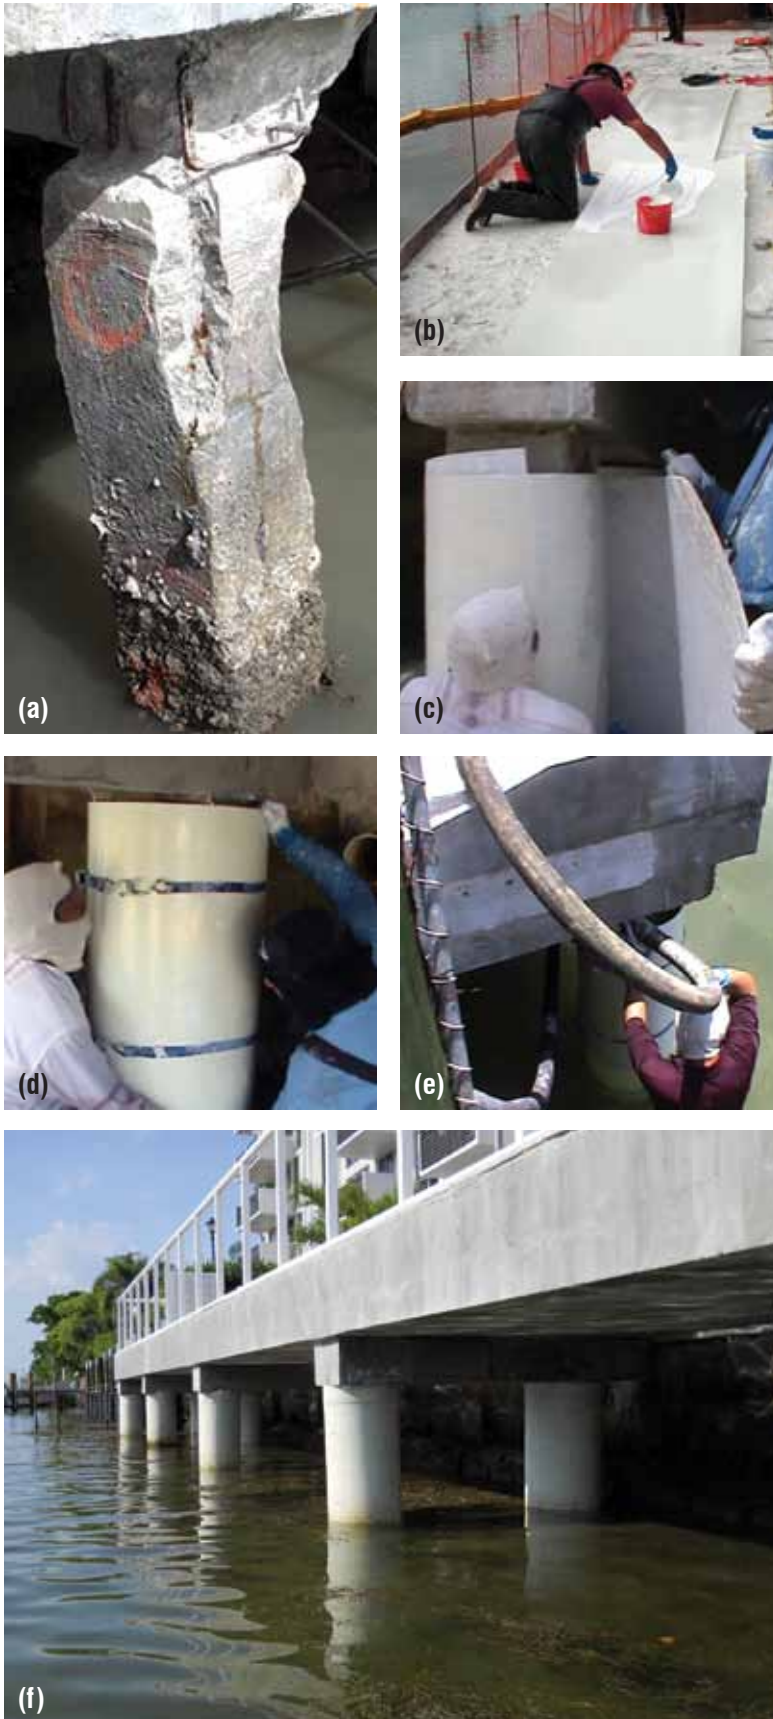
The 14 x 14 in. (356 x 356 mm) piles (refer to Fig. 4(a)) had substantial steel corrosion and spalled concrete. While searching for a repair methodology, the contractor recommended using the new FRP laminates for the piles that supported an overlook on the pool deck, for ease of installation and the added structural enhancement.

was mixed using a jiffy mixer and applied with a thickness of 40 mil (0.04 in. [1 mm]) to the  $66 + 8 = 74$  in. (1880 mm) length of the laminate; the first 66 in. (1680 mm) length of the laminate that will be placed next to the pile does not need to be coated with epoxy (refer to Fig. 4(b)).

Because the water was relatively shallow, the workers could pick up the laminate and walk it in water. At this time, the laminate is wrapped around the pile to create the 21 in. (533 mm) diameter shell (refer to Fig. 4(c)). At this stage, the uncured epoxy coating serves as a lubricant, allowing the laminate to slide easily as the crew makes final adjustments to the diameter of the shell. Ratchet straps were used to fix the diameter of the shell and prevent it from unraveling before the epoxy cures (refer to Fig. 4(d)). The cylindrical shell can be moved vertically along the height of the pile to its final position. In this case, it was pushed down into the mud to create a seal at the base.

An underwater grout was mixed and pumped with a hose into the annular space between the jacket and the pile (refer to Fig. 4(e)). As the tremie mixture rose to the top, it displaced the water in the annular space until the entire annular space was filled with grout. At this stage, the hydrostatic pressure of the grout pushes the two layers of the FRP jacket tightly against one another while the ratchet straps prevent the jacket from opening up. At the same time, the heat generated from the hydration process of the grout helps with the curing of the epoxy. Depending on the ambient temperature, the epoxy will cure in several hours, at which time the ratchet straps can be removed. The repaired piles at the conclusion of the project are shown in Fig. 4(f).
