PORT OF PORTLAND TERMINAL 5 STRUCTURAL REHABILITATION AND CORROSION PROTECTION

BY STEVE GEIGER

Port of Portland Terminal 5

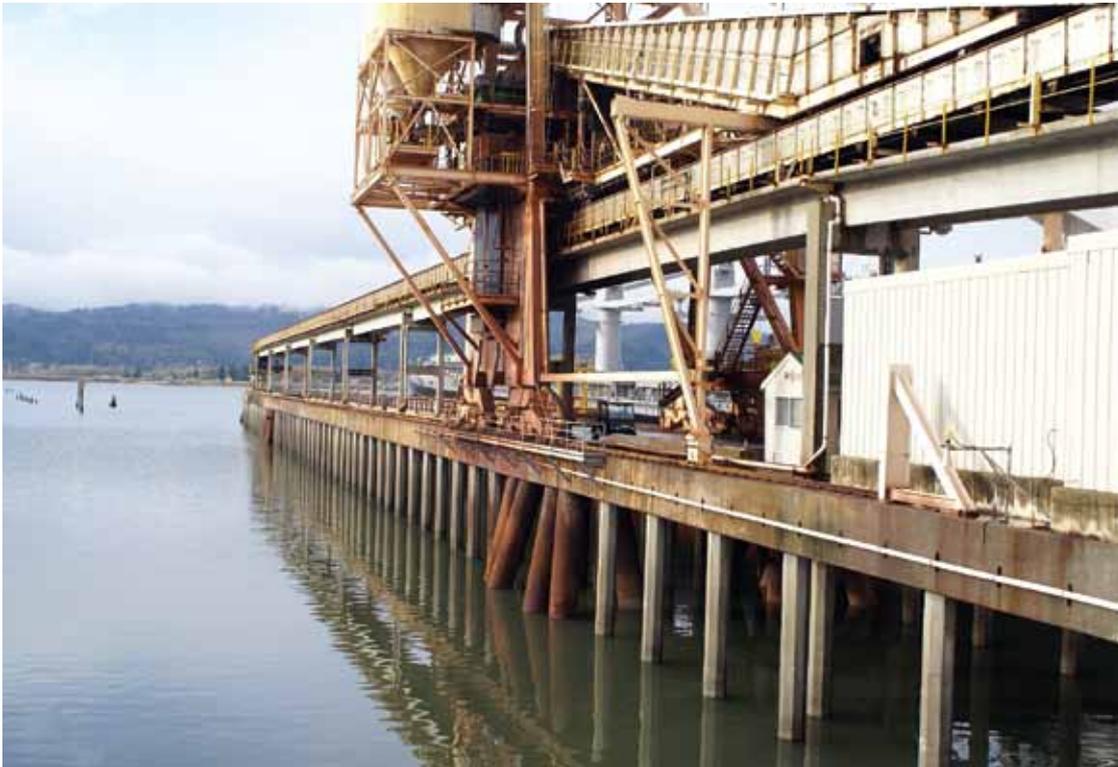
Project prior to repairs

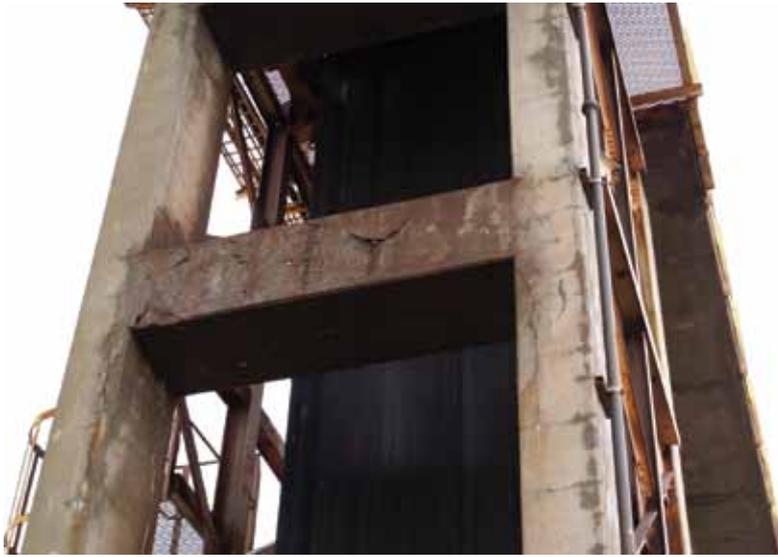
Deteriorated concrete at Port of Portland

Over the years, it became visually apparent that concrete deterioration was active on the elevated concrete conveyor support system and supporting pier. The existing concrete was experiencing spalls and minor-to-severe stress cracks, with many of the stress cracks resulting in loss of structural integrity and reduced load-carrying capacity. The decrease in structural integrity, combined with the maximum elevated height of 49.85 ft (15.19 m) for the conveyor system, created the potential for falling concrete spalls. This became a safety concern due to the potential for injuries. Visual and sound method testing was conducted to estimate the extent of the repairs.

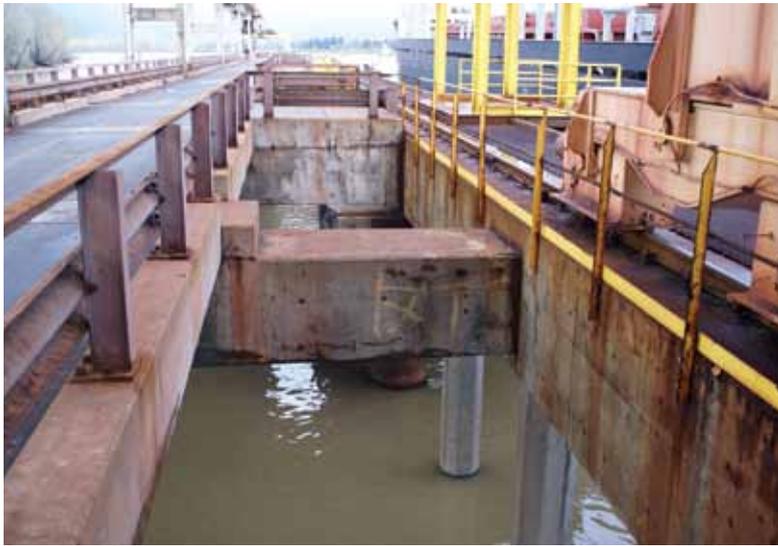
Deteriorated concrete on supporting pier

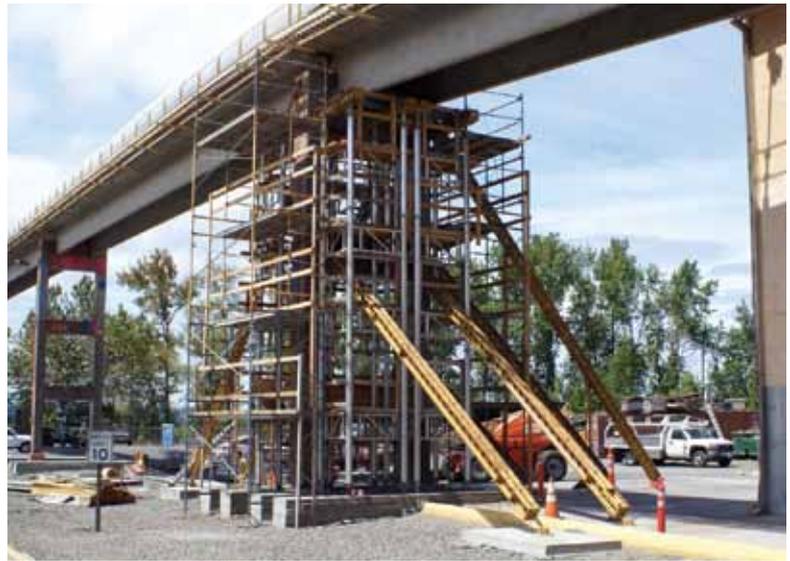
Extensive scaffolding was required on project

Extensive scaffolding was erected to provide safe access to perform the required concrete restoration on the elevated conveyor system and beam structure. Due to the severe deterioration and the resulting extent of concrete removal, an engineered shoring system was required to avoid any possible safety and operation issues.

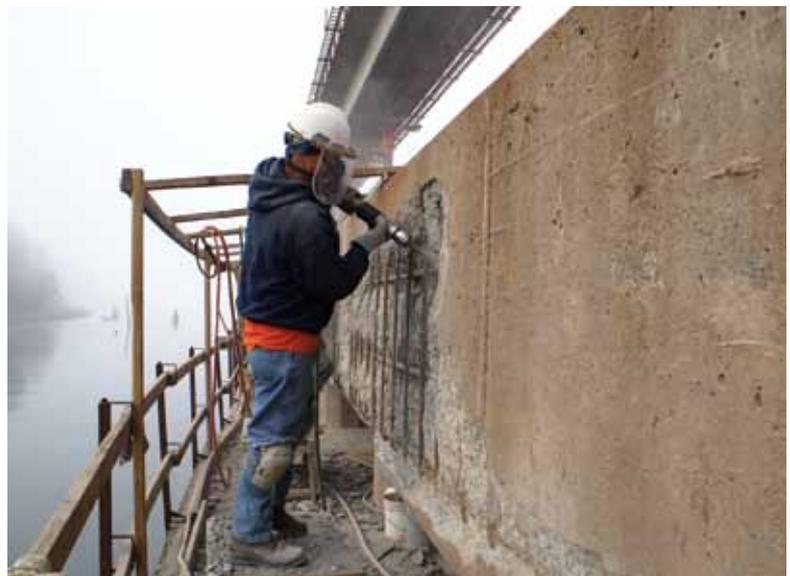
Removing deteriorated concrete

Pneumatic chipping hammers were used to remove the deteriorated concrete. The perimeter edge was then saw cut to a minimum of 2 in. (50 mm) in depth to ensure proper coverage and application. High-pressure water blasting was used to remove all loose concrete and concrete dust from the previous operations to help ensure a clean bond profile.

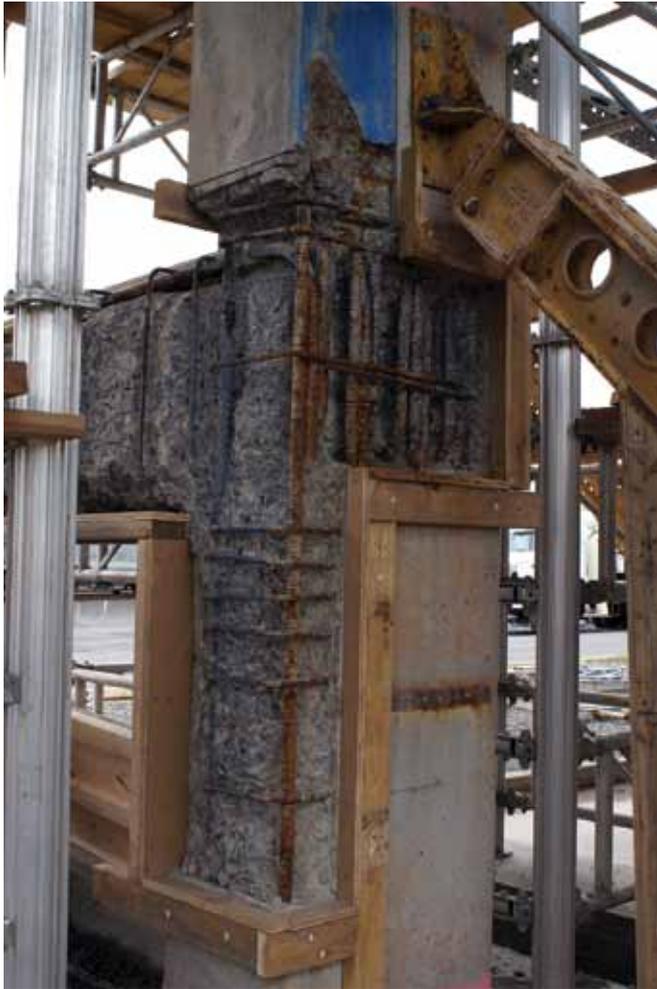
Framing in place ready for repair material

The reason for constructing the forming system using a wood frame, as required by the engineer, was to ensure a minimum embedment depth of 2 in. (50 mm) for the reinforcing steel.

The repair zone was predampened for 24 hours prior to application by filling the watertight formed area overnight with water. After 24 hours, the face board was removed and the water was drained. An appropriate time was given for the surface water to evaporate, leaving the substrate in the proper saturated, surface-dry condition for bonding. The forms were coated with a water-

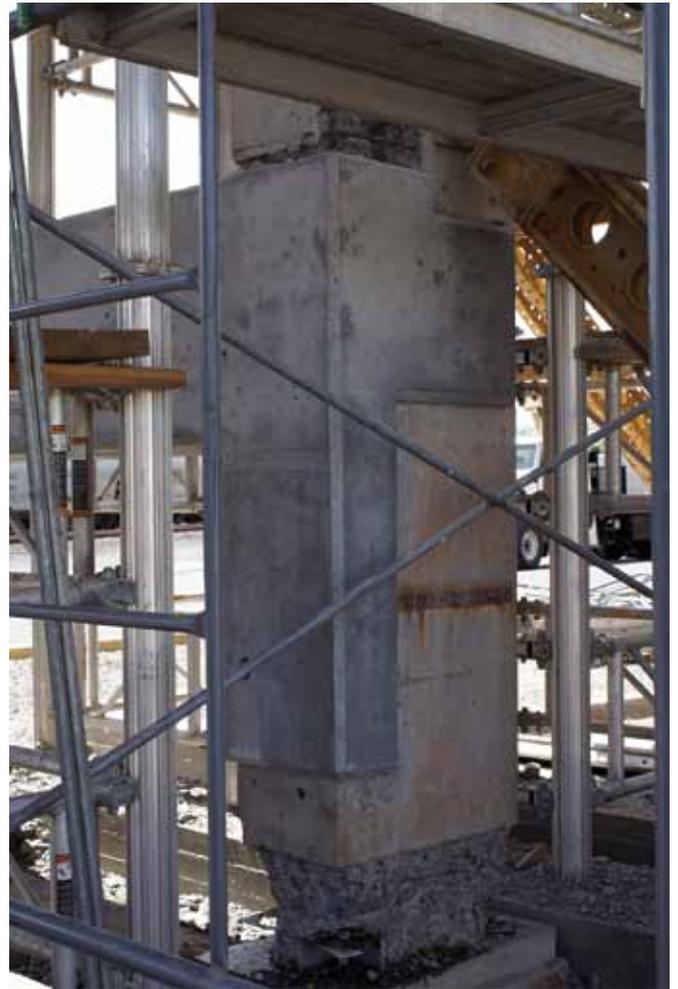
Column after repair

The product was mixed and installed using a mixer and pump combination. The product was mixed by a specialized mixer that uses an inline spiral mixer to properly combine the powder and water at the correct ratios on demand. As stated previously, this equipment allowed for the product to be mixed on demand, lowering overall project waste. The properly mixed product was delivered directly to the rotor-stator style pump for delivery to the preset, predampened forming system. The pump was able to deliver the product up to the top of the 50 ft (15.2 m) tower beams and legs without an issue. The two photographs above show the before and after of a typical type of concrete repair done on this project.

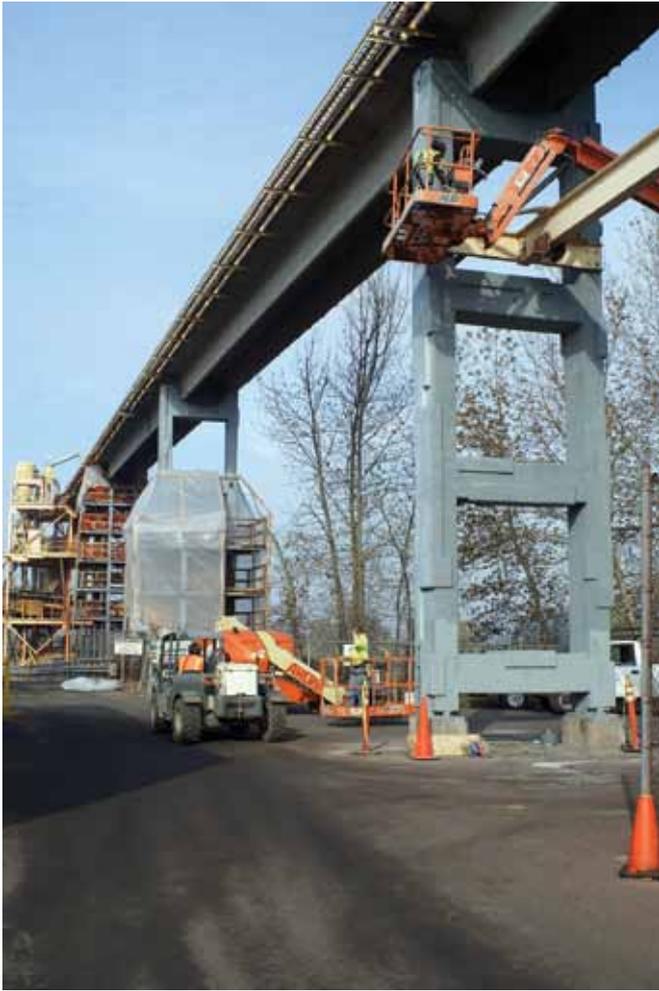
Project nearing completion

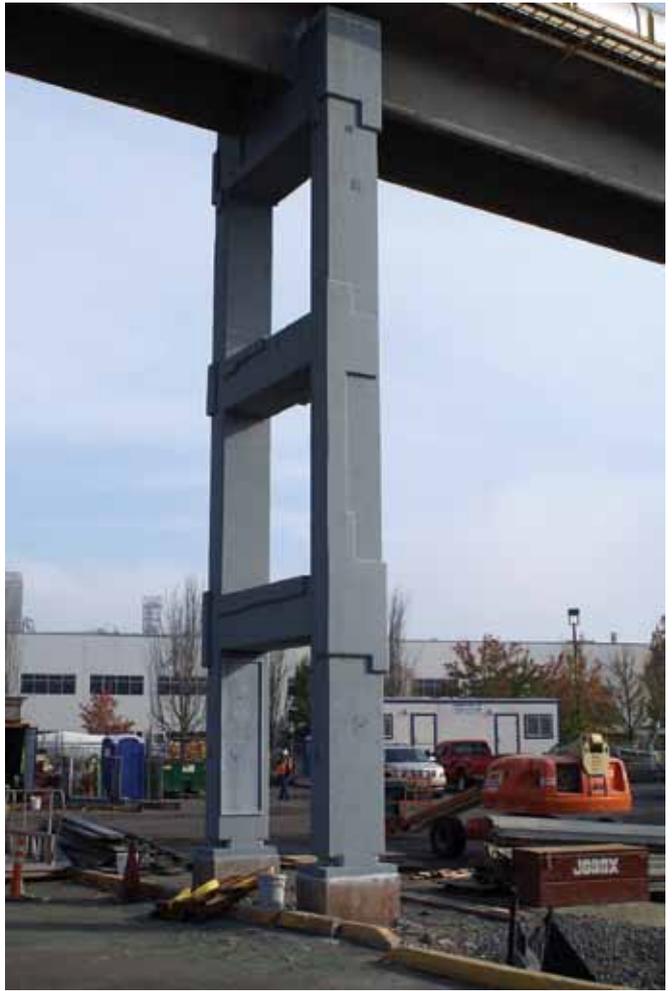
Finished project
