Motor Mart Garage

2000 National ICRI Concrete Repair Award

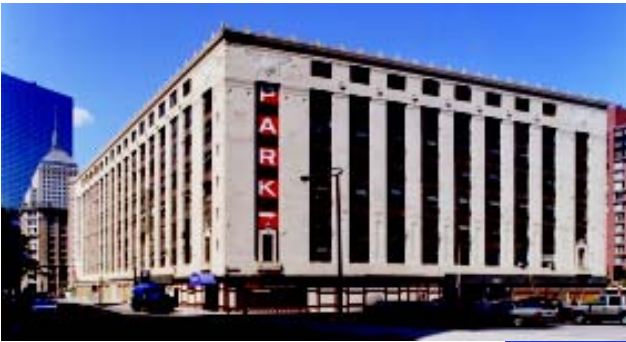
Facade from Stuart St. & Broadway Corner
(before)

As with the structural frame, the facade of the 76-year-old structure had weathered under harsh exposure conditions and was showing its age in the form of numerous cracks, spalls, and delaminations in the cast stone members. The industrial steel windows and ornamental metal panels above and below the windows were also in serious disrepair. Previous repair attempts had provided minor extensions to the service life. The once sharp detail of the neo-classical motif had been worn to a dull resemblance of its former grandeur.

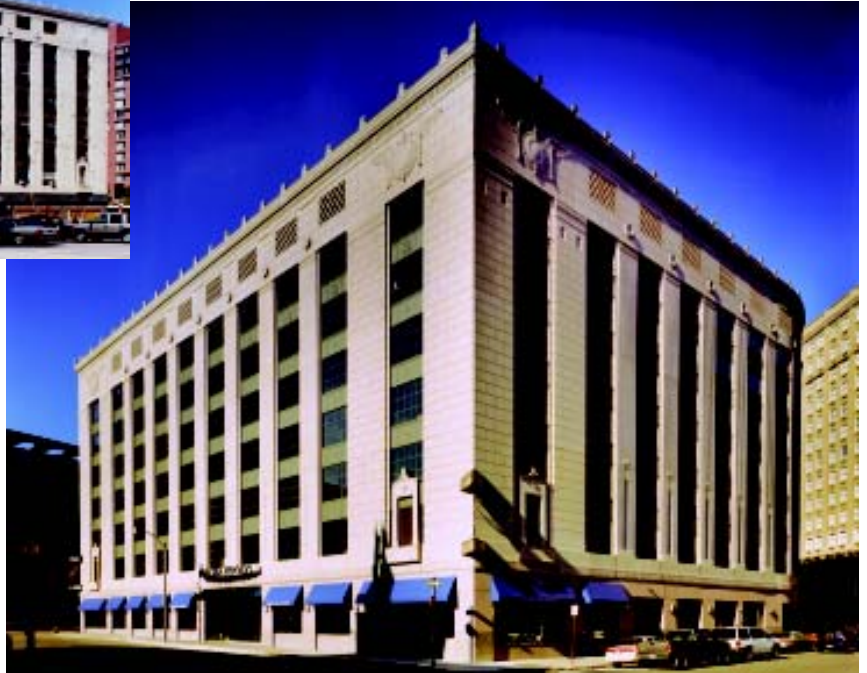
Facade from Stuart St. & Broadway Corner (after)

Cast stone construction was employed on the original facade. To preserve this cast-stone attribute, architectural precast concrete was utilized. Modern methods and machinery allowed designers to implement larger pieces and effectively maintain the cast-stone appearance through the use of false joints.

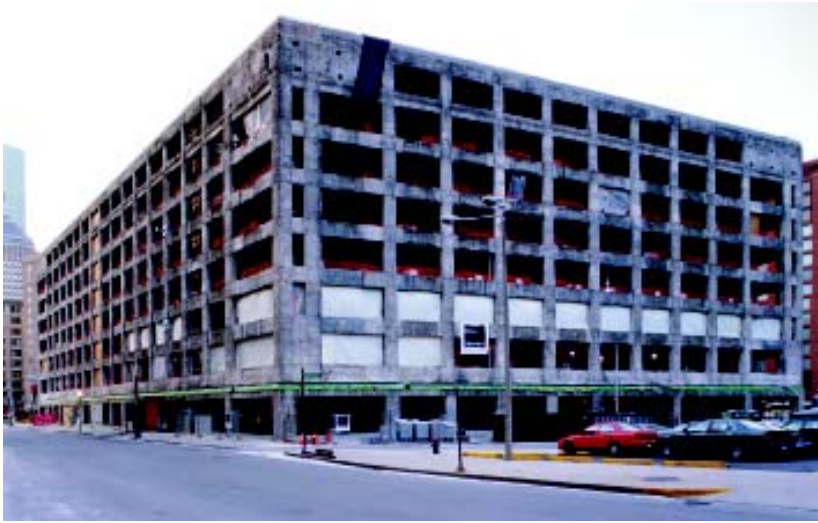
Facade from Stuart St. & Broadway Corner (during)

Following the removal of the cast-stone, windows, and ornamental metal panels, preparation of deteriorated structural frame elements was performed from the same scaffolding platform followed by any necessary cementitious repairs. Four scaffolding platforms were rotated in a leapfrog manner following the sequence of removal, preparation, and repair.

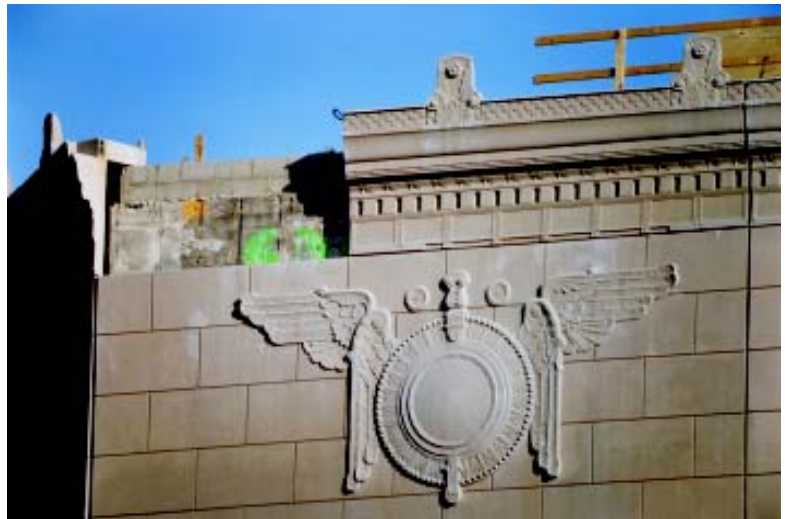
Facade detail (during)

Once the removal and repair program was sufficiently far along, new precast components were shipped to the site and erected on the prepared structure. To minimize site congestion, an offsite holding yard was used to store trailers loaded with precast components. The components were sent to the site for a “just-in-time” erection process, whereby a loaded trailer was scheduled to arrive onsite just as an unloaded trailer was departing.
