Repair and Rehabilitation of the Shipping House

By Imran N. Merchant

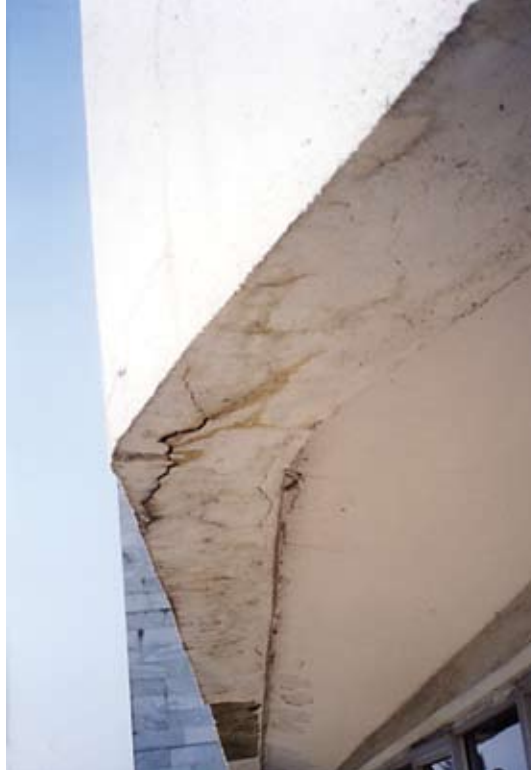
Reinforced concrete shearwalls were found to have nonuniform corrosion-induced macrocracks, and the plaster overlay was delaminated. External joints between reinforced concrete members and masonry cladding panels had also opened up. Varying intensities of water leakage were reported and observed from almost every office, and the terrace offices needed to be virtually abandoned during the monsoon season to escape the vagaries of the weather.

Delamination of façade render with corrosion-induced cracks

8. The shearwalls were also treated with a corrosion control treatment on the exposed steel and shotcrete reinforced with mesh and finished with two coats of cement render. Bands were introduced at every floor level to limit thickness of the mortar and to reduce the scouring velocity of rain-water during monsoon season. Special attention was paid to the joints of the masonry and concrete. A “V” groove approximately 2 in. (5 cm) deep was made by chiseling at the joint, and after cleaning, a cement mortar was pressed in. Dry aggregate pieces were then pressed firmly into the mortar. Nozzles for grouting were placed every 5 ft (1.5 m). After shotcreting and the first coat of cement render, cement slurry mixed with an expandable additive was injected under pressure into the nozzle. This helped ensure that the joint would not reopen in the future.

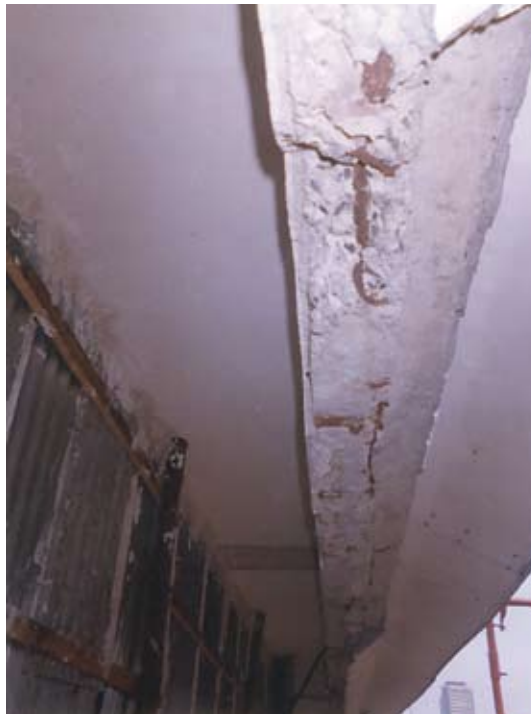
Due to inappropriate fixing details of aluminum windows over the peripheral reinforced concrete walls, the concrete of these elements, as well as the box section, showed extensive damage. Corrosion had also set in to the main reinforcing steel, resulting in the spalling of the concrete and setting off chain reactions for enhanced deterioration and damage.

Carbonation penetration was measured at 1.8 in. (45 mm) at the edges of box sections, and, in many places, the spalling was so severe that the reinforcing steel was visible.

Deterioration in façade concrete elements

5. The exposed corrosion-inflicted reinforcing steel was cleaned with a pretreatment to loosen the rust scales and passivated against corrosion with epoxy-based formulations. Extreme edges of box sections and composite beams were rebuilt with additional steel reinforcement and concrete. The entire façade was treated alike and eventually shotcreted with a rich polymer-modified cement mortar that averaged 1.6 in. (40 mm) thick, reinforced with a 10 gage welded mesh on a 3.9 x 3.9 in. (10 x 10 cm) grid.

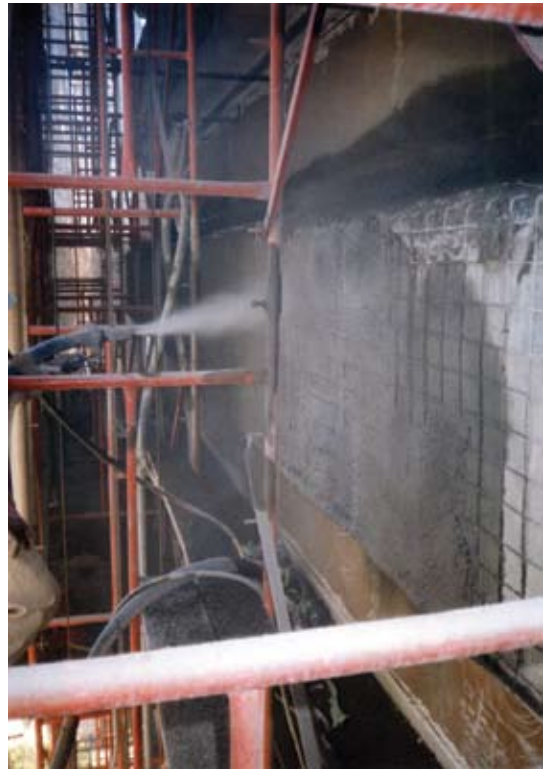
Shotcrete in progress

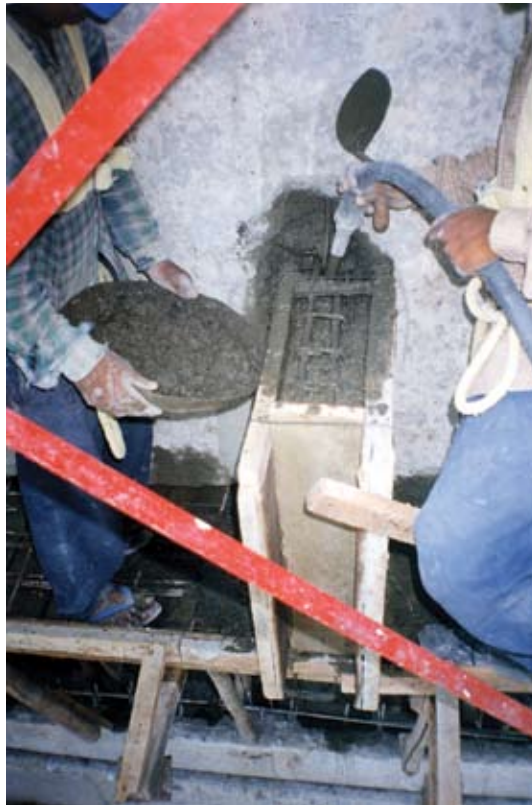
Bracket concreting and compacting using a needle vibrator

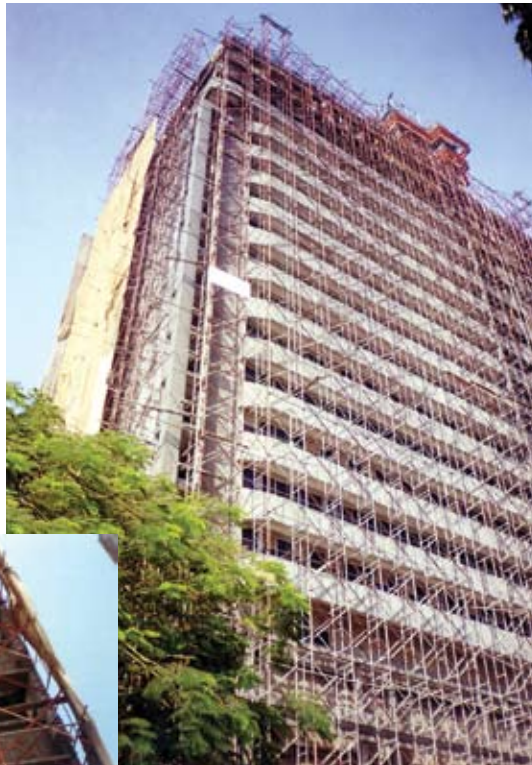
Fins being constructed with air-entrained lightweight concrete blocks

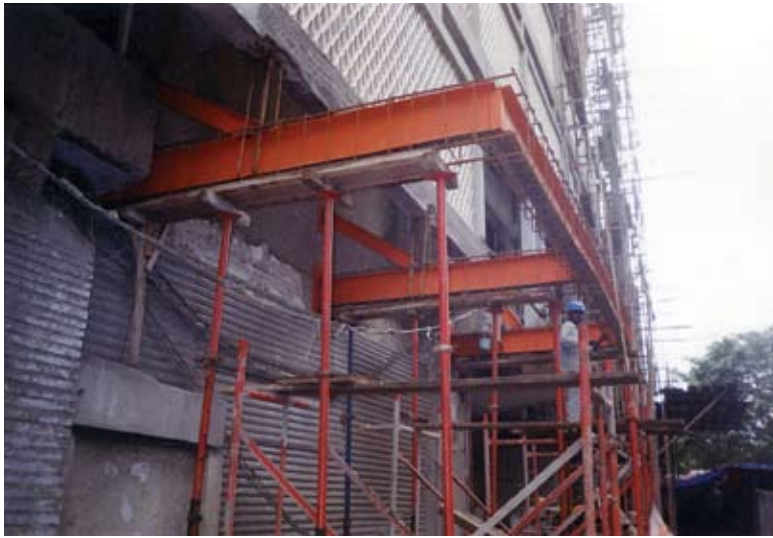
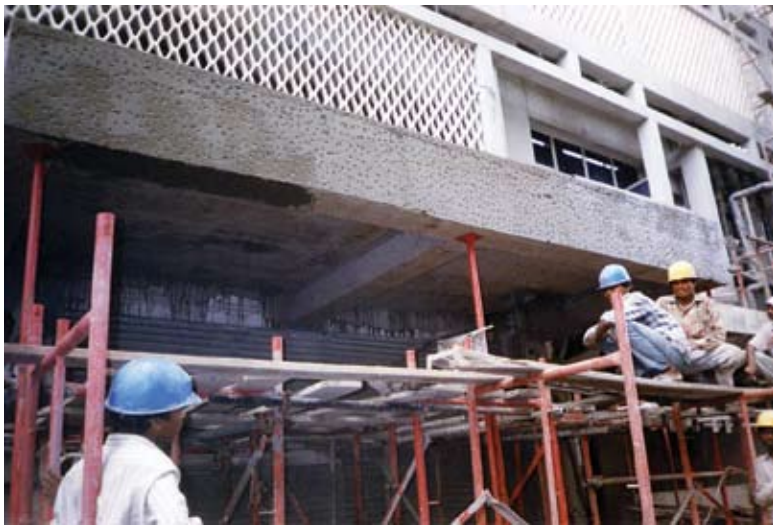
(Above and below) Construction of new 12 ft-cantilevered canopy
