A Comprehensive Approach to a Slab-on-Ground Repair

By Kip Gatto and Rocco Romero

A facility in Kent, Washington, experienced these conditions. The building is a nearly square 150,000 ft² (13,935 m²) area warehouse used for low-hazard storage. The floor system was originally constructed of self-consolidating 6 in. (15.2 cm) thick unreinforced concrete slab-on-ground with glass fibers added for shrinkage control. Control joints were cut 1-1/2 in. (3.8 cm) deep by 1/8 in. (0.32 cm) wide at a grid of approximately 16 ft (4.9 m). Roof support columns supported by below-grade footings were placed in a 32 x 52 ft (9.8 x 15.9 m) grid.

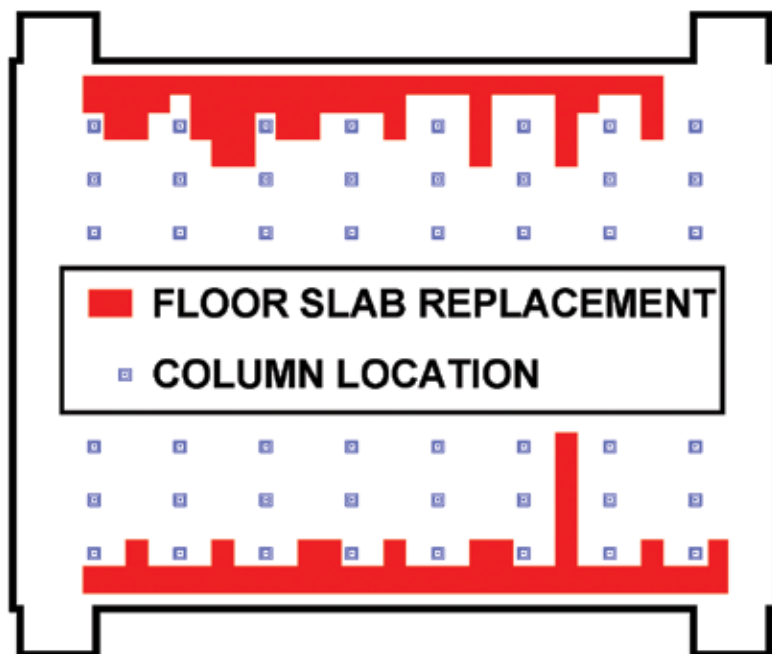
Floor slab replacement area

Near the delivery bay doors, the slab-on-ground had experienced severe distress. Large areas of cracking, displacement, and delaminations were common. At these areas, (approximately 20,000 ft² [1860 m²]) the slab was removed and replaced.

These high demand areas showed a vulnerability to damage, so these sections of the slab were replaced using concrete reinforced with deformed steel bars. Given that the primary purpose of the reinforcement was to minimize shrinkage cracking, which can initiate further damage, the subgrade drag formula given in ACI 302.1R “Guide for Concrete Floor and Slab Construction” was used to determine the minimum level of reinforcement. No. 4 reinforcing bars at 18 in. (46 cm) on-center were ultimately chosen to be placed in the top half of the slab. The bars were terminated just short of the planned control joints that were to coincide with the original joints.

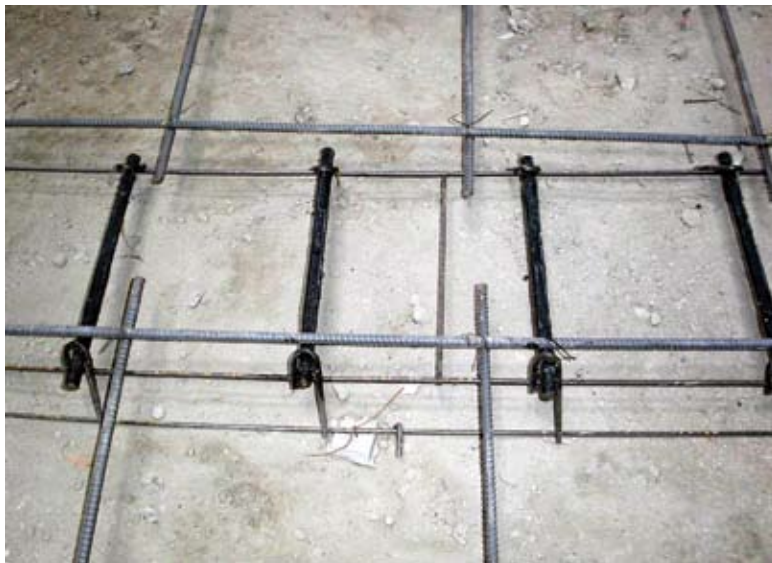
Greased round dowels at new-to-new slab joint

At control joints between new sections of slab, 16 in. (41 cm) long, 3/4 in. (1.9 cm) diameter greased round dowels were placed at 12 in. (30.5 cm) on-center. The dowels provided vertical load transfer across the joints but allowed shrinkage movement to occur with limited restraint in the direction of the dowel.

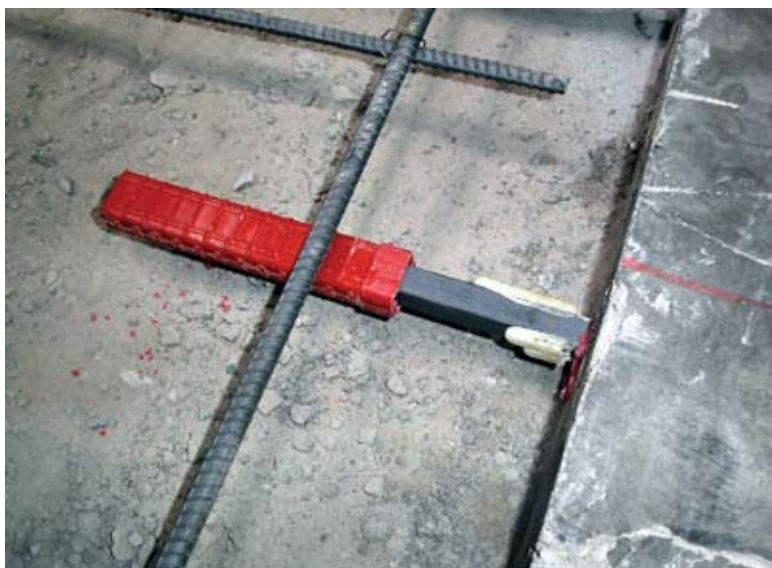
Square dowel with slip sleeve at new-to-existing slab joint

There was concern about the interface between the existing concrete that was to remain and the new long narrow sections of slab that were to be replaced adjacent to the delivery bay doors. Although round dowels can accommodate movement perpendicular to the construction joint, parallel movement is restrained. This is generally not a problem in new slabs because movement parallel to the construction joint is approximately the same on each side. In a “new-to-existing” slab construction joint, however, the existing slab obviously does not shrink, but the new slab will shrink and likely induce stresses at the dowel locations. To address this issue, 3/4 in. (1.9 cm) square dowels were used with plastic slip sleeves installed that theoretically accommodate movement in all directions except vertical. The sleeved dowels were intended to provide vertical load transfer across the new-to-existing construction joint while accommodating shrinkage stresses in all horizontal directions.

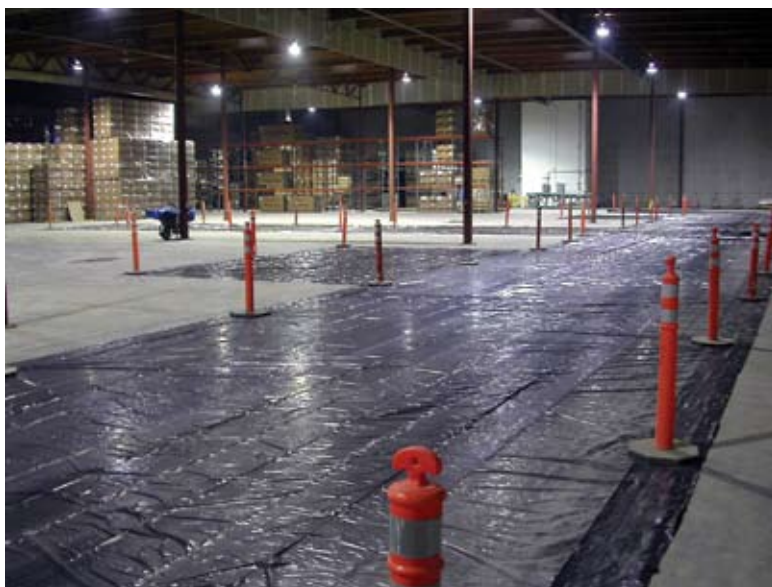
Floor slab curing

Considerable attention was given to subgrade compaction and grading, concrete mixture, concrete quality, slab curing, and timing of control joint cutting in an effort to maximize slab quality. These tasks are sometimes performed in a more informal manner, which reduces quality control and can result in increased cracking, curling, settlement, and general poor slab performance.

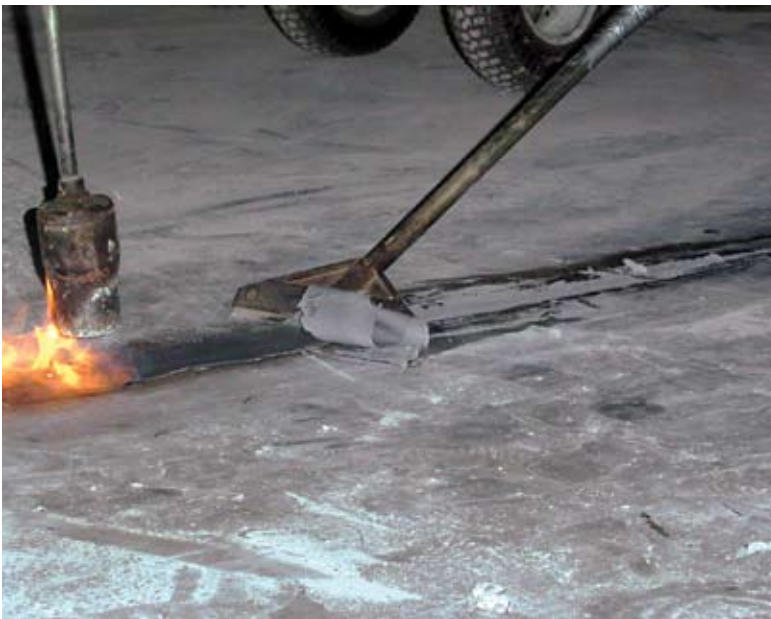
Cutting of semi-rigid epoxy filler at control joint

The control joints were frequently a source of edge spalling and distress. Some of the joints had already been filled with an inappropriate sealant that was ineffective in protecting the edge of the joints from forklift impacts. Filling the control joints with a semi-rigid epoxy, which is now recommended by ACI 302, “Guide for Concrete Floor and Slab Construction,” was performed at both existing and new joints.

The existing filler was removed and the semi-rigid epoxy applied. Bagged silica sand was used at the bottom of the joint to prevent epoxy from seeping away. The general procedure was to overfill the joint with epoxy, let it cure, then cut the surface flush using heat to facilitate the cutting. Power sanding was used to produce the desired profile at some areas where slight curling existed or the epoxy cut was irregular.

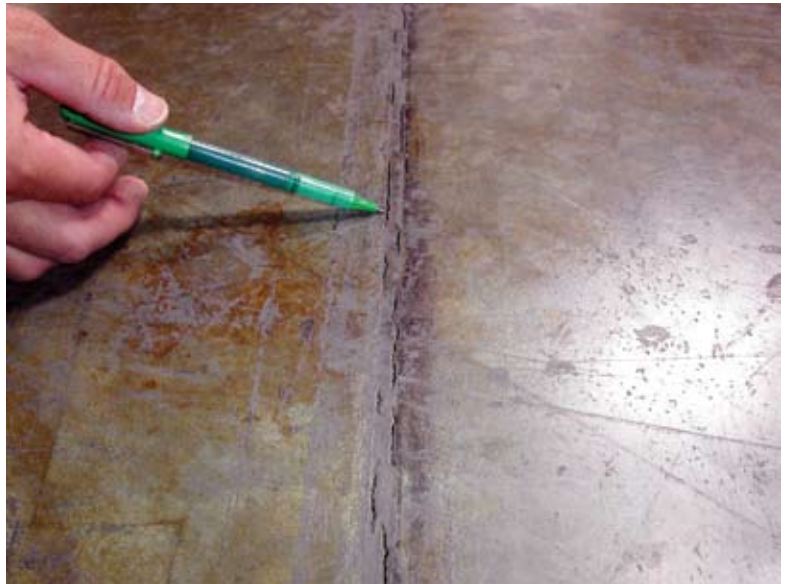
Epoxy applied at the new slab control joints was separating due to slab shrinkage intended to be accommodated at the joint. The epoxy was installed after the slab was cured for only 30 days, due to the building tenant requiring use of the repaired areas as soon as possible. Semi-rigid epoxy manufacturers recommend a waiting period (typically 1 year) before the epoxy is applied to prevent this condition from occurring. Given that the epoxy was reasonably effective in protecting the joint, however, even in the separated condition, it seems appropriate to apply it before the slab is used. Separated epoxy can always be repaired at a later time (the same product should be used when supplementing existing epoxy).

Epoxy separation after one year at new slab joint. Note that epoxy is still providing some protection of slab edge

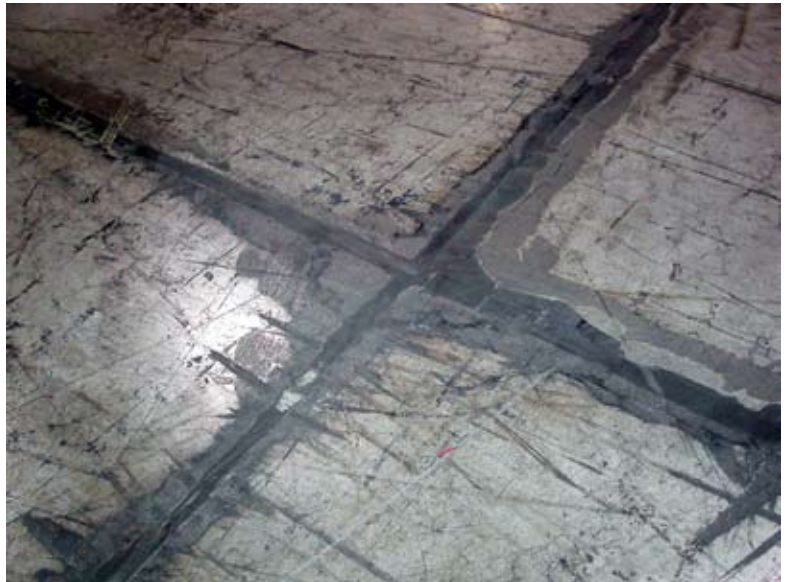
The semi-rigid epoxy applied at cracks and joints had largely appeared to be unaffected by the significant forklift traffic imposed over the year. At some locations where the epoxy was used to repair an edge spall, the repair had dished down leaving the edge again exposed. However, this was much more the exception than the rule. At one location the concrete had delaminated around the epoxy in a high traffic area leaving the epoxy in place. This is an area where a more aggressive repair may have

Epoxy joint and spall repair in existing slab after one year
