Multistory Building Steam Tunnel and Loading Dock Restoration

By David M. Morrison

Multistory Building Steam Tunnel and Loading Dock

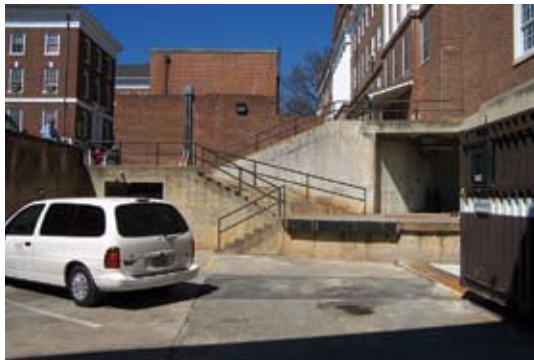
Fig. 1: Elevation view of loading dock, looking west, before restoration. The door to the steam tunnel is behind the car to the left

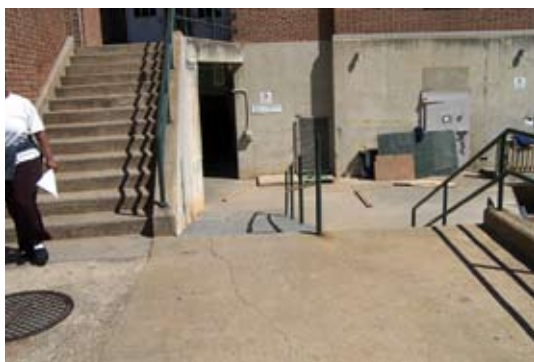
Fig. 2: View of loading dock and ramp, before restoration, as seen from the upper landing and looking north. The two-by-fours in the background approximately delineate the tunnel walls below

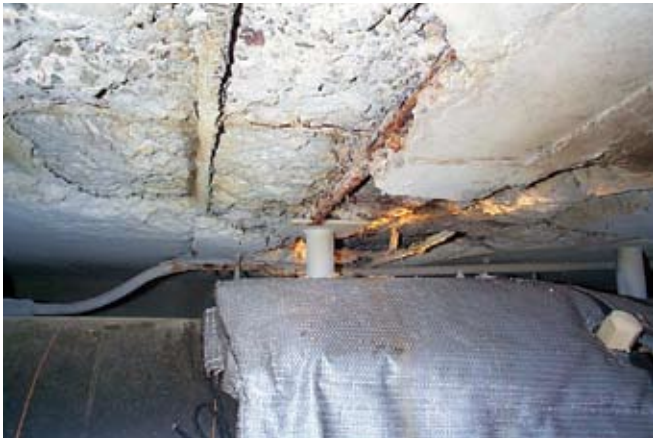
The owner was concerned that severe deterioration throughout the concrete structure threatened its safety and stability. A network of cracks in the top surface of the slab belied a far more extensive and serious spalling and corrosion problem in the soffit, visible from the tunnel below (Fig. 3). The tunnel walls displayed advanced spalling, delamination, and rebar corrosion (Fig. 4). The common wall between the tunnel and adjacent electrical manhole had spalling and delamination on the tunnel side (Fig. 5) and scaling on the electrical manhole side. A shallow concrete beam in the soffit of the tunnel, which supported the first-floor brick veneer at the southwest corner of the hospital building, exhibited severe spalling and corrosion of reinforcing steel (Fig. 6).

It is believed that 40 years of winter salt application was the primary cause of the severe deterioration observed in the structure. Heat from the steam piping very likely contributed by melting any snow and ice on the top slab and keeping it in a liquid state, in which it could maintain the concrete in a near-constant condition of electrolytic saturation. This constant supply of salt-laden meltwater is believed to have accelerated the corrosion and spalling process.

Fig. 3: Deterioration in the tunnel soffit

Repair system selection fell into three categories, depending on extent of repair and access. First, the top slab and beam required complete removal and repair. For these members, structural design calculations were performed and a highly redundant strategy was specified. The strategy, which was intended to forestall further deterioration, included a custom concrete mixture design, epoxy-coated reinforcing, and an epoxy broadcast overlay. The 4000 psi (27.6 MPa) concrete mixture required a very low 0.35 water-cement ratio, air entrainment, and a corrosion-inhibiting admixture. A superplasticizer was added to ensure workability.

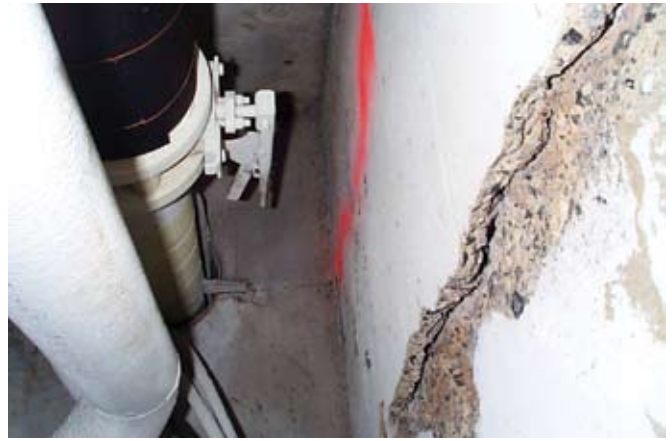
Fig. 5: Delamination, spalling, and scaling in the common wall between the steam tunnel and electrical manhole

Second, during demolition the common wall between the electrical manhole and the tunnel, which had been slated for full-depth removal and replacement, was discovered to be in better condition than originally thought and was patched instead.

Second, large vertical spalled areas on the walls were specified to be patched using a formed, polymer-modified repair mortar, chosen because thin sections were anticipated at some locations. Smaller areas were specified to be patched using a trowel-applied, polymer-modified repair mortar. In practice, the contractor elected to hand-trowel all patched areas.

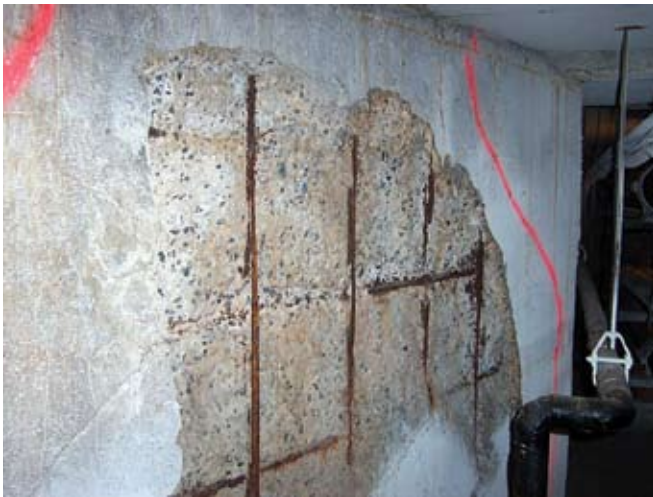
Fig. 4: Spalling and reinforcing steel corrosion in northwest diagonal wall. Note section loss in reinforcing steel

Contract drawings indicated simply “roughen and pressure wash” for areas requiring surface preparation. This left maximum flexibility to the contractor for selection of the method. The contractor used electric jackhammers. In addition, where patching was required adjacent to existing reinforcing steel, specifications required the contractor to remove concrete 360 degrees around and behind the bar. The contractor replaced bars exhibiting excessive section loss.

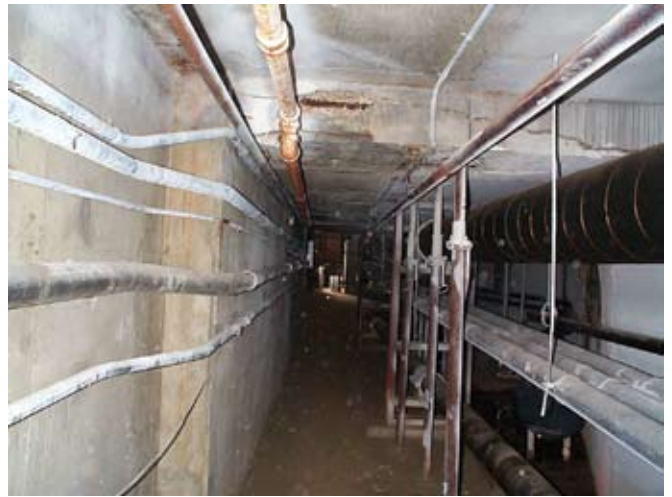
Fig. 6: Spalling and reinforcing steel corrosion in the concrete beam over the tunnel

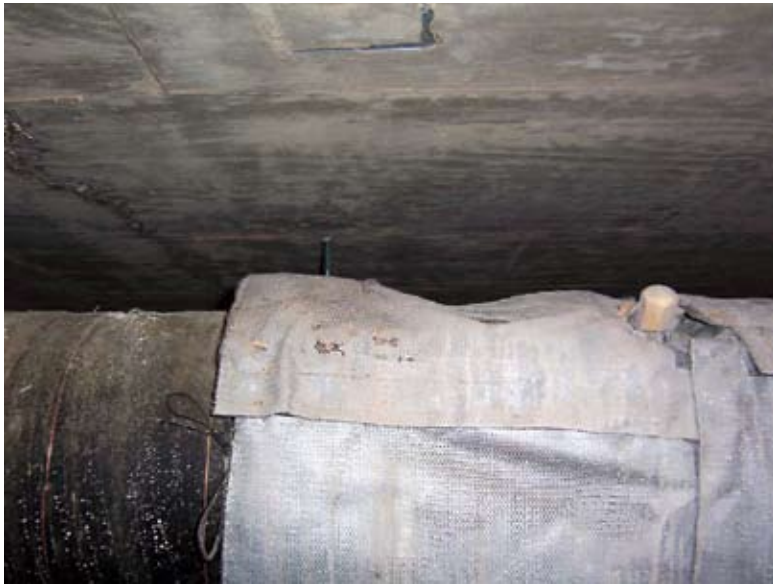
Fig. 7: Soffit of tunnel after restoration (compare to Fig. 3)

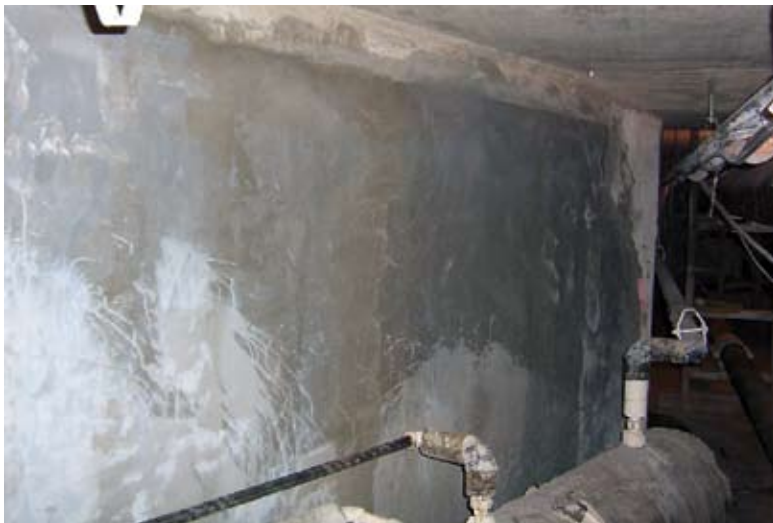
Fig. 8: Northwest diagonal wall after restoration (compare to Fig. 4)

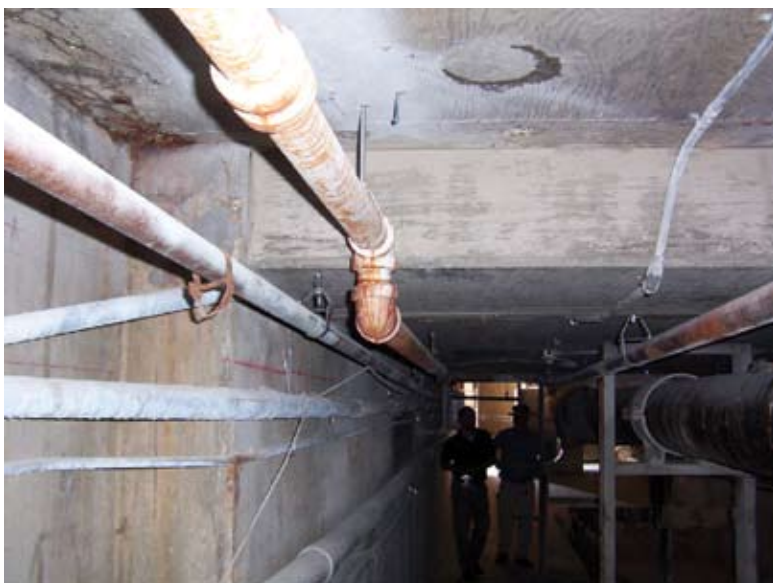
Fig. 9: Concrete beam after restoration (compare to Fig. 6)

Finally, the new concrete in the beam cured more slowly than anticipated, reaching only 1870 psi (12.9 MPa) at 13 days and creating a minor delay

in shoring removal. Low February temperatures are thought to be the cause. The beam and slab concrete later reached strengths in excess of 6000 psi (41.4 MPa) at 28 days.

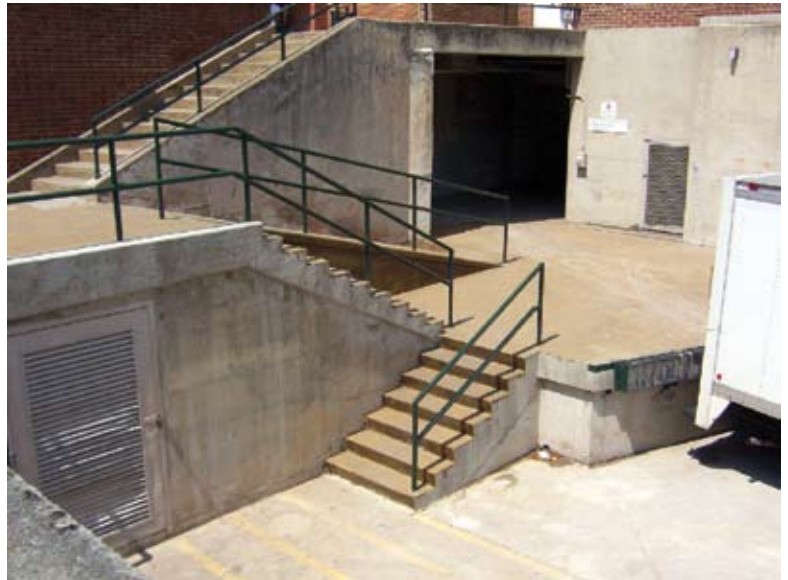
Fig. 10: Overview of finished project after restoration
