400 North Capitol Street Parking Garage Rehabilitation

By Robert Wychulis

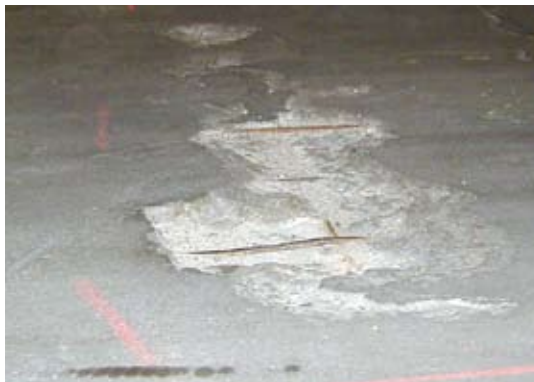
Typical top surface delamination with exposed reinforcing bars

The elevated parking decks were sounded via chain drag and mason's hammer to detect delamination of concrete due to corrosion of embedded reinforcing steel. Delamination of the top surface within the garage due to corrosion of reinforcing bars was documented in approximately 28% of the total top surface area of the elevated parking decks. Concrete delaminations typically occur when embedded reinforcing steel corrodes and exerts an expansive force on the concrete due to a volume increase, which takes place as iron is converted to iron oxide. The expansive force causes horizontal cracking at the level of the reinforcing bar. The slab-on-grade areas were, as expected, found to be sound. The 8 ft (2.4 m) wide section of mat slab was sounded on the Third Cellar level. Minimal concrete delaminations were found on the reinforced foundation mat.

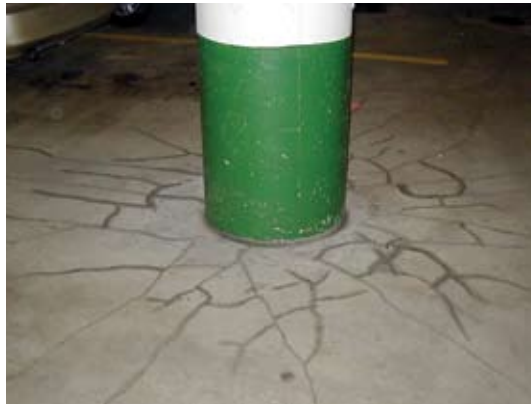
past garage repair included routing and sealing open concrete cracks. Top surface cracking either continued over the last 9 years or all cracks were not sealed during the repair. Generally, the crack sealant was in fair to poor condition. Splits and debonding of the existing caulk were typically apparent. Construction joints in the elevated parking decks were found to be unsealed. Typically, the cracks were more closely spaced at the negative moment areas in the slabs. Negative moment areas are located at the slab areas around supports such as columns, beams, and walls. Cracks propagate in all directions away from the columns and longer cracks extend from column to column. Open cracks and construction joints allowed salt-laden water to penetrate easily through the slab. As the saltwater passed through the concrete, the salts corroded the embedded, unprotected steel reinforcement. Water leakage can be seen throughout the garage on the soffits, or ceilings, of the slabs. The quantity of cracking noted in the quantity summary reflects only the estimated quantity for cracks >1/16 in. (0.16 cm) width as all smaller cracks would be bridged by the waterproof membrane.

Typical top surface negative moment cracking around column due to low top surface steel location

Observing the location of the top mat of reinforcing during demolition answered questions such as why there was such extensive cracking in the negative moment areas (top surface of the slab) and ponding of water in almost every bay. The slab was deflecting and cracking until the top mat of bars engaged to resist the induced stress. Basically, the top 2.75 in. (7.0 cm) of the slab was unreinforced, free to deflect and crack. During the repairs within the garage, the majority of the top mat was around the 2.75 in. (7.0 cm) level of cover. If the BOCA code did not change the live load requirement from 75 psf (3.6 kPa) to 50 psf (2.4 kPa) over the decades, the large garage repair could have been a large garage replacement program.

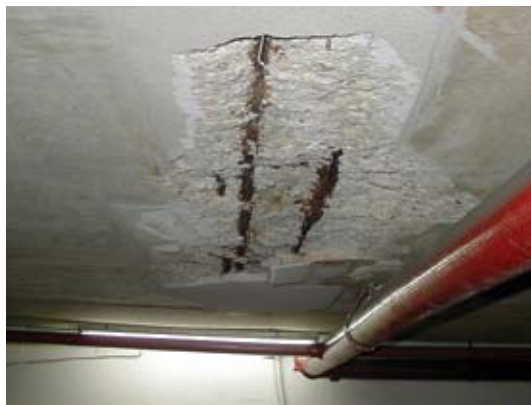
The past soffit concrete repairs can be seen extensively throughout the garage. Typically, almost every bay has soffit repairs or new delaminations. The soffit patching conducted in the past was not in conformance with the proper repair procedures that are being used today. Apparently, the contractor just removed the surface delamination and applied a trowel-applied material back in the void over an unsound substrate. A few important steps were not completed in the soffit repairs such as not properly exposing and cleaning the reinforcing steel and leaving feathered edges around the patch perimeters. A portion of the repair area was easily removed to reveal the improper techniques used in the past.

Typical previously repaired soffit patch. Note the old patch was not properly repaired—the reinforcing bars were not undercut

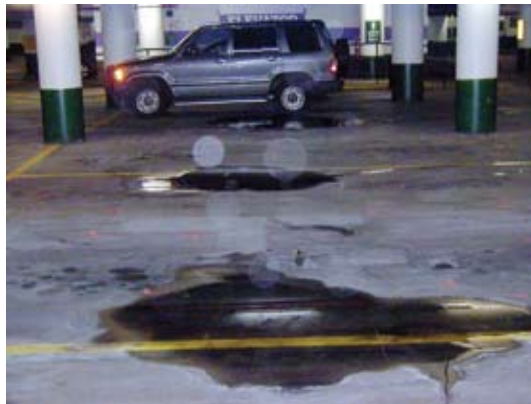
After observing the garage after rain and snow storms, poor drainage of top surface water was apparent throughout the structure. In many areas of the garage, low spots were observed in the center of the bays, both drive lanes and parking stalls. These low spots often led to concrete deterioration as the standing water kept the concrete below saturated and exposed to large amounts of saltwater. Top surface cracking located within the low spots also allowed saltwater to easily penetrate into the

Typical ponding of water at low spot in center of bay

slab. Large soffit delaminations were typically found under all low spots in the garage. Floor drains should be installed where these low spots are located.

New floor drains were installed in the phase areas as required to alleviate standing water. Due to the large amount of concrete removed, entire bays were resloped to new floor drains. All of the concrete repairs were completed prior to the application of a corrosion inhibitor treatment (CIT) and a waterproofing membrane system. After all concrete repairs were completed and cured for a minimum of 28 days, the CIT was applied just prior to the waterproofing membrane on all elevated decks. The phase areas of the CIT and membrane application mirrored the same areas as the concrete repairs.

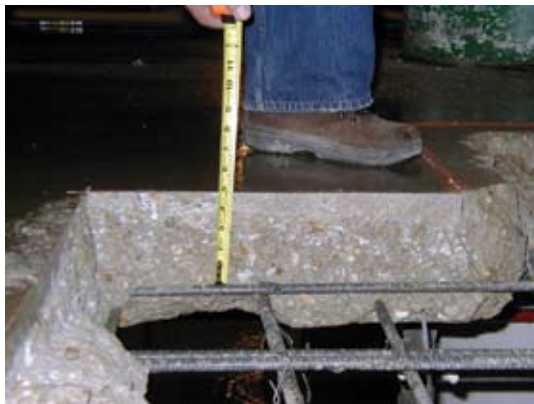
During the first phase of the project, it was observed that the top mat of steel reinforcement was significantly lower in the slab than specified on the original structural drawings. The original drawings specified 3/4 in. (1.9 cm) cover over the top mat. It was observed that the top mat of steel had anywhere from 1 to 5 in. (2.5 to 12.7 cm) of cover.

The location of the top mat immediately caused structural concerns. The project engineers conducted a slab analysis to determine the severity of the misplaced bars. The slab was initially designed for 75 psf (3.6 kPa). The current BOCA code requires a minimum of 50 psf (2.4 kPa). The slab analysis applied the 50 psf (2.4 kPa) to the existing slab geometry and amount of reinforcing steel. The engineer then determined the maximum cover that can be provided to meet the current BOCA code live load requirements. A maximum cover of 2.75 in. (7.0 cm) was determined from the analysis.

Top mat of reinforcing steel with 4-3/4 in. of cover. Note the top bar was actually tied to the bottom mat of steel

(1.9 cm) and providing 2.75 in. (7.0 cm) of cover left only 2 in. (5.1 cm) of concrete below the top mat. Such a thin amount of concrete could not be salvaged. In areas where the top mat of steel had more than 2.75 in. (7.0 cm) of cover, the entire bar was disengaged from the slab and raised up to the point of 1.5 in. (3.8 cm) of cover. Due to the extensive amount of full-depth repair areas around the columns, a large number of lateral braces were required to shore the structural elements during the demolition.

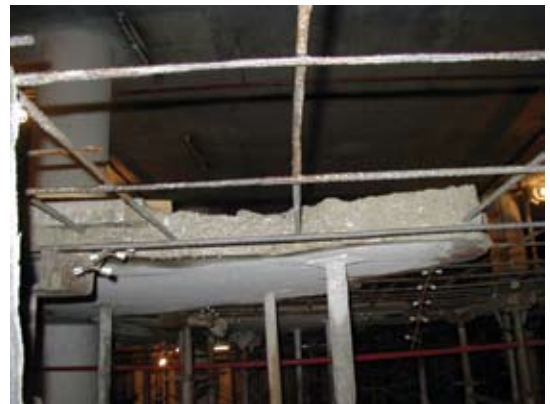
The amount of full-depth repair areas within the garage grew significantly as a result of this deficiency. During hydrodemolition, undercutting the top mat No. 6 bars in both directions by 3/4 in.

Full depth repair. Note the depth of the top mat located at the left side of the picture. The top mat is depressed to mid-depth of the slab

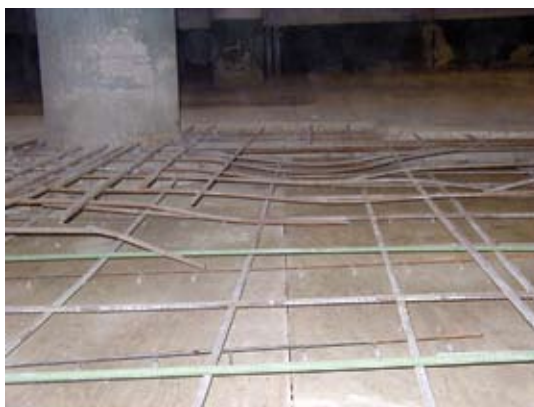
Full depth repair area. Note the deflected top bars, from original concrete pumping operations and additional epoxy coated bars were installed due to the lack of amount of bottom steel

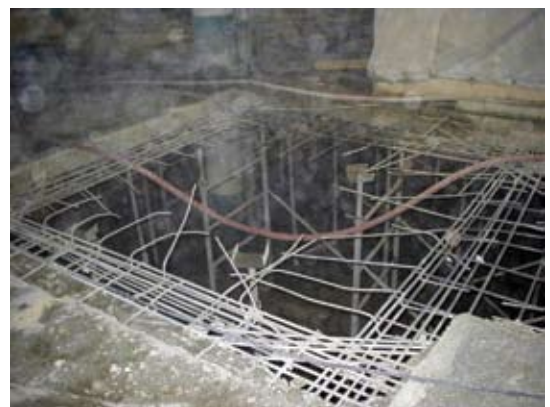
Full-depth repair at a crane opening

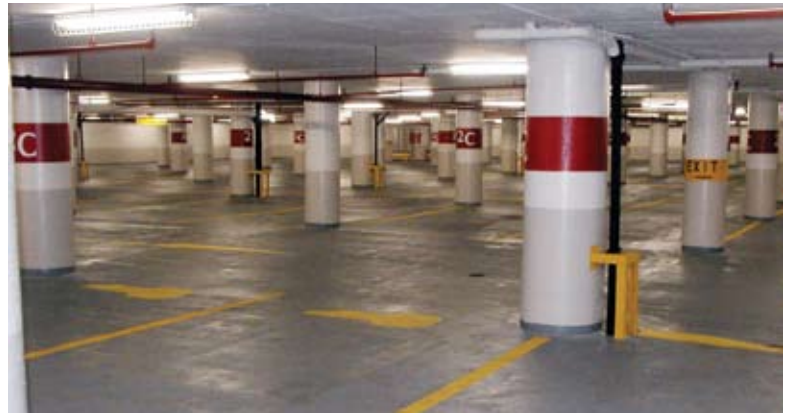
The finished garage. The battleship gray waterproofing membrane has sealed and protected the new repairs and original concrete from additional chlorides entering the slabs. The entire garage was painted and new lighting was installed
