Exterior Repairs to University Building

Exterior of the Robert Purcell Community Center

RPCC

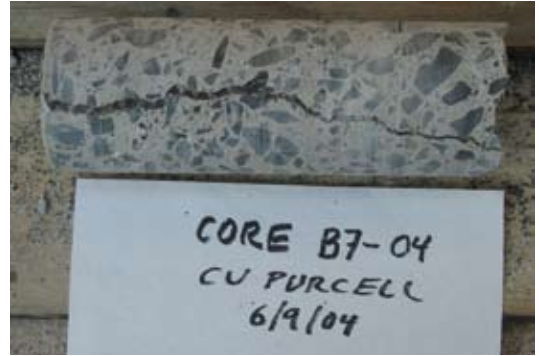
Concrete core

Core samples were analyzed by petrographic examination using methods from ASTM C 856. The examinations showed that the concrete had minimal air entrainment and contained four types of alkali-silica gel. These findings are consistent with the map cracking patterns in the concrete. The examination also identified secondary gel deposits, which are typical for concrete with long-term moisture exposures.

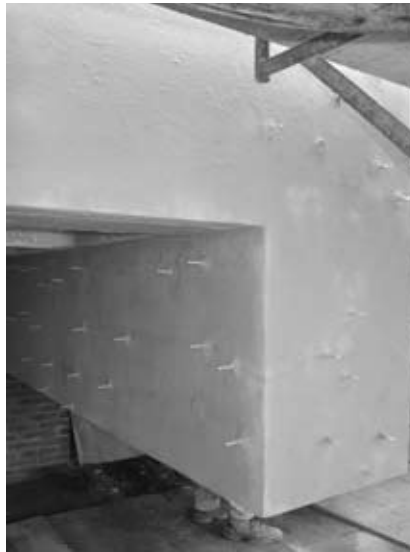
Injection ports

- removing and shoring bricks bearing on the top of the beams;
- sandblasting previously applied coatings, surface sealing cracks;
- setting a network of ports to create a vacuum, then drying the internal cracks via the vacuum;
- injection of the epoxy resin;
- test coring;
- application of the finish coating;
- adding flashing and weeps; and
- brick replacement.

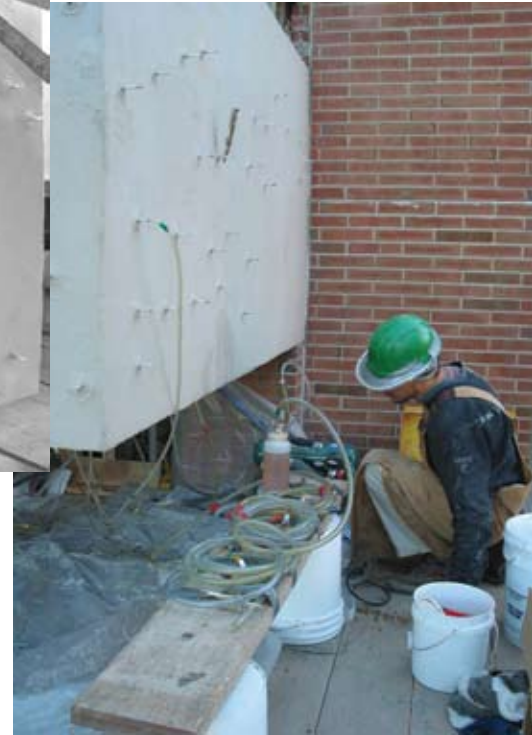
Vacuum injection of resin

An alternative method proposed by the structural engineer was based on a process of vacuum injection/impregnation. This method creates a vacuum simultaneous with injection on isolated sections of beams. The vacuum process draws resins into cracks much smaller than through conventional injections. Because of the extensive cracking, much of it on a micro scale, the technology appeared to be worthy of consideration.
