Corrosion Mitigation and Column Strengthening at the Atalaya Towers Condominium

By J. Christopher Ball, Alan J. Schweickhardt, and C. Robert Thaxton

Atalaya Towers is a 16-story oceanfront condominium located in Garden City Beach, SC, approximately 20 miles south of Myrtle Beach. Built circa 1985, Atalaya Towers was constructed with reinforced concrete columns, shear walls, and concrete floor slabs with an exterior that is clad with brick veneer and stucco.

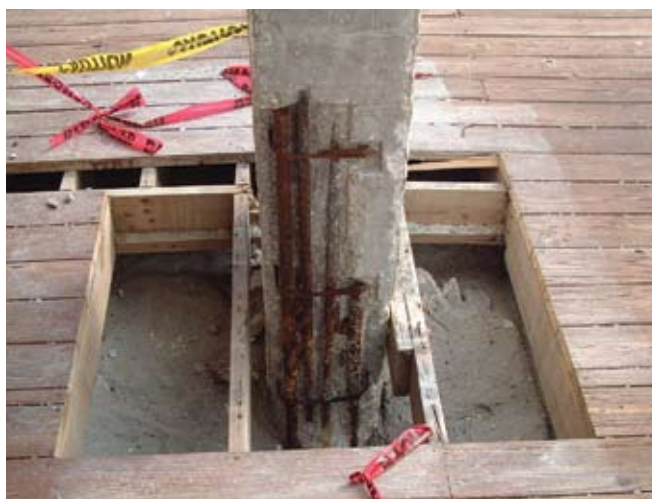
During the field survey, the engineer also noted that a smaller 12 x 24 in. (30.5 x 61.0 cm) ground floor concrete column at the southeast corner of the structure had significantly spalled concrete and corroded reinforcing steel. The vertical steel and ties were exposed, and the deterioration extended around the column and down below the sand line, beneath the wood frame deck that was built around the column.

Significant concrete damage on 12 x 24 in. (30.5 x 61.0 cm) column

Carbon fiber strengthening, which has become more commonplace in recent years, was deemed to be a more practical solution from an installation standpoint. For these reasons, the engineer recommended that the column be strengthened using externally bonded carbon fiber sheets wrapped horizontally around the column using the wet lay-up process. The carbon fiber design was performed using the manufacturer's engineering guidelines and ACI 440.2R-02, "Guide for the Design and Construction of Externally Bonded FRP Systems for Strengthening Concrete Structures." The design requirement was four layers of a 0.015 in. (0.038 cm) thick unidirectional carbon fiber fabric, field laminated using epoxy. The corners of the column were rounded to a 2-1/2 in. (6.35 cm) radius to meet the design parameters.

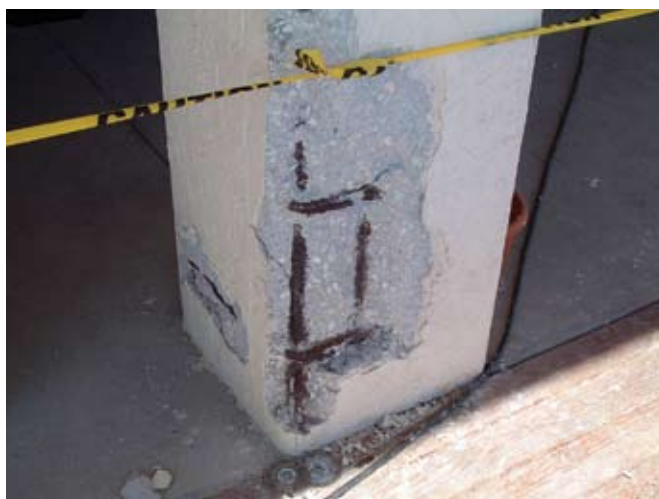
During the survey, evidence of concrete deterioration and corrosion of the reinforcing steel was observed at the ground floor 12 and 24 in. (30.5 and 61.0 cm) square and rectangular columns and 12 in. (30.5 cm) shear walls throughout the structure. Several sections of concrete came off the structure when sounded with a hammer, and there was concrete damage and rusting of the reinforcing steel. Due to the proximity of the structure to the

Typical concrete damage on ground floor columns

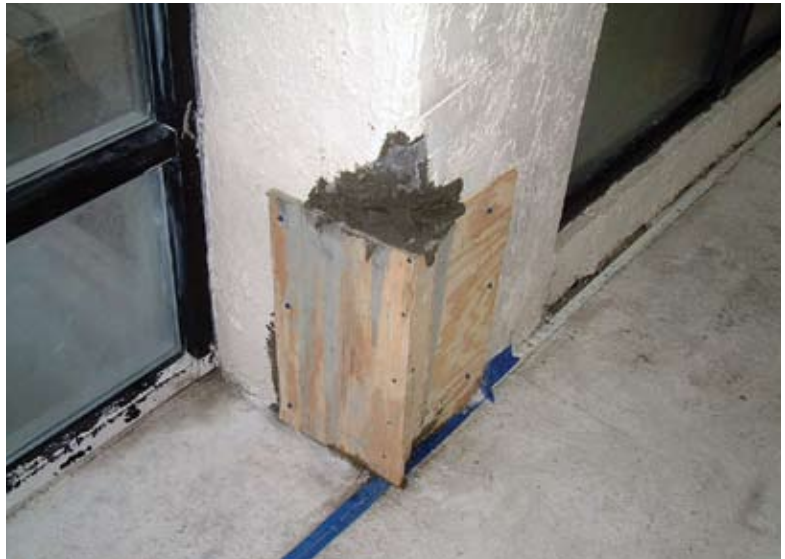
Concrete patch repair

All spalled and delaminated areas in the columns were repaired in accordance with ICRI Guideline No. 03730, "Guide for Surface Preparation for the Repair of Deteriorated Concrete Resulting from Reinforcing Steel Corrosion." Concrete removal was completed with 15 lb (6.8 kg) chipping hampers to minimize microcracking and bond failure of the repair material.

The area of concrete removal continued until clean steel was encountered. Concrete was also removed from around the full circumference of the exposed steel and the steel was sand blasted to remove all corrosion by-products and cement paste that is likely chloride-contaminated. If more than 25% of the bar diameter was lost to corrosion, supplemental reinforcing was provided by splicing in new steel. By following these industry recommended procedures, the areas with the most advanced corrosion activity were addressed.

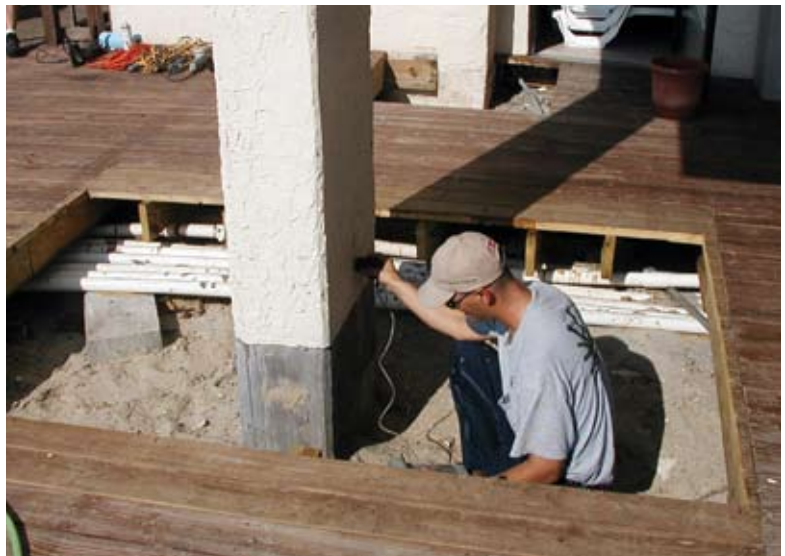
Locating reinforcing steel prior to galvanic anode installation

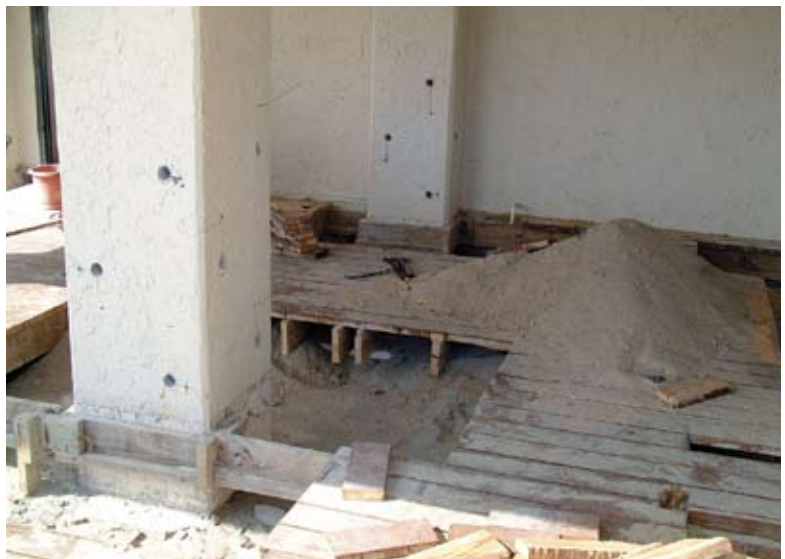
Decking removed and sand excavated for access to column below sand line

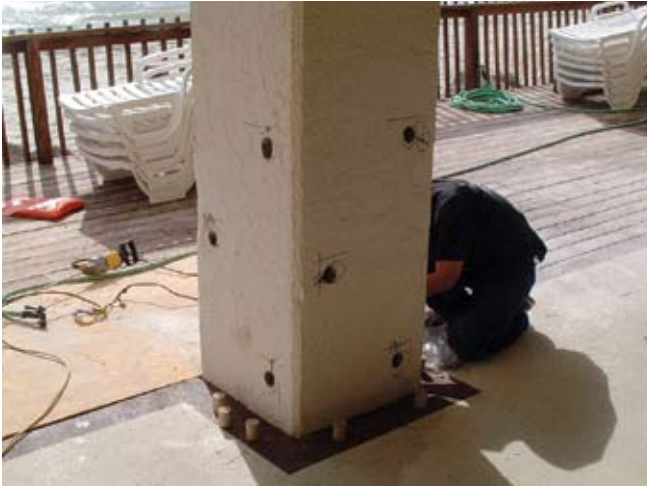
Holes drilled prior to anode installation

The spacing between the individual cylindrical-shaped anodes was determined based on the density of steel to be protected (steel: concrete surface area ratio). Based on this information, three galvanic anodes were installed into the face of each column with a vertical spacing of approximately 16 in. (40 cm) between anodes. The anodes were staggered such to provide a more even current distribution, especially to the steel in the corner of the columns, which are particularly vulnerable to corrosion damage. Where wood decking concealed a portion of the columns above the sand line, the wood decking was removed and the anode installation started approximately 8 in. (20 cm) above the sand line. The anodes were grouted into 2 in. diameter x 4 in. deep (5 x 10 cm) holes and individually connected to the reinforcing steel.

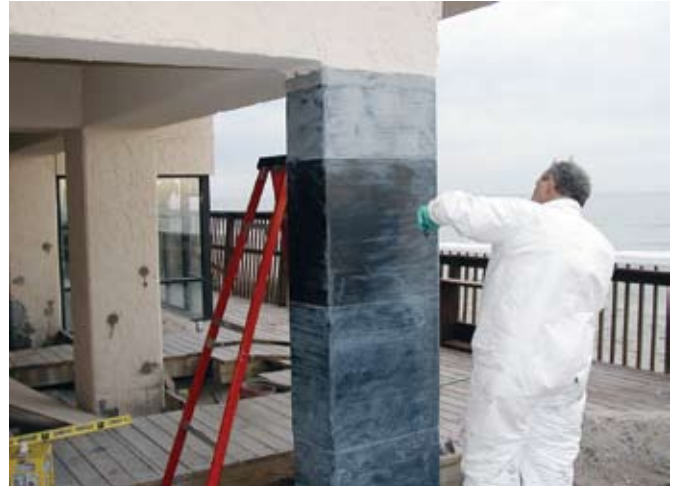
Installation of carbon-fiber strengthening system

After the galvanic anodes were installed, the carbon fiber sheets were bonded to the column with epoxy using a wet-layup method.

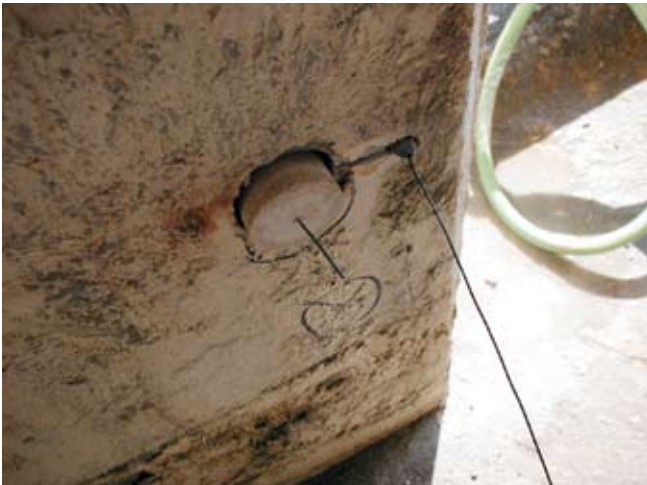
Close-up of anodes and reinforcing bar connector

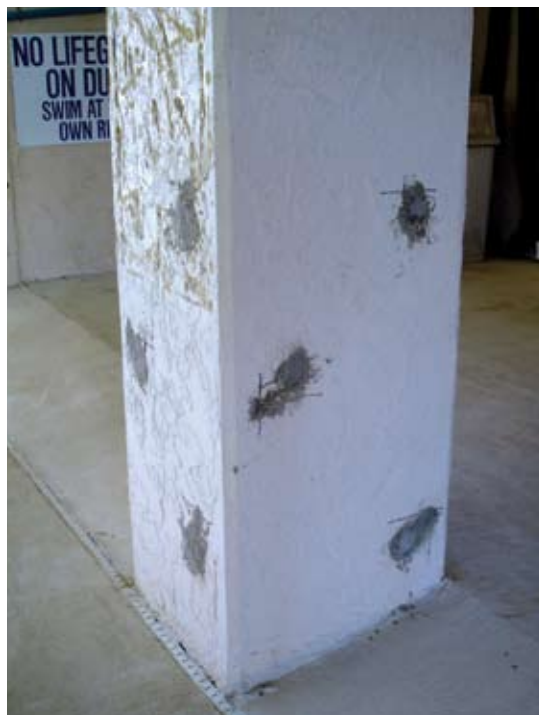
Anodes installed into column on staggered grid pattern

Galvanic protection was targeted to control the corrosion activity in the bottom 4 ft (1.3 m) of each column in the three rows of columns closest to the ocean, an economic approach to extend the overall service life of the structure. Galvanic corrosion protection systems provide a naturally generated electrical current to the embedded steel to mitigate corrosion activity. Compared to impressed current systems, they do not require an external power source or system monitoring and are generally maintenance-free over their design life.
