INNOVATIVE DOUBLE-TEE REPAIR SOLUTION

BY CHRISTOPHER M. MORGAN

Double-Tee Roof Structure Repair

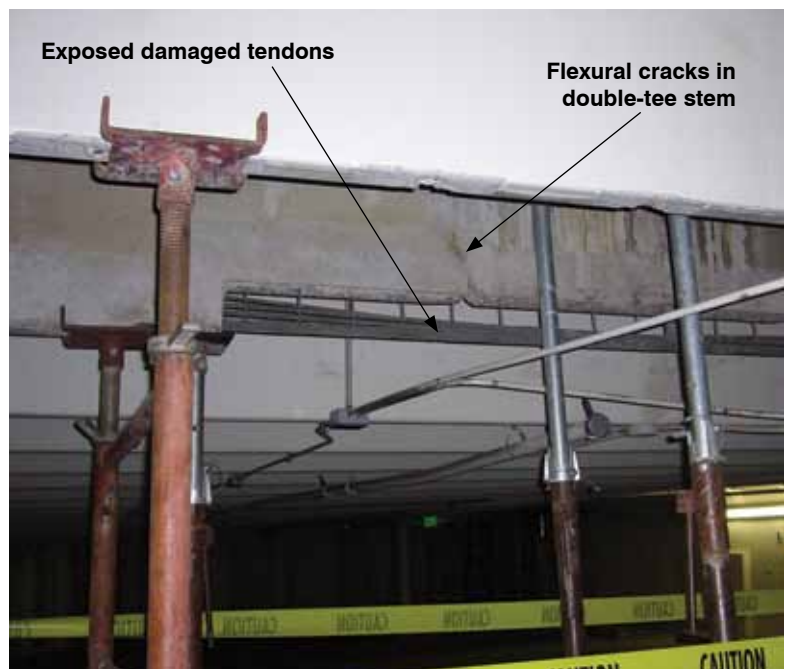
Fig. 1

In 2006, the damaged stem of a concrete double-tee roof structure required a unique repair. The roof structure supported a parking and plaza area over an underground parking garage. The structure was built in the 1970s and consisted of internally-reinforced concrete, precast double-tee beams with a clear span of approximately 53 ft (16 m), bearing on cast-in-place concrete foundation walls. At midspan, an opening had been cut through one flange of one double-tee to allow for the installation of a ventilation shaft. Over the years, water and deicing salts had reached the internal prestressed tendons within the double-tee stem through typical flexural cracks, causing corrosion and resulting in failure of the tendons (refer to Fig. 1).

One of the stems of a concrete double-tee beam for a roof structure developed a significant structural flexural crack. It was discovered that all six of the prestressed reinforcing tendons within the stem had failed due to corrosion. Shoring, which had been placed underneath both stems of the double-tee, was immediately reinforced to provide emergency support for the entire weight of the double-tee and the associated parking and plaza area above. The challenge was to repair the damaged double-tee beam without reducing the clear span and without reducing the headroom clearance within the underground parking garage. Conventional external post-tensioning repair methods could have been used if only one tendon had failed, but they could not be used to provide sufficient strength to replace six tendons, or the equivalent of approximately 180,000 lb (81,650 kg) of force.
