TRENCHLESS EMERGENCY REPAIR OF MILE-LONG PIPELINE WITH FRP

BY MO EHSANI AND CARLOS PEÑA

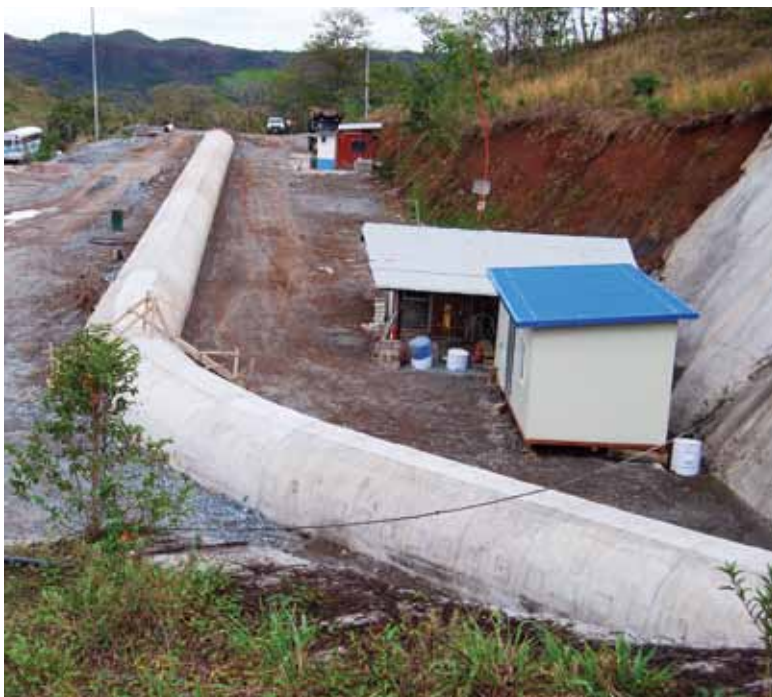
The low-pressure pipeline at the El Encanto power plant (Fig. 1) conveys river water from an upstream dam to the turbine complex downstream. The pipeline is built of cast-in-place reinforced concrete with an inner diameter of 7 ft (2.1 m) and a total length of 5742 ft (1750 m). The water flows by gravity, but because of the elevation difference between the dam and turbine complex, as well as the continuous changes in the vertical and horizontal alignment of the pipeline required to conform to the mountainous topography, the water flow is pressurized.

Although the structural design had properly addressed the strength requirements of the pipeline and accounted for the design pressure and hydrodynamic loads, the pipeline's serviceability requirements were overlooked. The pipeline exhibited significant longitudinal and transverse

Fig. 1: Aboveground segment of the El Encanto pipeline

cracking during a pressurized test and, as a result, as much as 20% of the flow was lost due to leaks.

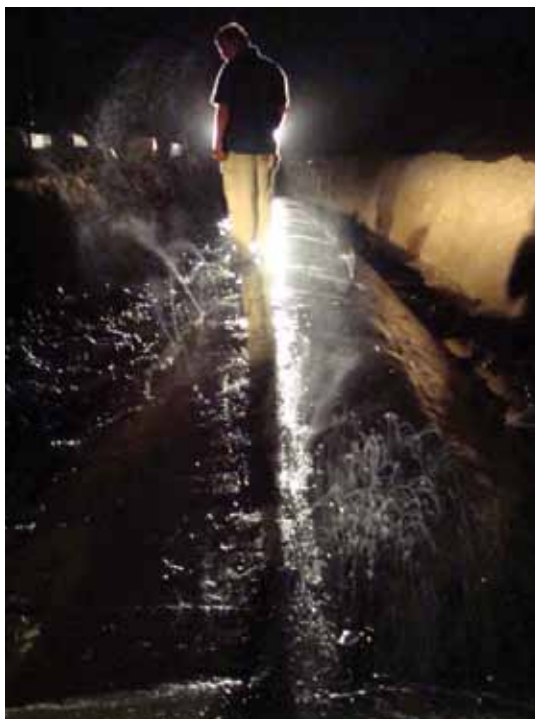
The pipeline was drained and all visible cracks were sealed using typical repair materials. When the pipeline was pressurized for a second time, the repaired cracks leaked again. The leaking at the repaired cracks was most likely due to the increase in the crack width due to the deformations of the pipeline caused by the increase in internal pressure. Given the relative rigidity of most crack sealing materials, full deformation compatibility between the repair material and the surrounding concrete could not be achieved, degrading the integrity of the seal and allowing leaks to reoccur. Figure 2 illustrates typical leaks occurring along the length of the pipeline during tests conducted at maximum operational pressure.

Fig. 2: Leaking after conventional crack sealing

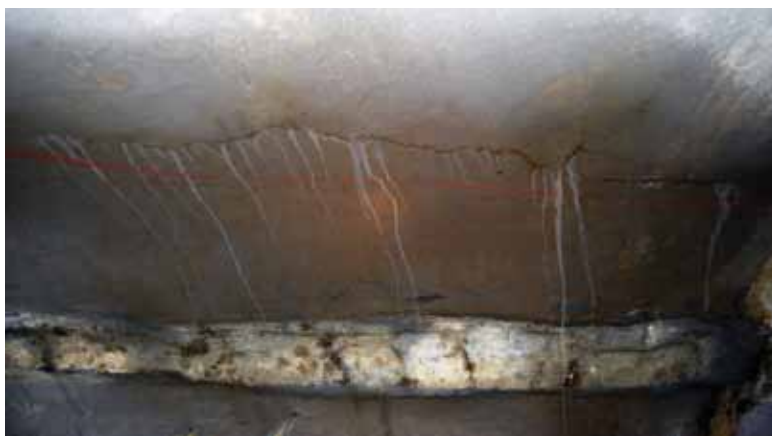
Moreover, the cracks generated multiple paths for humidity intrusion that reached the steel reinforcement of the pipeline, allowing for corrosion problems that, if not properly addressed, could compromise the structural integrity of the pipeline in the future. Complicating the problem even further was the combination of mountainous topography and the constant tropical rains. Because most of the pipeline is buried underground, water draining down the mountains keeps the surrounding soil constantly saturated, which generates seepage pressures. In fact, with the pipeline empty, seepage water was observed draining through some of the longitudinal cracks (Fig. 3).

Fig. 3: Water seeping into pipeline

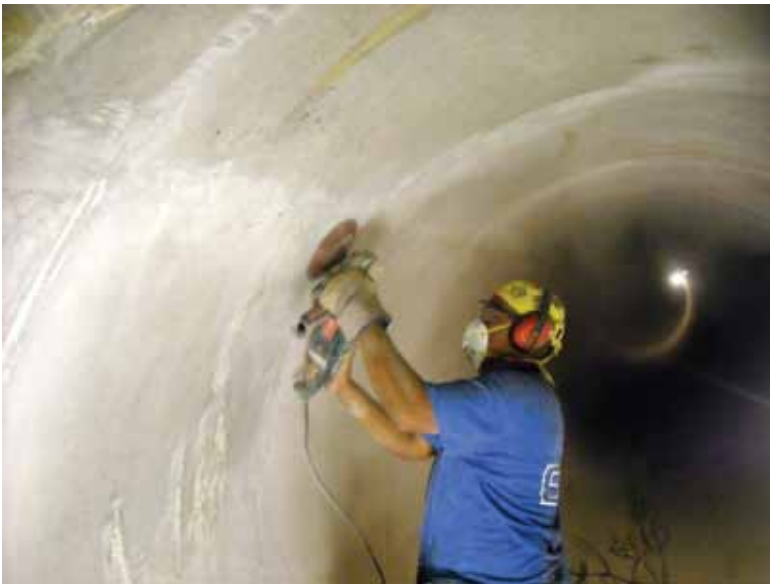
Fig. 4: Preparation work prior to installation of FRP lining

concrete cylinder pipe (PCCP). Evidence of cast-in-place procedures such as construction joints and formwork fins was visible in the pipeline. The pipeline was pressure washed with 7000 psi (48.3 MPa) machines to remove any scour, sediment, curing compounds, and any other substance that could hinder the bond between the FRP and the pipe surface. Figure 4 shows grinding of protrusions on the interior surface of the pipeline.

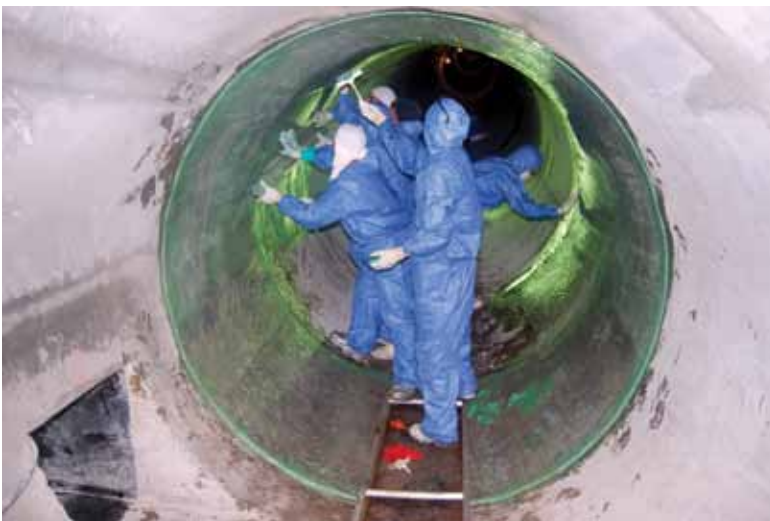
Fig. 5: Installation of FRP sheets on the interior surface of the pipeline

An epoxy paste was applied to the top half of the pipeline; the main purpose of the paste is to prevent peeling due to self weight of the saturated FRP fabric and to seal the surface to prevent excessive absorption by the dry concrete surface of the epoxy resin from the saturated FRP fabric. Figure 5 shows the installation of the first roll of FRP lining material at one of the installation stations. The access point is clearly visible on the lower left portion of the figure. No epoxy paste was used in the lower half of the pipe. Because gravity forces in this area tend to hold the FRP fabric in place, only a seal coat of epoxy resin was used to

prevent excessive absorption by the dry concrete surface of epoxy resin from the saturated fabric. The edges of the 50 in. (1270 mm) wide bands of fabric were adequately overlapped in the hoop and longitudinal directions to achieve full continuity of the FRP. The edges of the overlaps were feathered with epoxy paste and/or epoxy resin to secure the overlaps in the lining in place.

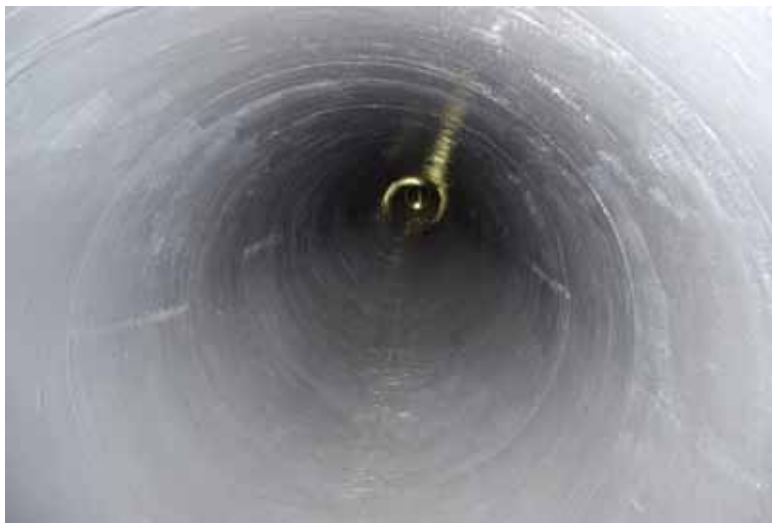
Fig. 6: Completed segment of pipeline prior to testing

The FRP lining installation was completed on July 8, 2009, and pressurized test runs were successfully completed on July 15. Figure 6 shows a completed lining installation prior to testing.
