SURGERY IN EXISTING STRUCTURES

MAJOR CHANGES IN STRUCTURAL SYSTEMS FOR ADAPTATION OF NEW FUNCTIONS OR REPLACEMENT OF EXTREMELY DETERIORATED MEMBERS

BY REFAAT M. SALLAM

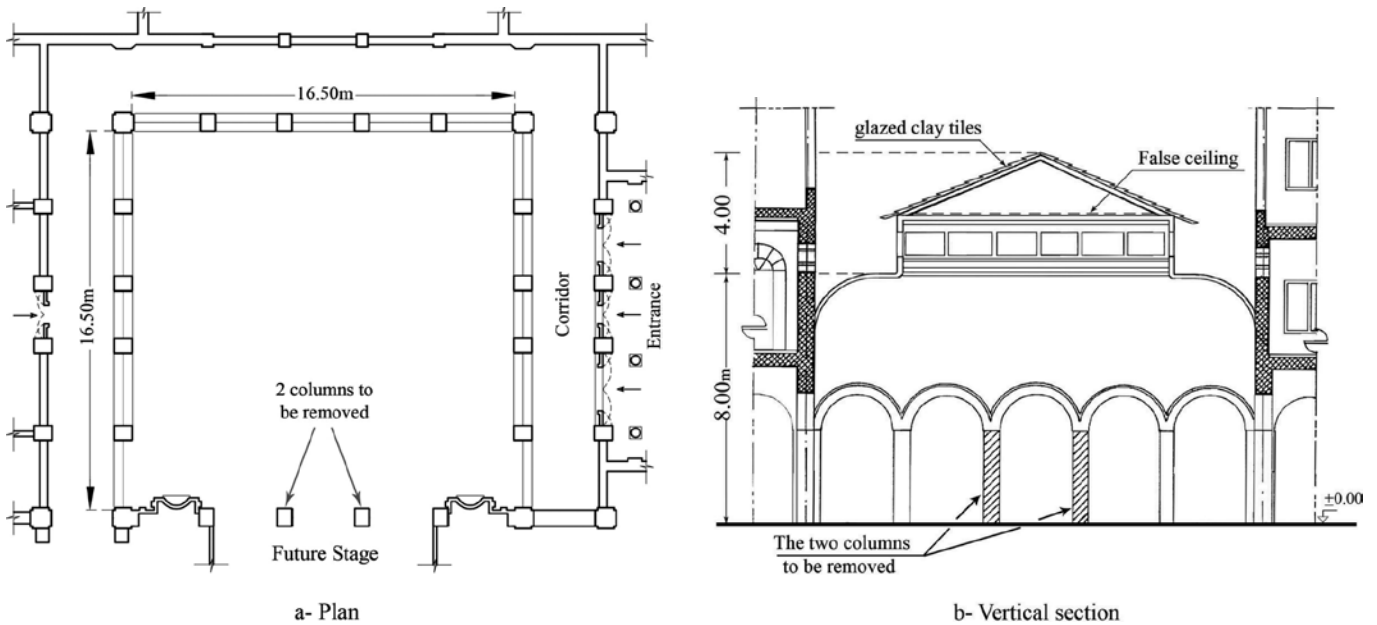
Fig. 1: Main hall to be transformed to a theater (Note: 1 m = 3.28 ft)

The stage of the theater, with a width of about 24.4 ft (8 m), is obstructed by two such columns, which are marked on Fig. 1 and 2. These two columns have to be demolished after being replaced by a new bearing system (the replacement system).

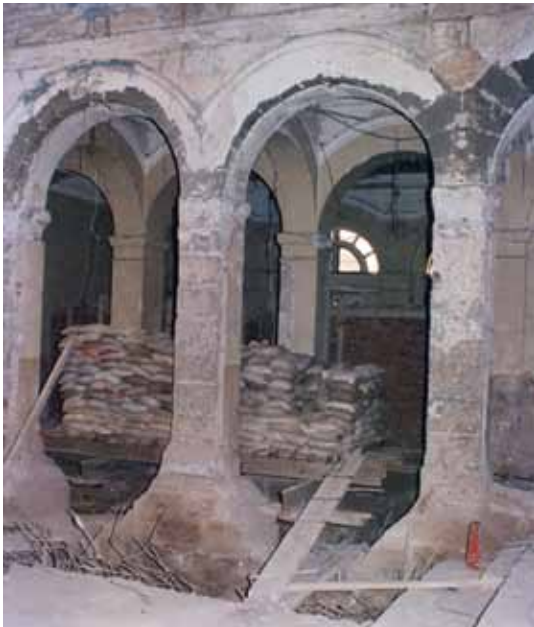
Load test on single pile. Foundation of existing granite columns also shown

In the course of execution of the new pile foundation, a load test on a single pile was performed. The settlement under a load of 1.5 the working load of the pile was measured and found equal to 0.1 of the value allowed by the local code of practice of soil mechanics. This was expected in the course of a design for minimal deformations.

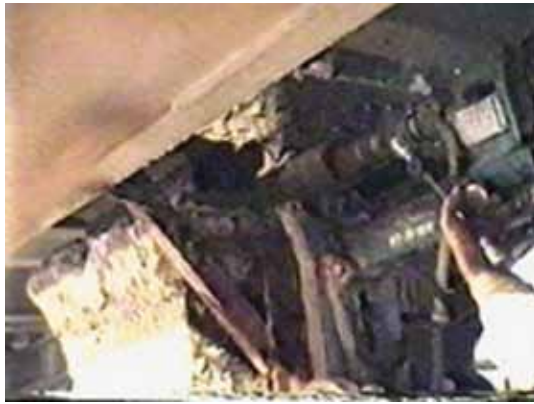
Stitch drilling to separate granite columns from the rest of the structure

When all checks proved positive, the removal of the two columns was carried out. The removal was simplified because each of the main hall columns was composed of ten blocks—nearly of the same height—fitting exactly to the upper and lower blocks and stuck to them by an adhesive. This meant that what was required was only to separate the columns at their top and bottom horizontal sections from the rest of the structure. This was done using stitch drilling by overlapping bore holes—beginning at the top section—after which the different blocks of a column were manually separated.

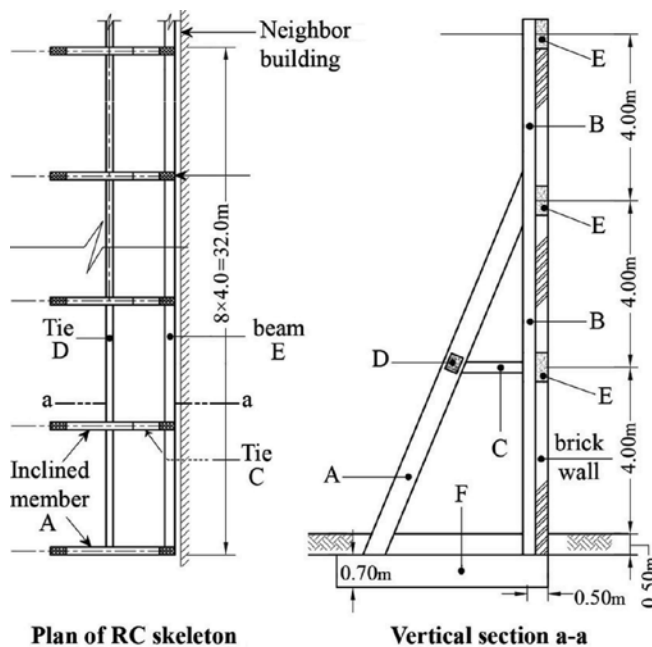
Fig. 5: Details of existing curtain wall and bearing RC skeleton
(Note: 1 m = 3.28 ft)

The dimensions of the wall are: length (l) = 105.0 ft (32 m), height (h) = 39.4 ft (12 m), and thickness (t) = 0.82 ft (0.25 m). Figure 5 represents a plan and a cross section of the existing curtain wall and the supporting structure. Different members of this structure are defined by letters on the same figure.

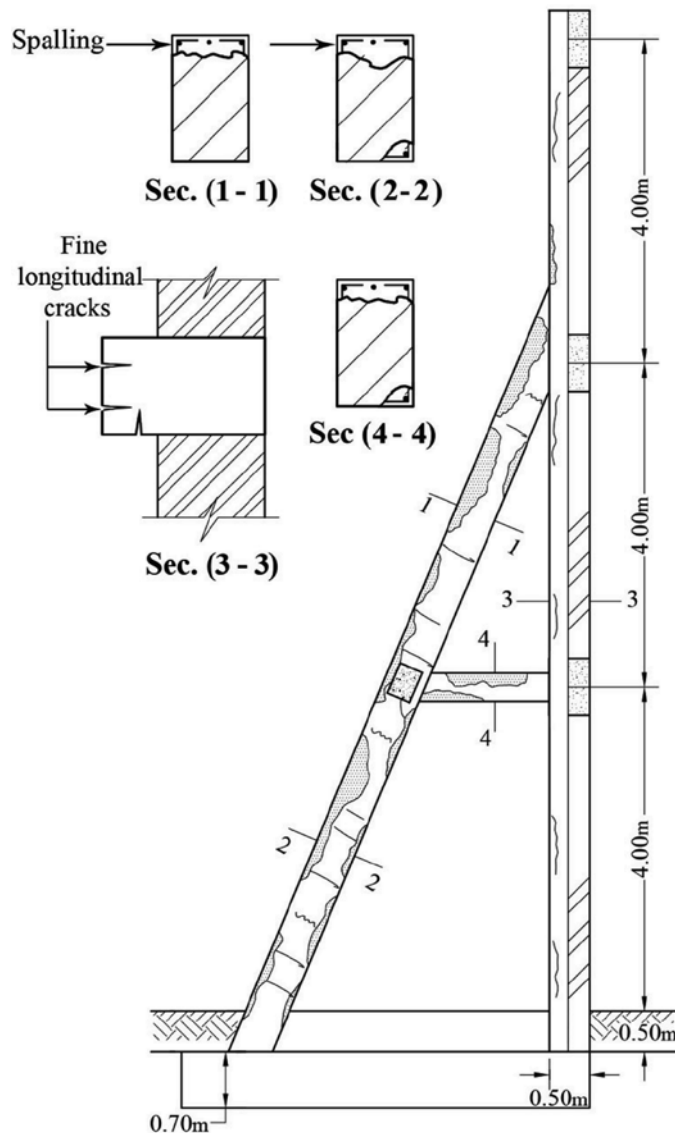
Fig. 6: Cracks and spalling of existing RC members due to corrosion and salt weathering (Note: 1 m = 3.28 ft)

Because taking photographs was prohibited at this site, it was decided to map cracking and spalling of the main members of the structure as close as possible to the in-place condition to illustrate their states of damage (Fig. 6).

- Member A, the inclined member of the main frames, and the horizontal tie Members C and D,

were severely damaged to the extent that they could not be repaired and needed to be replaced. Besides nearly continuous spalling and cracking in the longitudinal and perpendicular directions caused by reinforcement corrosion (Fig. 6), the decay of concrete surfaces was caused by severe salt weathering. Horizontal and inclined exposed surfaces were more liable to salt-weathering attack than vertical surfaces.

The weather conditions at the site promote attack by salt weathering. When airborne seawater is deposited on the surfaces of concrete due to the temperature decrease at night to the dew point, the next day, when the temperatures rise to higher degrees, it leads to rapid drying of the surface layer of concrete. Thus, pure water evaporates, leaving salt crystals in the pores of this layer. This phenomenon is progressive and leads to the continued growth of salt crystals in the pores, causing disruption of the cement mortar to a

- For Member B, the vertical members of the main frames, and Member E, the horizontal curtain wall beams, unlike Member A, are mostly protected against the aggressive agents by the curtain wall itself (refer to Fig. 5). The corrosion of reinforcement was manifested as narrow, intermittent, mainly longitudinal cracks on the exposed parts of their surfaces.
