VALLEY CREEK WASTEWATER TREATMENT PLANT REPAIRS

BY PRASAD M. SAMARAJIVA

Valley Creek Wastewater Treatment Plant is an 85 million gal. (320 million L) per day sewage treatment facility. With the pump station in operation, it has 600 million gal. (2.27 billion L) per day peak flow treatment capacity.

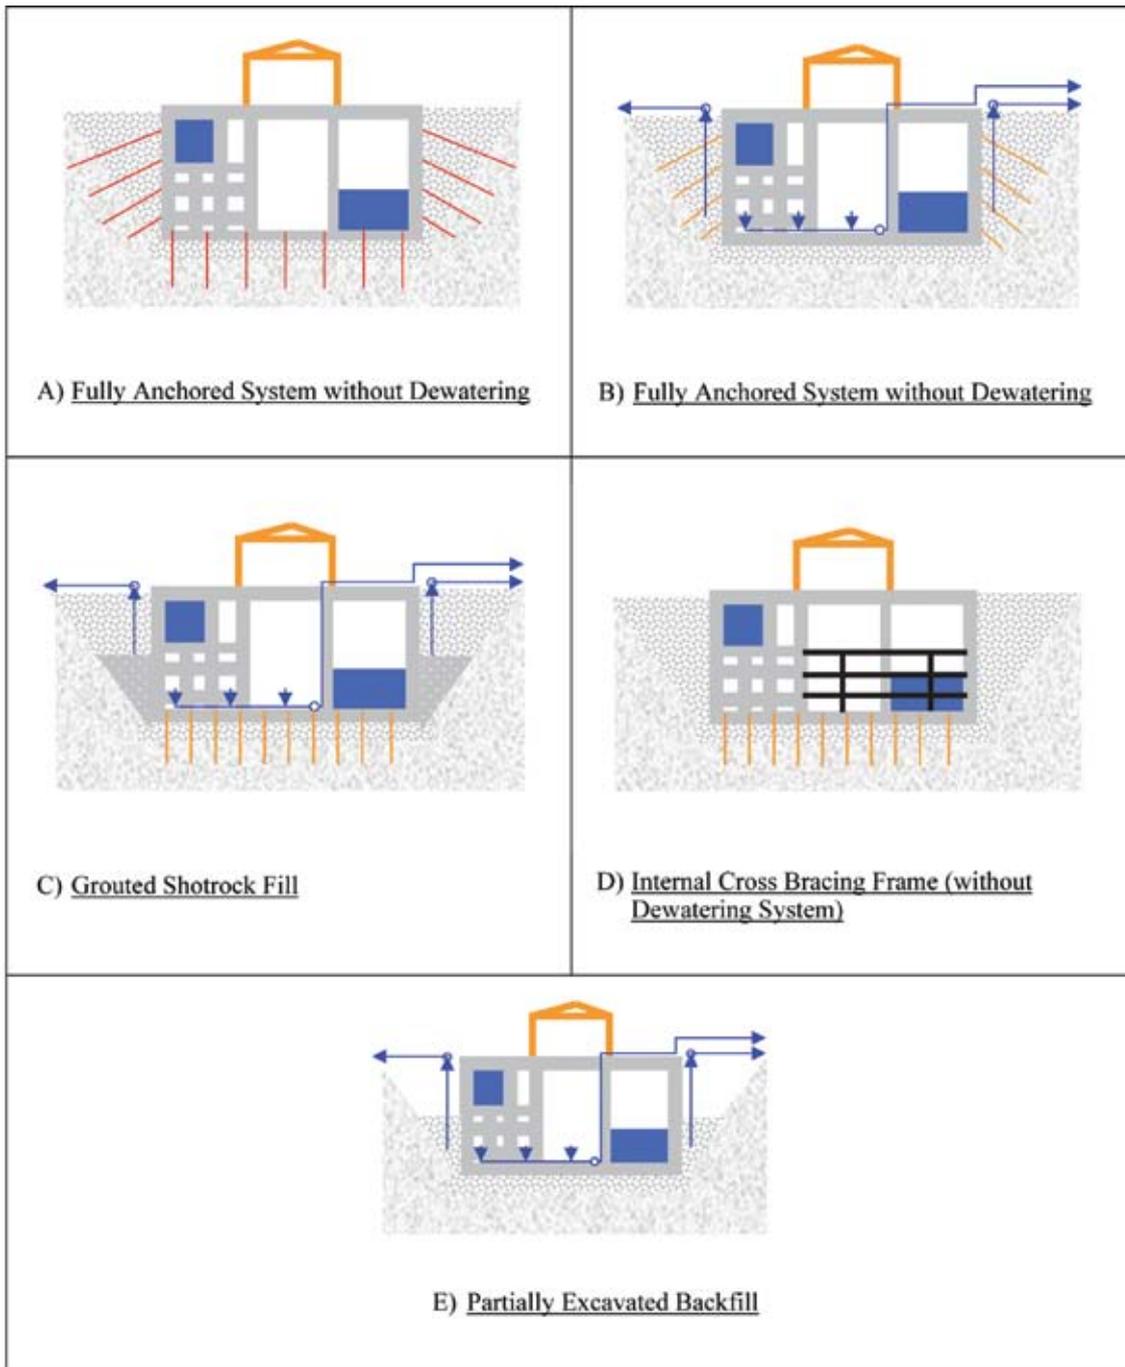
Based on the owners' input, five conceptual repair schemes depicted in Fig. 1 were developed with approximate construction costs. After evaluating the associated risk, construction issues, and cost and life expectancy of the pump station, the owner chose a combination of Options C and D. This included strengthening the structure to resist

Fig. 1: Considered repair options

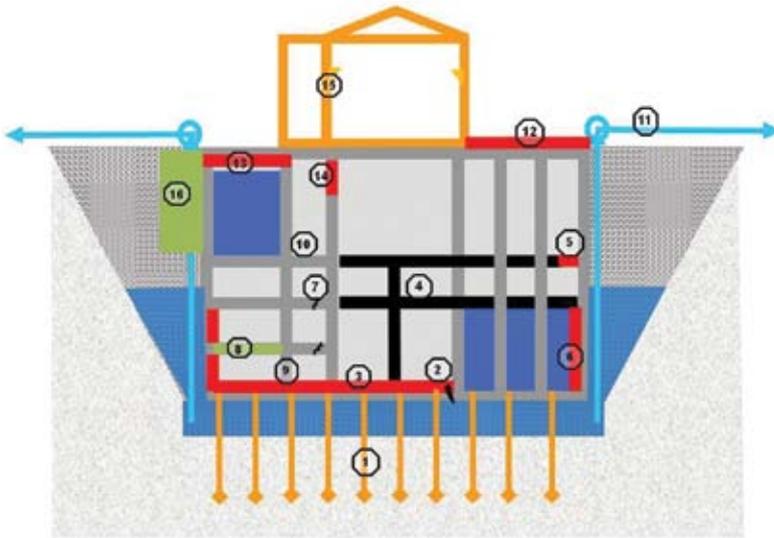
Fig. 2: Various items of repair

After considering all the associated issues and the owner's desire to have the pump station operational even during a failure of the groundwater pumping system, the repairs pictured in Fig. 2 were designed and are described as follows:

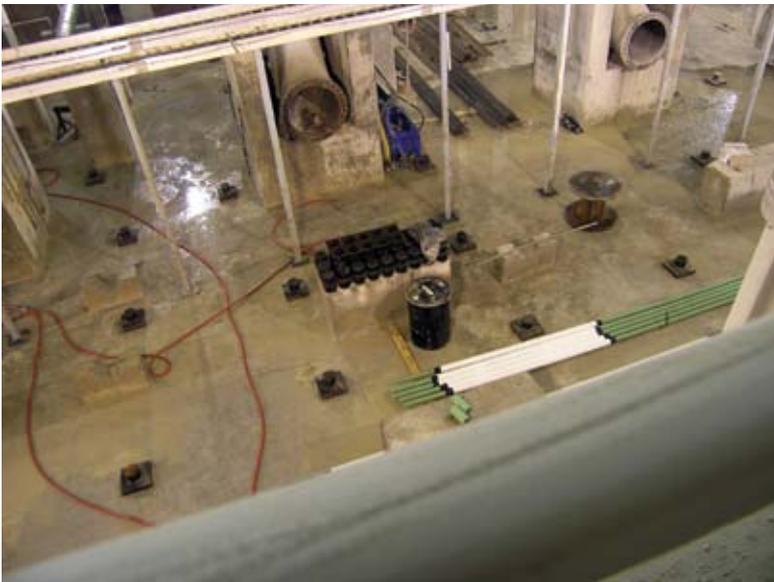
ANCHORING THE MAT SLAB USING ROCK ANCHORS (NO. 1)

Fig. 3: Installed rock anchors

Nearly 700 rock anchors were installed (refer to Fig. 3) on 9 x 9 ft (2.7 x 2.7 m) grid in the dry well and 9 x 12 ft (2.7 x 3.7 m) grid in the wet well. Finite element analysis was used to ensure effectiveness of the anchors when they were repositioned beyond the allowable 2 ft (0.61 m) tolerance.

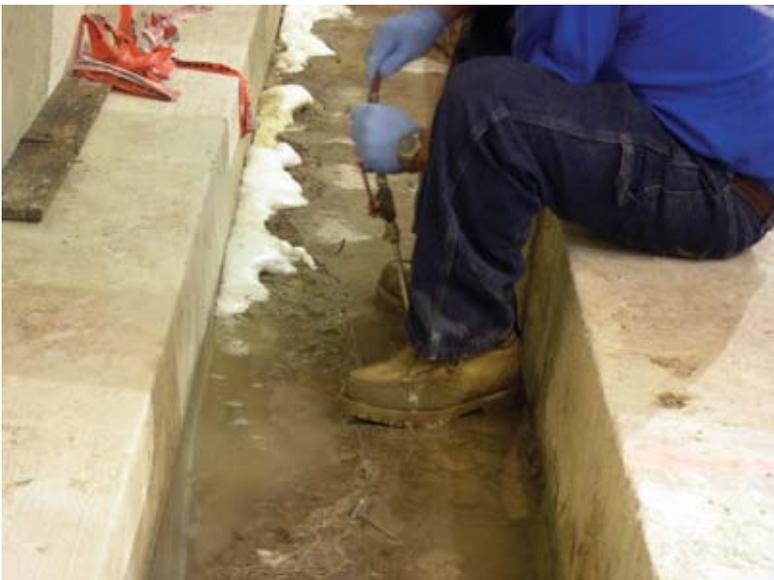
MAT SLAB MAJOR CRACK INJECTION (NO. 2)

Fig. 4: Urethane crack injection in progress

The major crack in the mat slab was injected to its full depth using hydrophilic polyurethane grout (refer to Fig. 4). The presence of many fractures in the area made it difficult to seal all the cracks. Injection could be stabilized only after several attempts to bridge the gap.

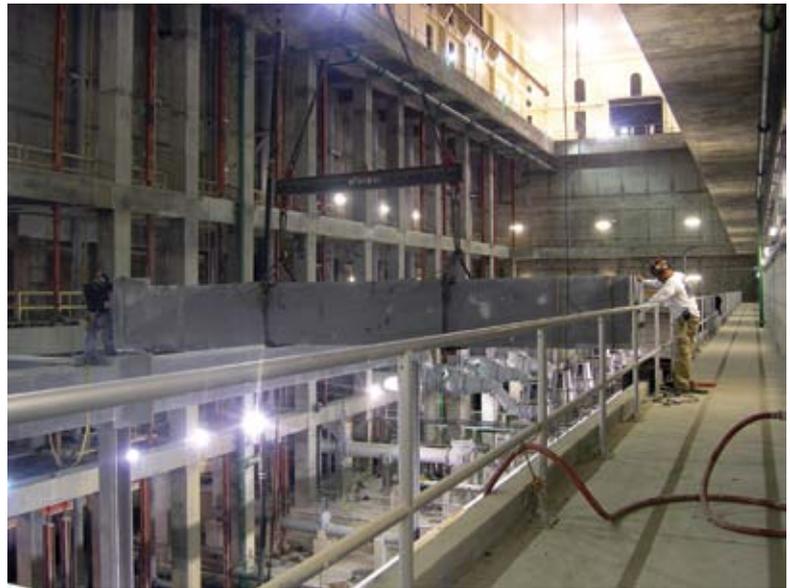
TRANSVERSE BRACING (NO. 4)

Fig. 5: Steel strut installation in progress

New 36 x 36 in. (910 x 910 mm) transverse bracing struts (refer to Fig. 5) were designed to match the existing beams. Concrete was chosen for the wet well section and galvanized hollow structural steel square sections were chosen in the dry areas. The complexity of precise positioning of the bracing struts was met by the contractor.

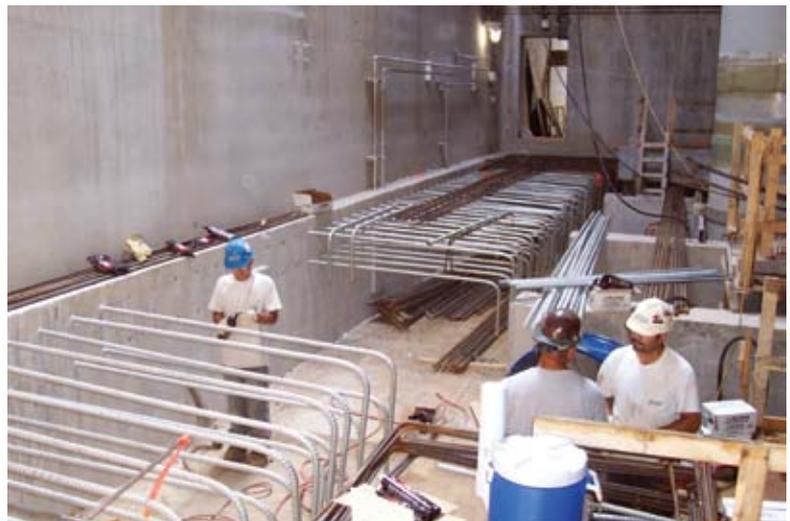
WALER BEAM IN WET WELL (NO. 5)

Fig. 6: Waler beam epoxy doweling in progress

A new 96 x 60 in. (2440 x 1520 mm) high-strength concrete waler beam (refer to Fig. 6) was attached to the concrete wall with epoxy-grouted galvanized dowels. For accessibility reasons, the locations of construction joints, stirrups assembly, and lap splicing were customized so the contractor could conduct other repair tasks simultaneously in the level below.

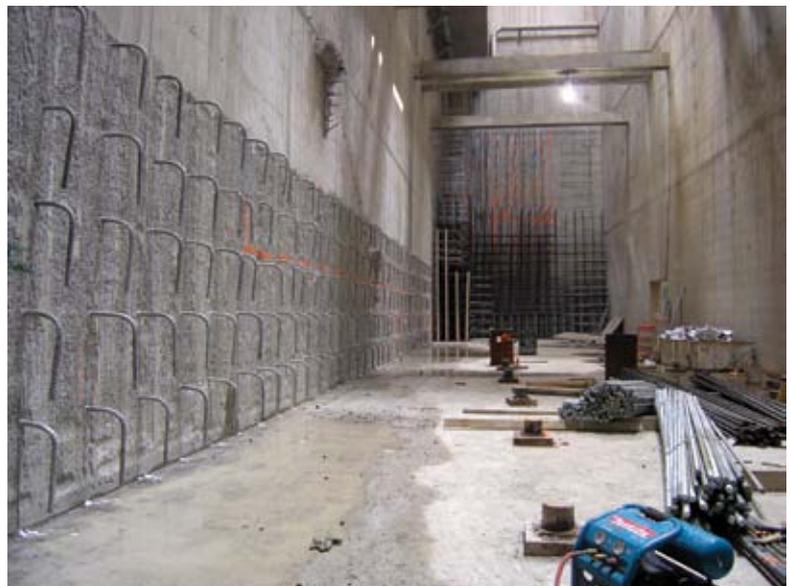
WALL STRENGTHENING (NO. 6)

Fig. 7: Wall strengthening in progress

Existing 72 in. (1830 mm) thick perimeter walls were thickened over a 35 in. (890 mm) height above the mat slab with thickness varying from 72 in. (1830 mm) at the bottom to 24 in. (610 mm) at the top of the thickened section using high-strength concrete (refer to Fig. 7). Epoxy-grouted galvanized steel dowels were used to ensure composite action between the existing wall and the new wall.

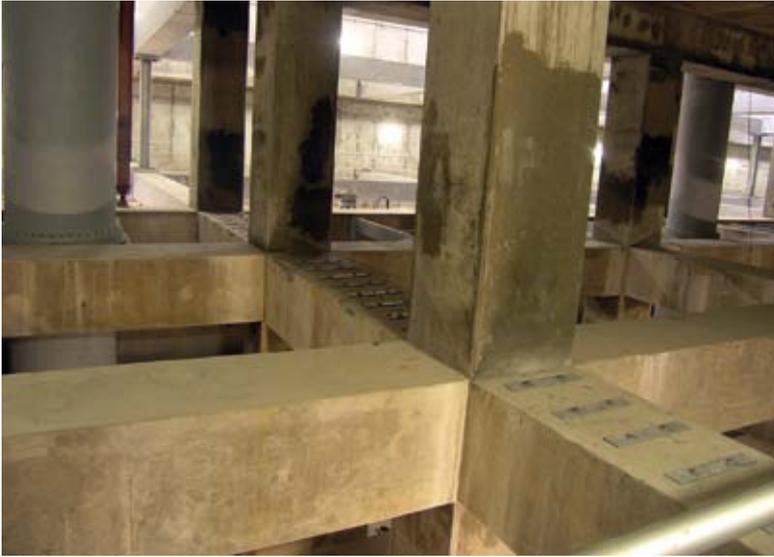
EXTERNALLY BONDED TIES FOR COLUMNS AND STRUTS (NO. 9)

Fig. 8: External compression ties

New externally bonded steel plates designed to function as ties that were found to be insufficient in the existing members were used together with epoxy anchors to restrain unconfined longitudinal reinforcement (refer to Fig. 8).

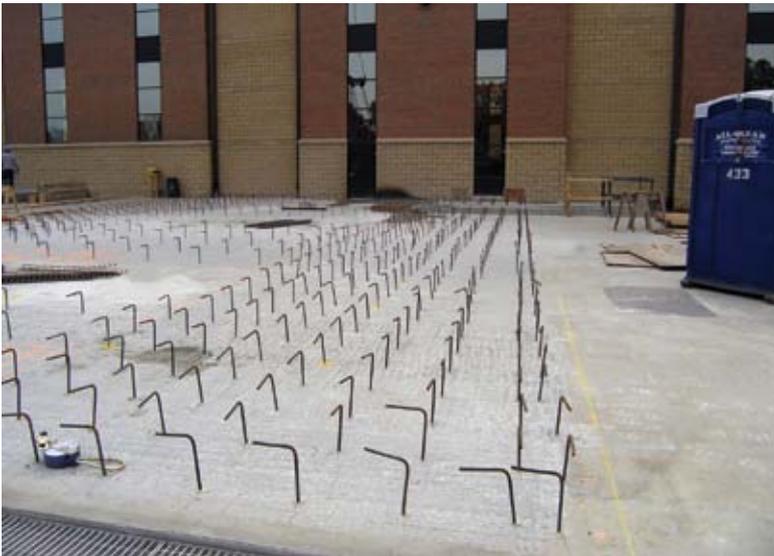
WET WELL DIAPHRAGM STRENGTHENING (NO. 12)

During construction, some additional structural deficiencies were discovered. The majority of these deficiencies can be attributed to the discovery of the substitution of precast hollow core slab panels for a cast-in-place reinforced concrete slab at the ground level to function as a diaphragm. It was determined that these hollow core slab panels were not designed to act like a diaphragm. As a result, creating new

Fig. 9: Installation of dowels for wet well overlay

A new high-strength overlay concrete slab was installed over the wet well top diaphragm (refer to Fig. 9). The thickness of the overlay was limited because installation of shoring was impractical in this deep well to support the existing slab.

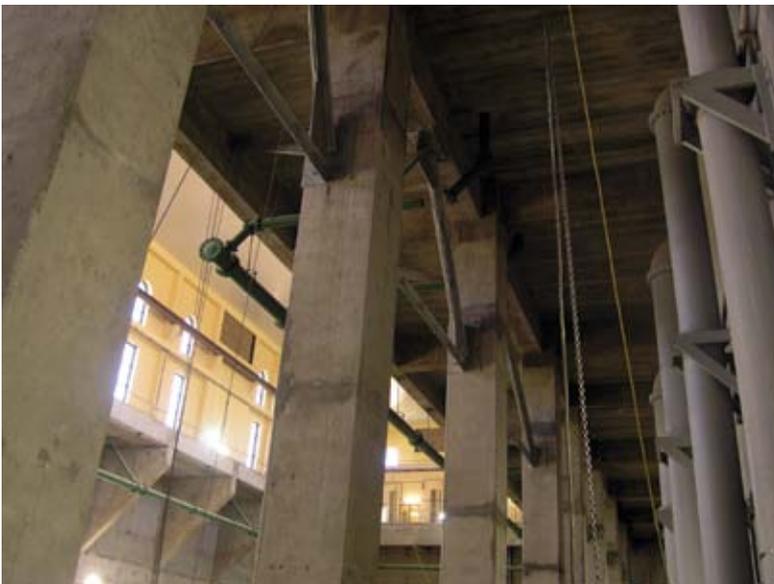
STEEL TRUSSES TO SUPPORT CRANE BEAMS (NO. 14)

Fig. 10: Steel trusses designed to support crane beams

access hatches for the wet well repairs became impossible without strengthening the diaphragm slab. In addition, the concrete corbels for the bridge crane and the transfer beams under the crane columns were found to be structurally deficient. To correct these deficiencies, the repairs pictured in Fig. 2 were designed and are described as follows:

Galvanized steel trusses were designed to facilitate field assembly so workers could install them in pieces without the use of a heavy crane (refer to Fig. 10).

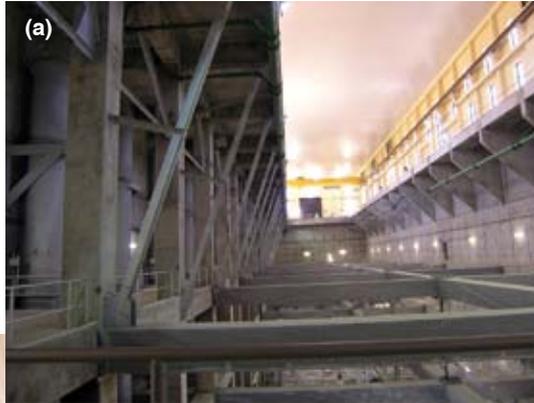
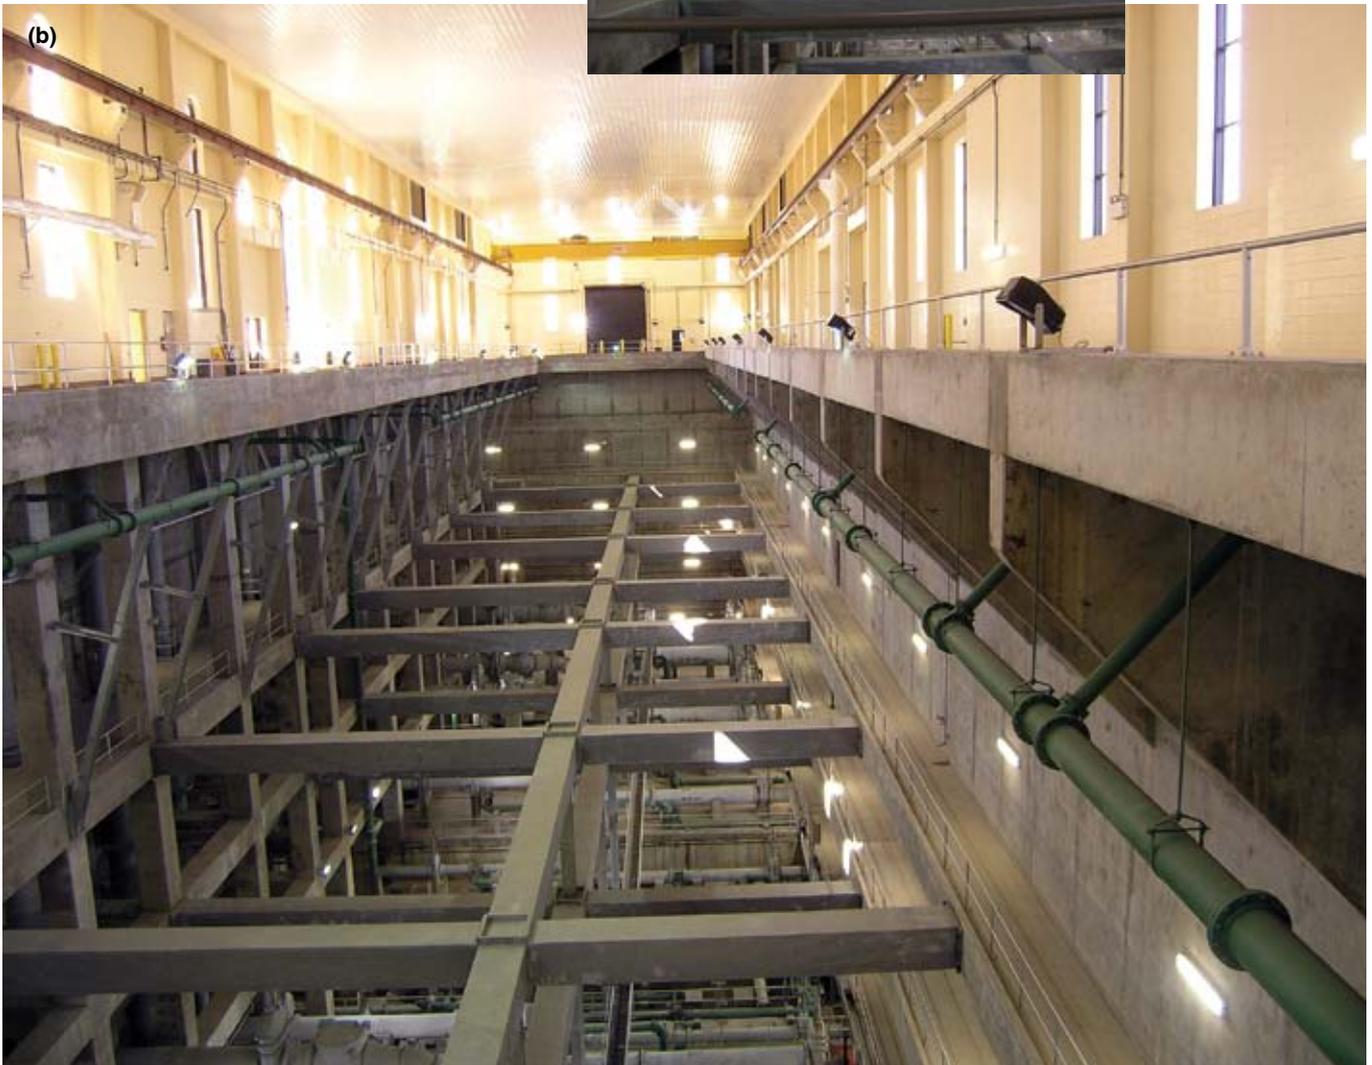
Fig. 11(a and b): Pump station restoration complete

Despite the magnitude and challenges of the repairs, the pump station was restored and fully operational to the owners' satisfaction in less than 3 years from the time of failure (refer to Fig. 11). The success of these unusual repairs should be credited to the exceptional teamwork and creative structural solutions by all parties involved and the owners' unwavering commitment to restore the pump station to serve the community.
