EMERGENCY SANITARY SEWER TRUNK REPAIR

Atlanta Sanitary Sewer Trunk Pipe

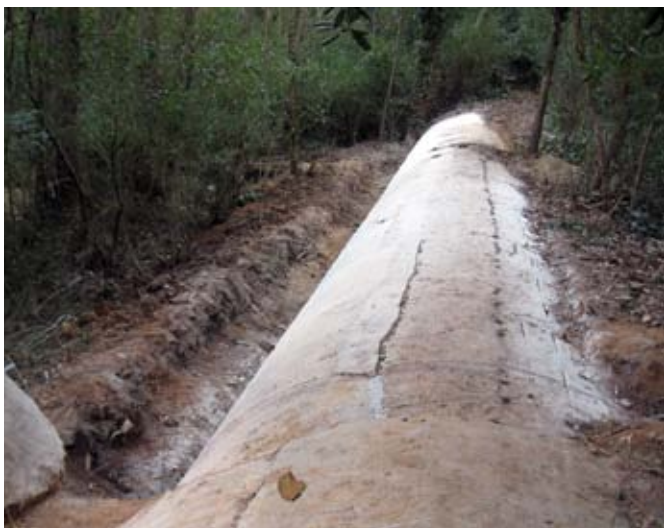
During the second week of December 2008, the city of Atlanta, GA, experienced a severe storm with a heavy downpour. During the storm, a portion of the 90 in. (2290 mm) sanitary sewer trunk burst and overflowed. The pipe had been repaired previously for the same reason. Upon immediate inspection, the control joint at the three o'clock position and cracks at the crown of the pipe appeared to emit the most overflowing liquid.

This 90 in. (2290 mm) sanitary sewer trunk line was built in the 1930s. The pipe's 8 in. (203 mm) thick walls were cast in place with nonreinforced concrete. Construction joints appear at the three and nine o'clock positions on the pipe. A portion of the pipe's circumference is embedded in the earth. The embedded portions of the pipe varied from 45 to 70%, depending on the pipe's relative elevation to the ground. The weight of the earth offered natural strengthening by placing various portions of the pipe underground in compression.

Fig. 1: Ninety in. (2290 mm) sewer pipe located in Atlanta, GA

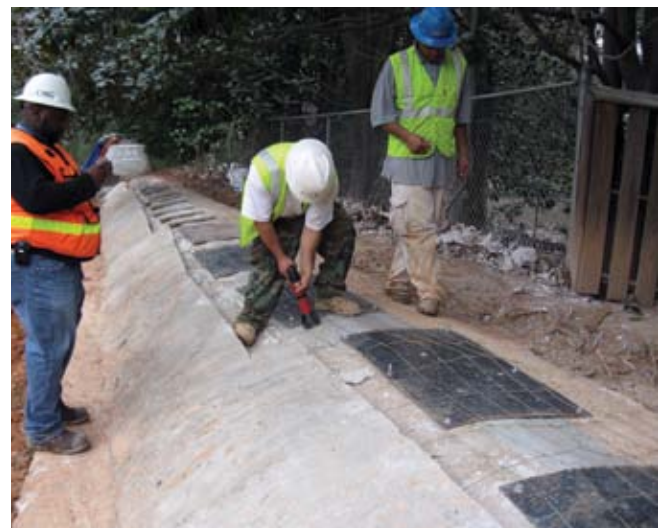
Fig. 2: Use of steel plates followed by placement of fresh concrete

- To prepare the pipe's surface, a 3 to 4 in. (76 to 102 mm) deep section of previously placed concrete topping around the cracks was removed;
- Steel plates (0.25 x 12 in. [6 x 305 mm] wide x various lengths) were anchored on both sides of the cracks with 0.5 in. (13 mm) diameter stainless steel anchor bolts;
- Shear pins (3/8 in. [9.5 mm] threaded studs) were installed for adding bond strength between the new and old concrete; and
- A concrete cap was placed with embedded wire mesh.

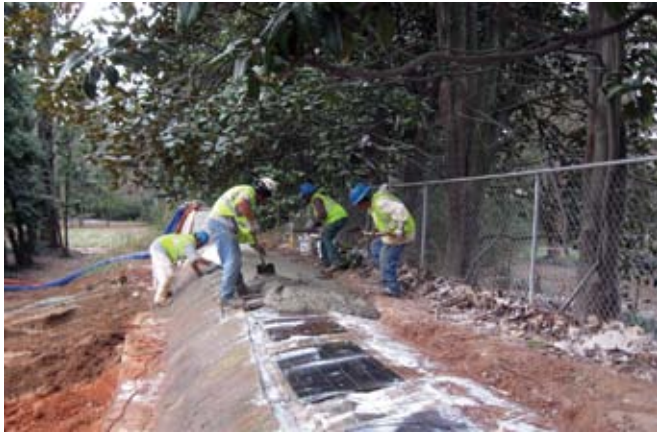
Fig. 3: Steel mesh was added prior to the concrete placement

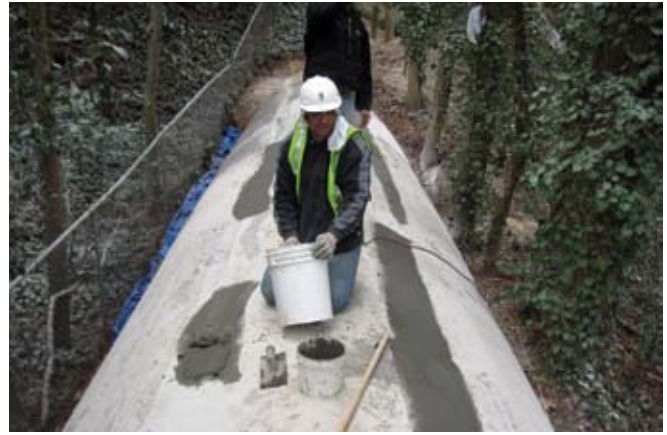
Fig. 4: Application of the repair material

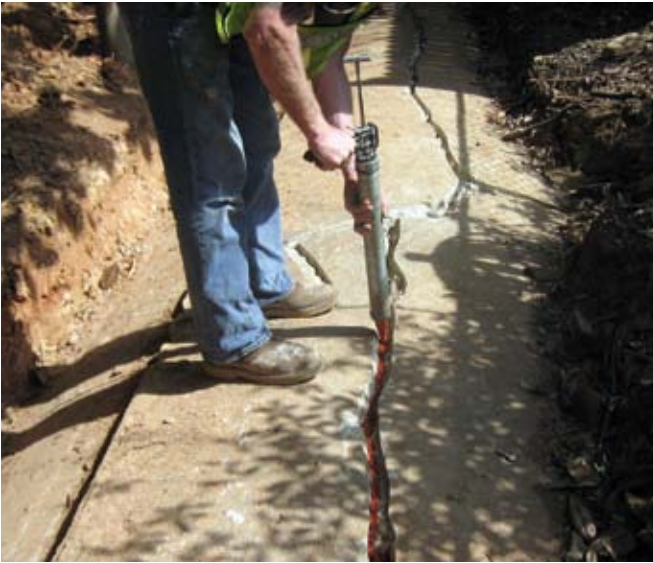
Fig. 5: Route and seal with a swellable water stop

All large cracks were routed and sealed with a swelling water stop and covered with a high-modulus epoxy paste. Smaller cracks were routed and sealed with epoxy.

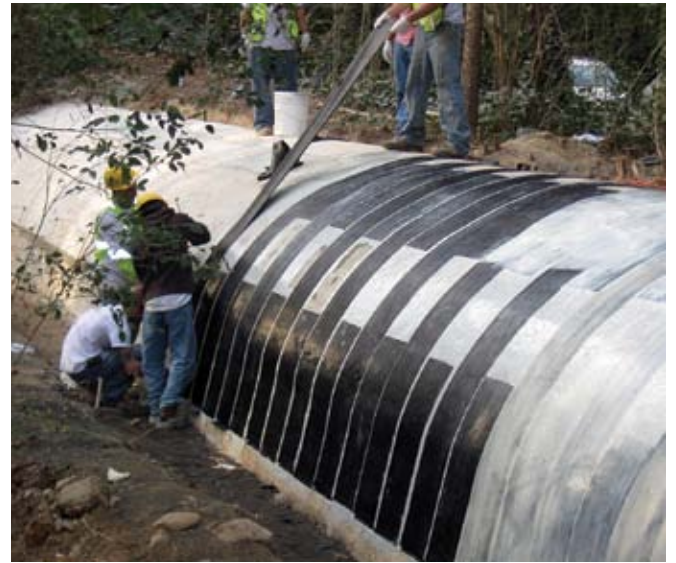
Fig. 8: Multiple layers of CFRP installed

Upon completion of the necessary surface preparation, 12 in. (305 mm) wide CFRP fabric was installed on the entire exposed length of pipe. Where circumferential cracks were observed, the unidirectional CFRP fabric was installed longitudinally prior to installing the primary circumferential 12 in. (305 mm) wide CFRP fabric. To ensure complete bond, 3/8 in. (9.5 mm) carbon fiber rods were encapsulated with epoxy into reglets at the ends and on top of the 12 in. (305 mm) wide circumferentially oriented strips. All surfaces received two coats of an acrylic coating to protect the system from UV rays.

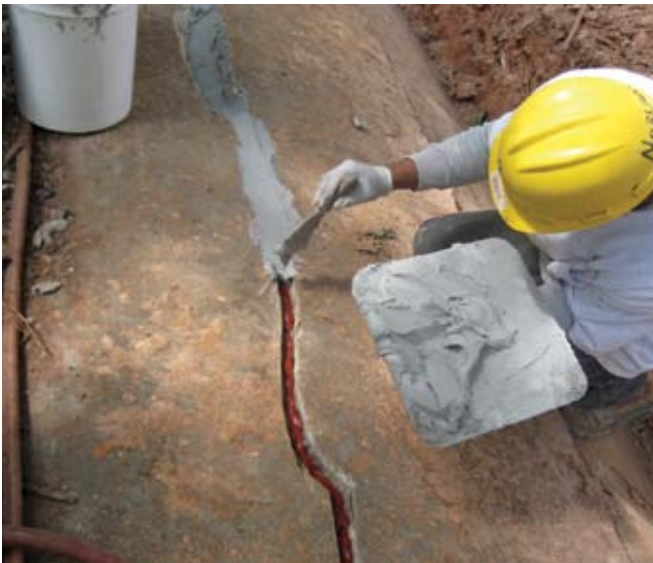
Fig. 6: Swellable water stop capped with an epoxy

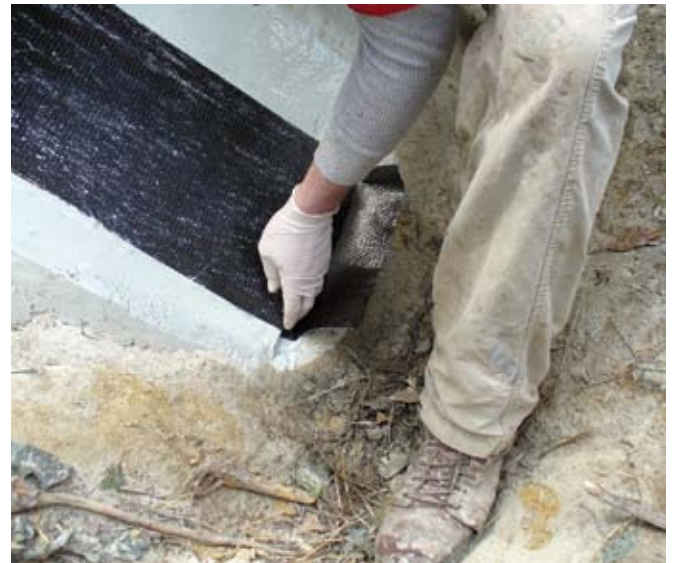
Fig. 9: Three-eighths in. (9.5 mm) CFRP rod installed in the groove

The design engineer selected a unidirectional, 12 in. (305 mm) wide CFRP fabric to be installed using the dry layup method on the circumference of the pipe at 24 in. (610 mm) on center. This left a 12 in. (305 mm) wide open space between strips. Additional 3 ft (0.9 m) long strips were used in this space to “stitch” epoxy-filled cracks together. CFRP rod anchors were installed to provide additional bond strength.

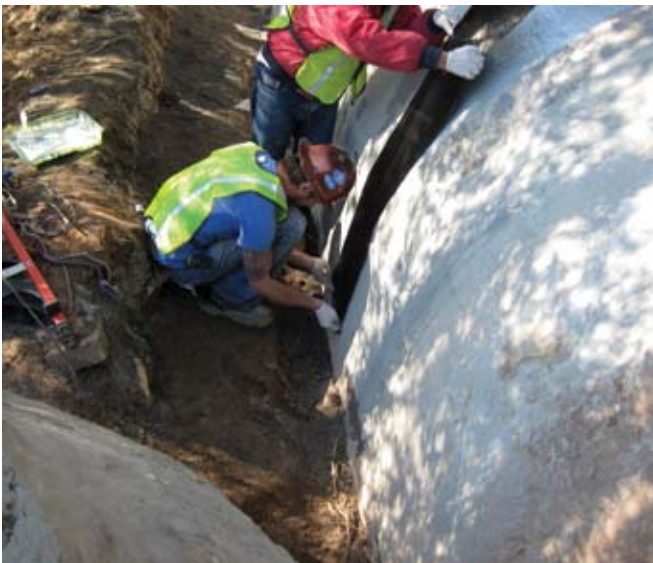
Fig. 7: Dry layup technique used to install the fabric

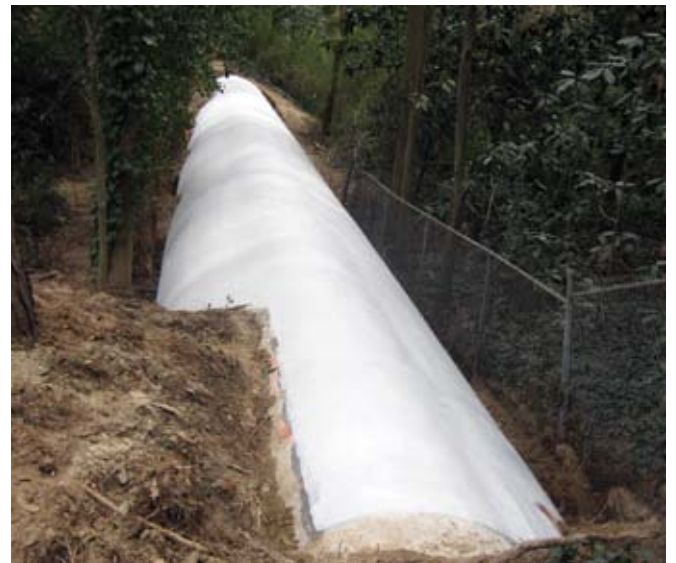
Fig. 10: The repaired pipe after being coated with a water-based acrylic coating
