# REPAIRING LEAKING EXPANSION JOINTS AT RECLAMATION FACILITIES

BY KURT F. VON FAY AND WESTIN T. JOY

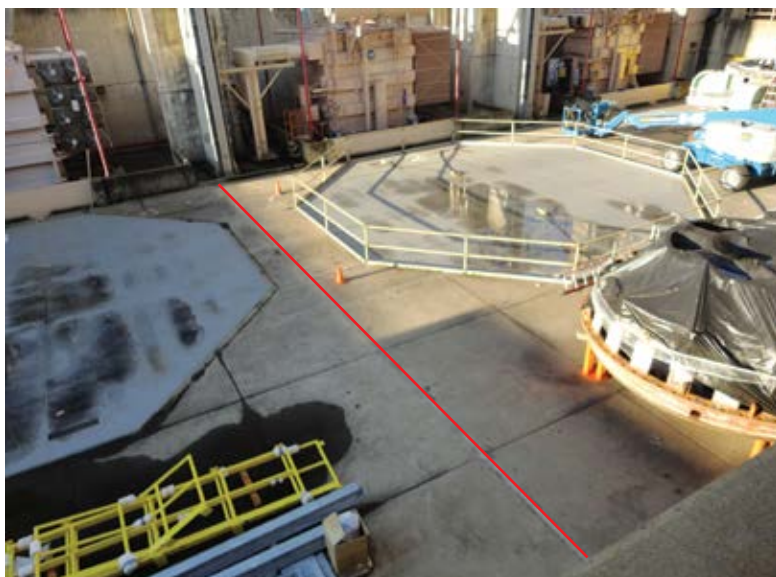
Fig. 1(a): Folsom Dam Power Plant deck—red line shows location of expansion joint

(b)). Leakage through the expansion joints was creating maintenance issues in the spaces below the joints. At Folsom and Davis, the water leakage was threatening electrical components in the power plants; and at Grand Coulee, the water leakage was affecting workers, materials, and equipment in the machine shops below the deck of the pump generation plant.

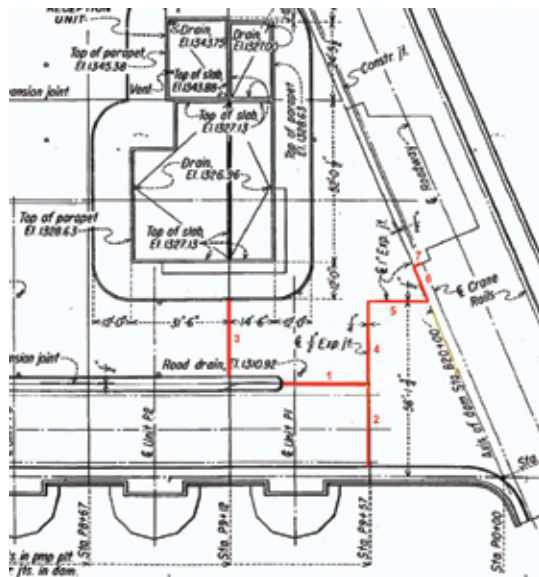
Fig. 2(a): Grand Coulee Dam—red lines show joints that were grouted

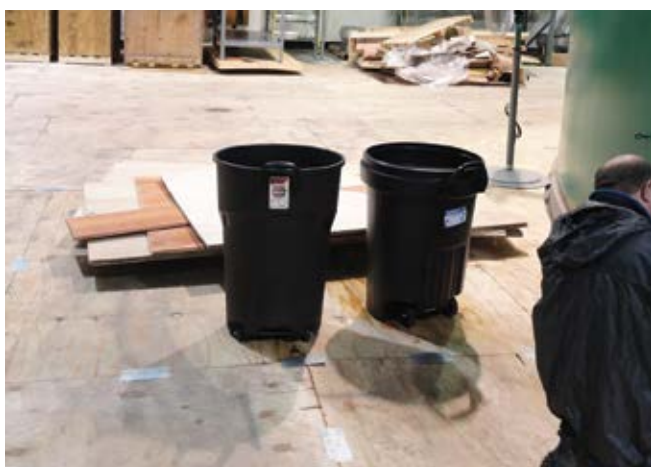
Fig. 1(b): Trash cans used to collect leaking water

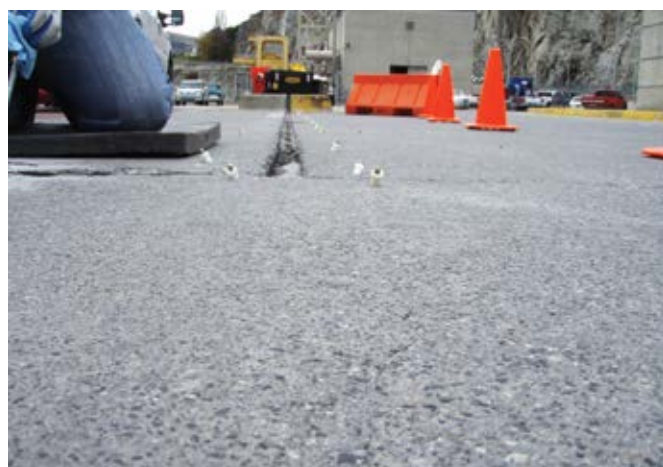
Fig. 2(b): Photo of grout ports and grease zerks

Because the majority of the grouting was at relatively low pressure, simple plastic ports installed with a hammer (Fig. 8) were able to be used for most of the work. After the plastic ports were installed, grease zerks were pushed into the open ends of the ports for attachment to the grouting assembly.

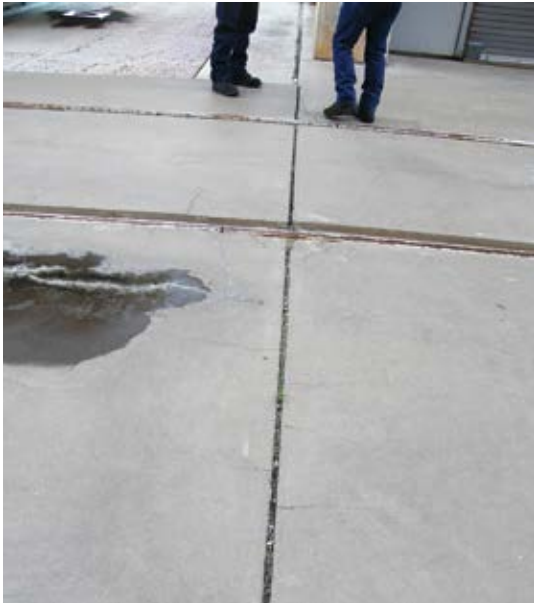
The specific reason the joints started to leak is unknown; however, badly deteriorated joint compound and corkboard were found in some areas of Davis Dam. At other locations, the leaking may have

Fig. 3(a): Davis Dam—typical expansion joint before grouting

been the result of a failing waterproofing membrane and/or water seeping through existing rock pockets that resulted from poorly consolidated concrete during construction. During injection work at Folsom, stagnant water was pushed out of the joints by the expanding grout; at other locations, grout easily flowed out the bottom of the joint, indicating there was a path around the rubber waterstop.

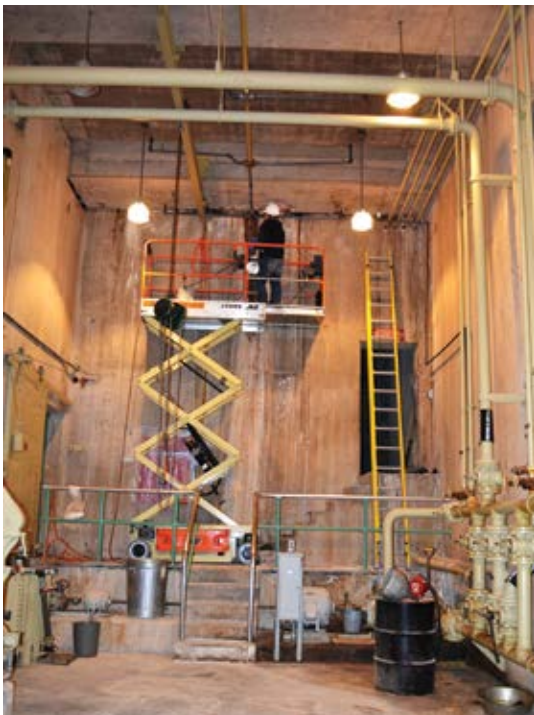
Fig. 3(b): Repairs being performed below transformer deck

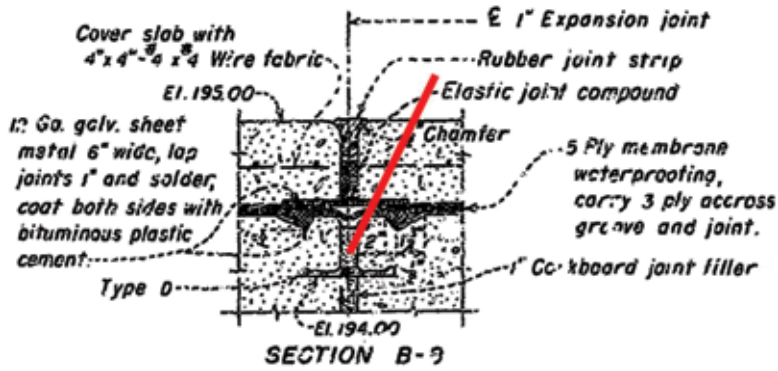
Fig. 6: Angled drill holes shown in red on Folsom Dam joint detail (Note: 1 in. = 25.4 mm)

After examining the joint details, it was determined that the best approach would be to drill holes for ports that were angled to deliver the grout between the top metal plate and the lower rubber water stop (Fig. 6 and 7). The metal plate and rubber water stop would serve to help contain the grout as it expanded, resulting in a more durable repair.

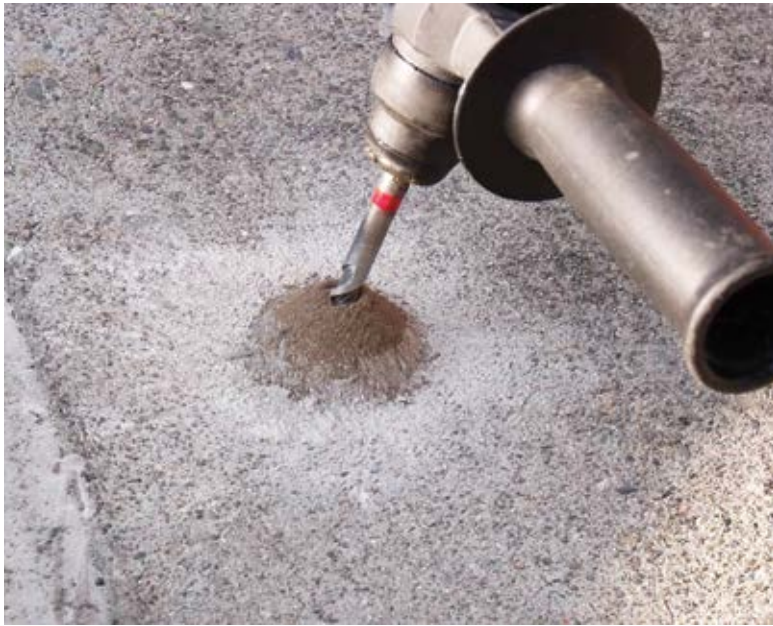
Fig. 7: Drilling holes for injection ports—note color change of cuttings, indicating corkboard has been intercepted

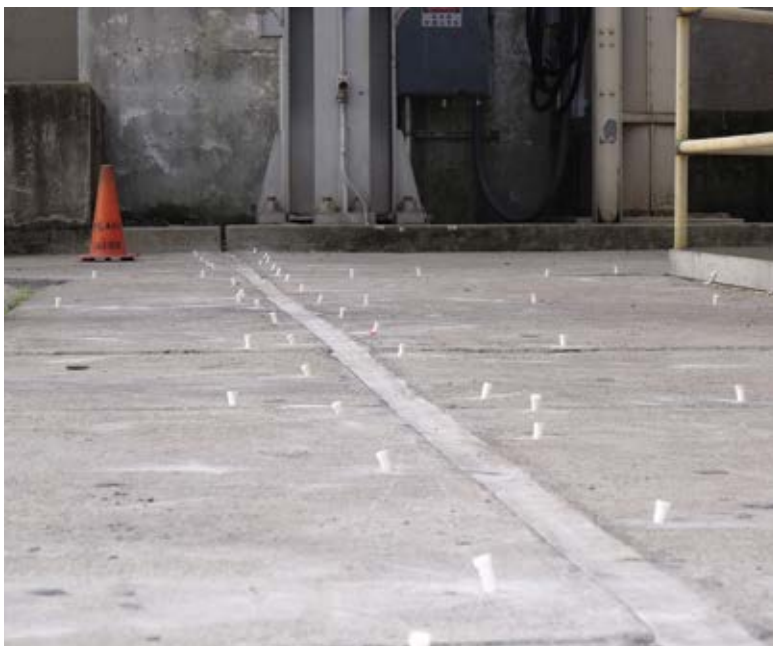
Fig. 8: Plastic ports for grout injection at Folsom Dam

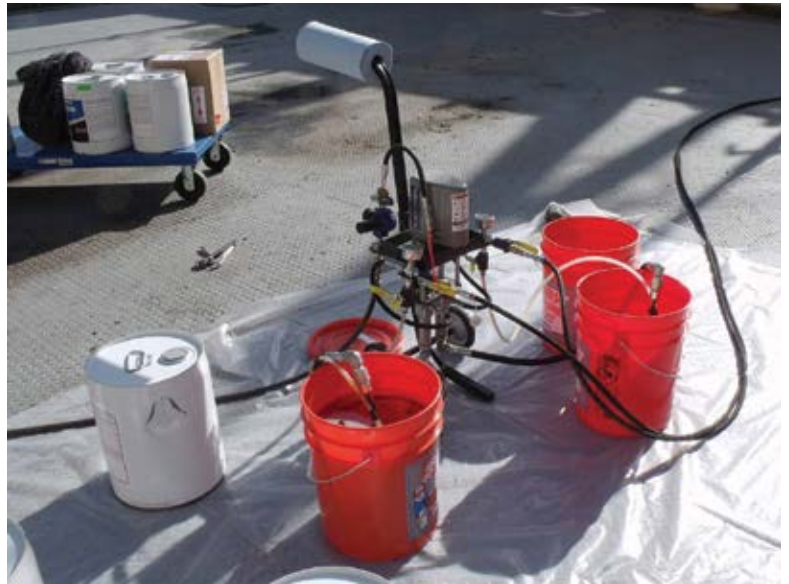
Fig. 9: Air-powered pump for grouting

For most of the work, a single-component polyurethane grout consisting of a water-activated hydrophilic resin was used. These resins tend to cure relatively quickly and form a flexible foam product. The resins are usually mixed with equal parts water and injected using special pumping equipment (Fig. 9) and a special fitting where the mixing occurs just prior to injection (Fig. 10).

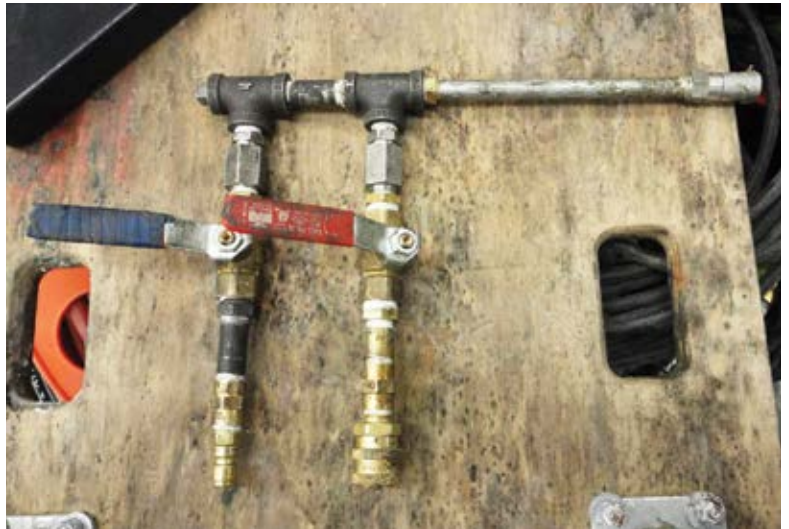
Fig. 10(a): "F" assembly for mixing grout and catalyst

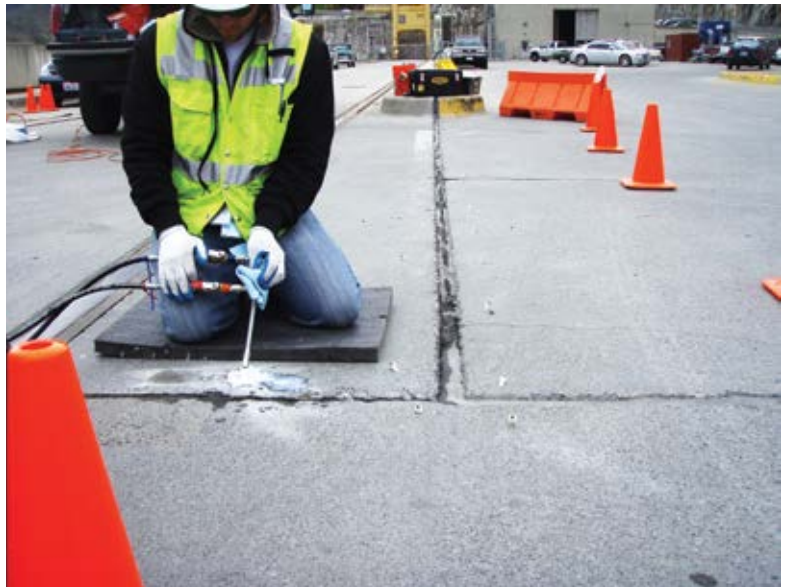
Fig. 10(b): MERL employee injecting grout
