VALLEY PREFERRED CYCLING CENTER—VELODROME TRACK REPAIR AND RESURFACING

BY KEITH EBERHARDT AND BRANDON KEEZER

Valley Preferred Cycling Center

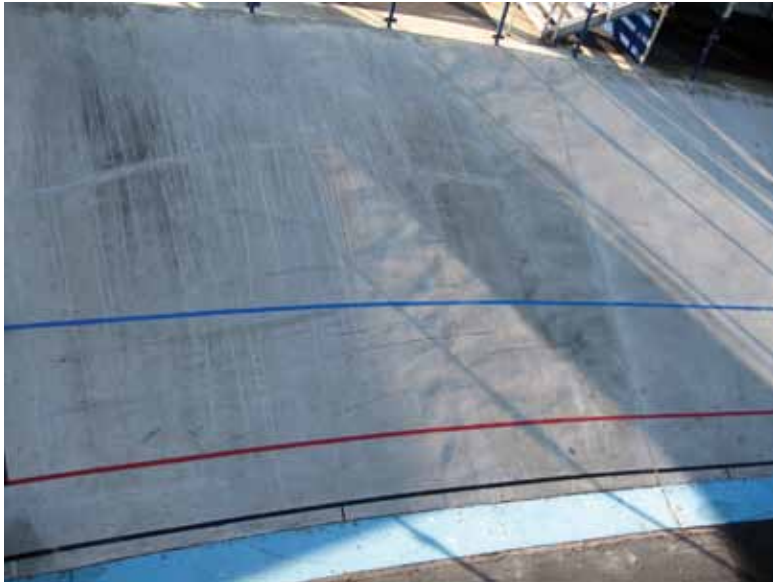
Existing conditions of track surface showed surface deviations (waves on the surface) and discoloration

Major deflections in the track surface located at expansion joints were attributed to slab curling, caused by differential shrinkage throughout the slab. The minor deflections present over much of the track surface were the result of various causes, such as reflective cracking of the slab—causing coating failure—and finishing techniques applied during the structure’s original construction. Delaminations to the track surface near the inner and outer perimeters were caused by an insufficient joint width to allow for thermal expansion of the slab.

was presented as a possible method; however, this would have been cost prohibitive for the client. Surface grinding proved to be the most effective method to address the deviations, while providing the flexibility to be applied in increments at any location of the track.

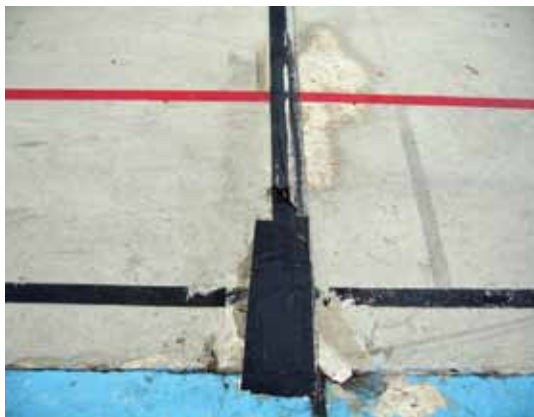
Distressed concrete area at transverse joint—notice the duct tape repairs

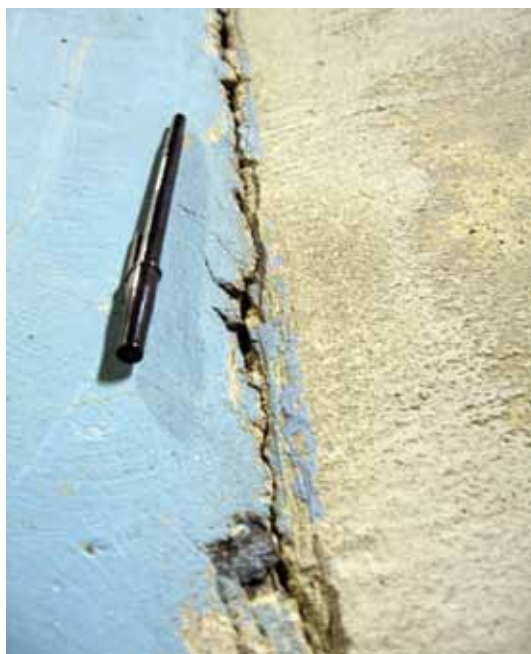
Spalled edges at inside perimeter joint where sloped track meets the interior apron
