VETERANS ADMINISTRATION MEDICAL CENTER BUILDING 1 SEISMIC CORRECTIONS

EDITED BY KELLY M. PAGE

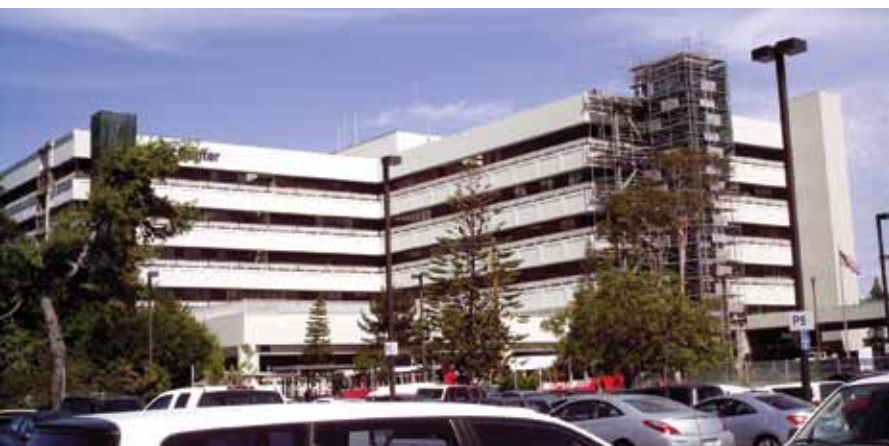
Fig. 2: View of walkways

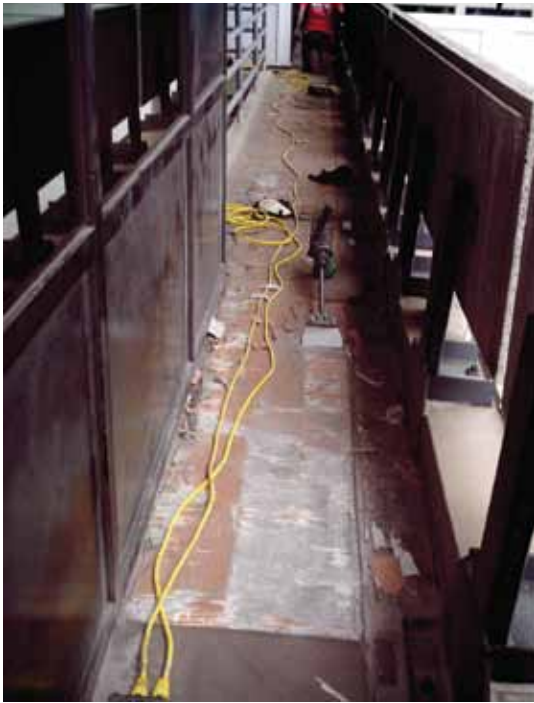
Fig. 3: Concrete surface preparation on walkways

The concrete surfaces first had all the walkway coverings removed with mechanical scrapers (Fig. 3).

After the removal of the coatings, all the deteriorated and unsound concrete was removed. In accordance with ICRI Technical Guidelines, small-sized demolition hammers were used to avoid damaging the underlying concrete. After the removal of the unsound concrete, the surface was cleaned of all dust and other bond-inhibiting materials by abrasive blasting.

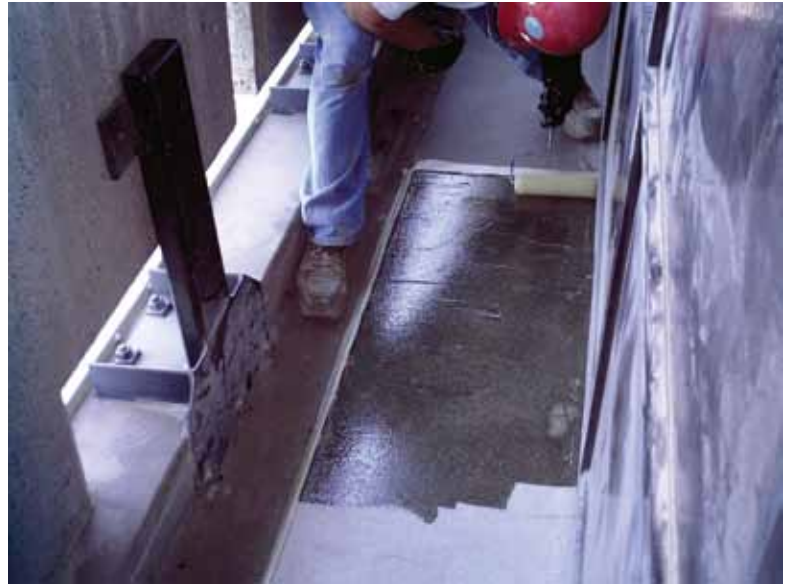
Fig. 4: Application of primer coat to walkways

After the surface was cleaned, a low-viscosity, 100% solids, polyamine-cured epoxy primer was rolled onto the surface. This first-applied component

of the system is used to penetrate the pore structure of cementitious substrates and to provide a high-bond base coat (Fig. 4).

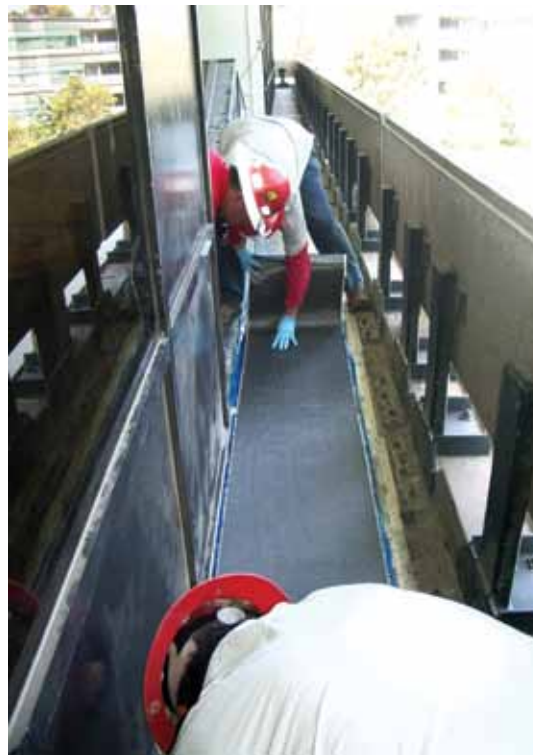
Fig. 5: Carbon-fiber fabric being applied to walkways

The fabric is constructed of very-high-strength, aerospace-grade carbon fibers. These fabrics were applied to the surface of the existing structural

member and then encapsulated with another layer of epoxy saturant (Fig. 5 and 6).

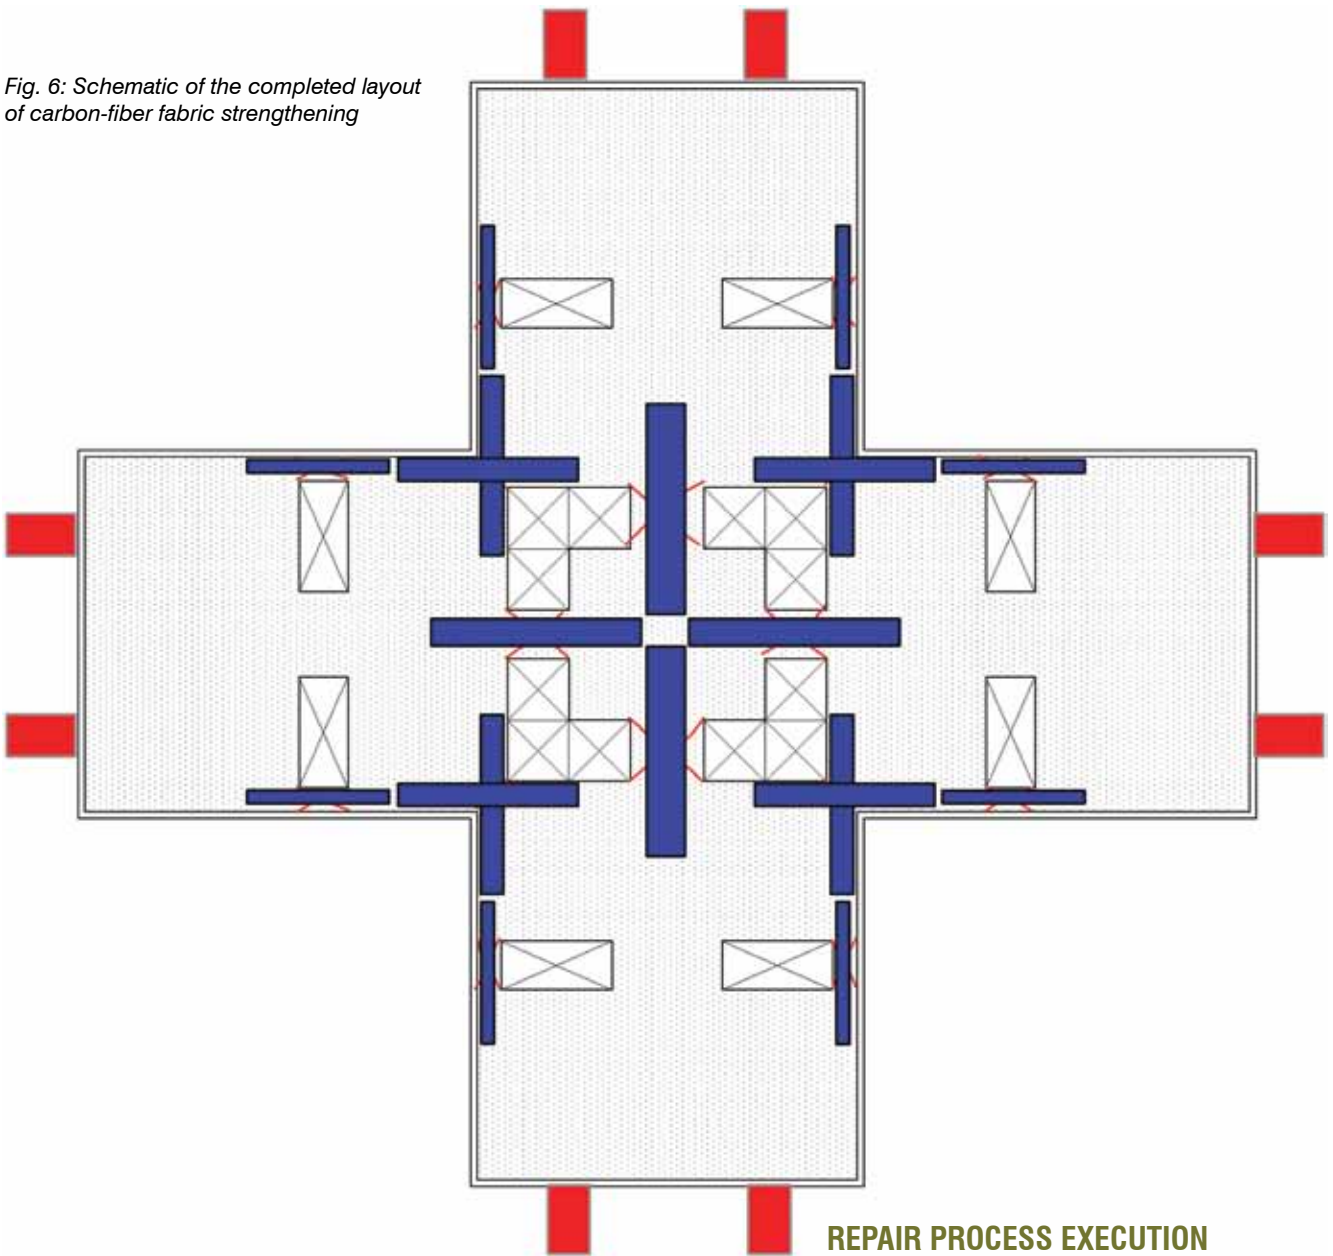
Fig. 6: Schematic of the completed layout of carbon-fiber fabric strengthening

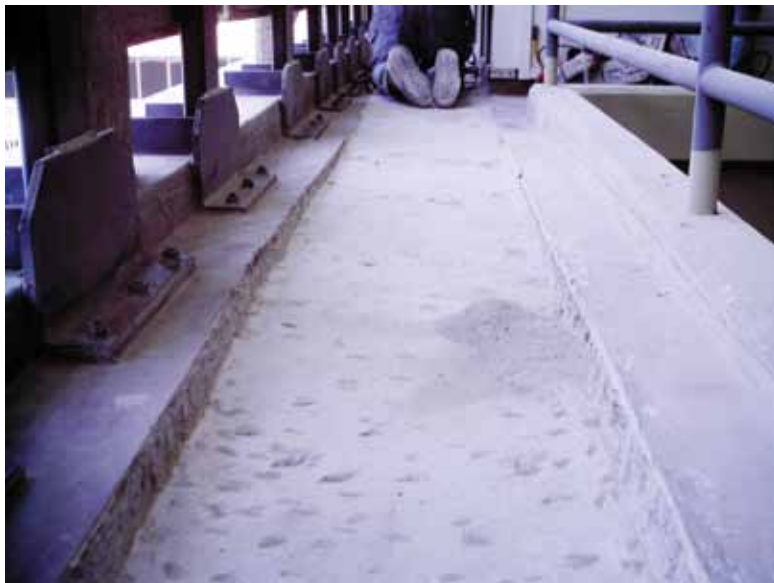
Fig. 7: Milled-down surface of walkways

As the FRP system was being installed, other architectural changes were being incorporated into the building as well. Interior walls were being relocated and new roofing systems and new flooring were being installed. The design and installation of the FRP system in many areas had to be modified “on the fly” to adapt to the ever-changing obstacles to placement of the FRP material. In addition, several layers of the FRP system were required, in some areas, to meet the force demands. In areas where multiple layers were applied, the FRP system had to be installed beneath the surface of the slab to allow for placement of a vinyl composite tile floor. The surface of the concrete was milled down to the appropriate level in these areas (Fig. 7).
