REPAIR OF THE COMMERCIAL DECK OF QUETZAL MARINE TERMINAL

INSPECTION, DIAGNOSIS, MATERIALS, AND PROCESSING METHODS

Quetzal Marine Terminal

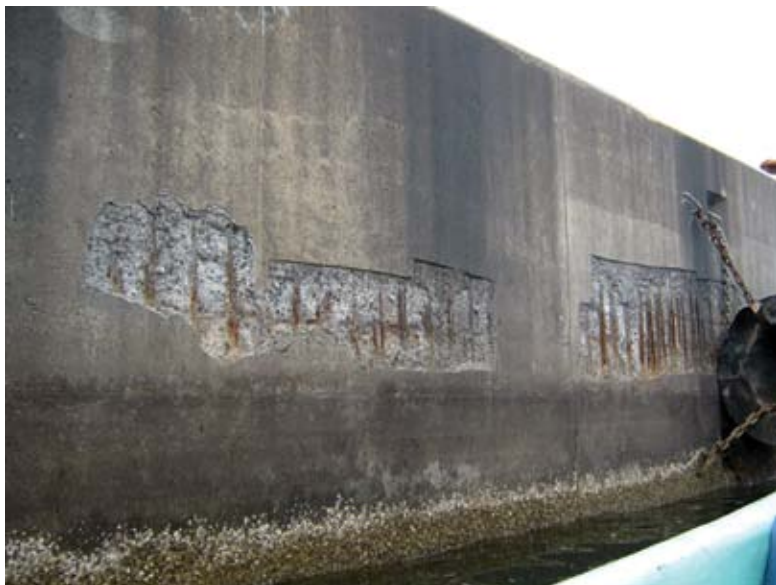
Fig. 2: Damage on the concrete sheet piling crowning beam

Maintenance records indicate that in 2007, the front part of the pier was repaired; but according to the port's staff, the repair works were incomplete, leaving several areas with exposed steel reinforcing bar (Fig. 2). Apparently, repair works limited the substitution of steel parts in the concrete structure but neglected to restore the damaged or demolished concrete. The exposed steel structure was considerably deteriorated due to corrosion.

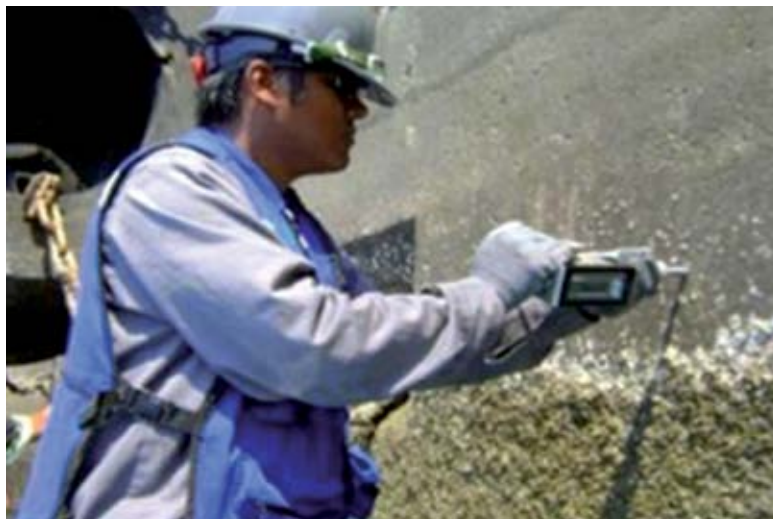
The mechanical strength of the studied concrete was evaluated using procedures described in ASTM C805. Physical impacts were made on the concrete structure using a sclerometer (Fig. 3). Results showed that the strength of the concrete was acceptable because 97% of the readings showed impact resistance values higher than 4267 psi (3 kg/mm²), while only 3% of the readings had unacceptable values (Table 1).

Fig. 3: Strength tests

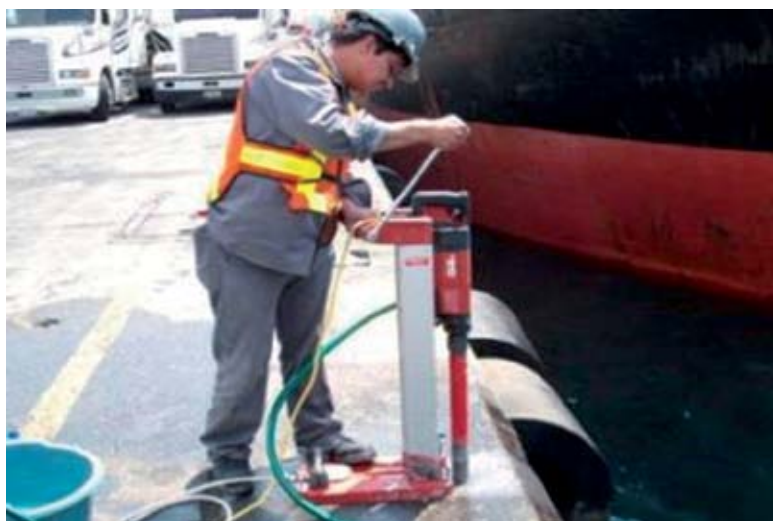
Cylindrical concrete core samples were taken from the concrete beam of the pier using a pedestal drill machine (Fig. 4). The core samples served as specimens for the study of pH, carbonation, and penetration of chloride species. The samples had between 2 to 3 in. (50 to 75 mm) in diameter and different depths, and were taken from severely damaged sections and from areas where concrete appeared in good condition. To retrieve the concrete cores as near as possible to the internal steel reinforcing bar, a metal detector was used. The specimen cutting, preparation, and analysis were performed according to ASTM C42.

Fig. 4: Concrete core removal

The chemical analysis of the concrete samples indicated that there was no significant amount of carbonate species, but the chloride content was above the recommended limit of 0.025% by weight in almost all of the core samples (Table 2). This indicated that active corrosion of the metal reinforcing bar was most likely present.

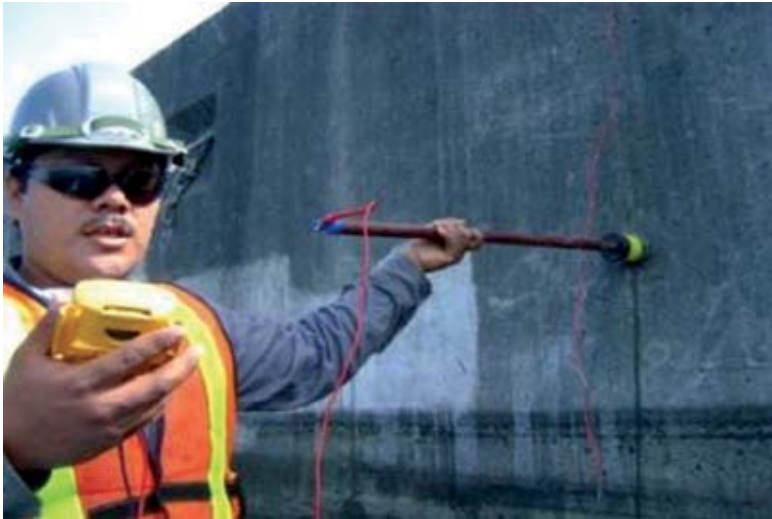
Fig. 5: Concrete core removal

of its steel reinforcing bars. The E_{corr} measurements were carried out using a standard copper/copper sulfate (Cu/CuSO₄) reference electrode connected to a high impedance input multimeter according to ASTM C876 (Fig. 5). Table 3 presents the percent of the tested concrete surface with low, moderate, and high probabilities of corrosion. The results show that less than the half of the testing points presented potentials above the low corrosion risk limit.

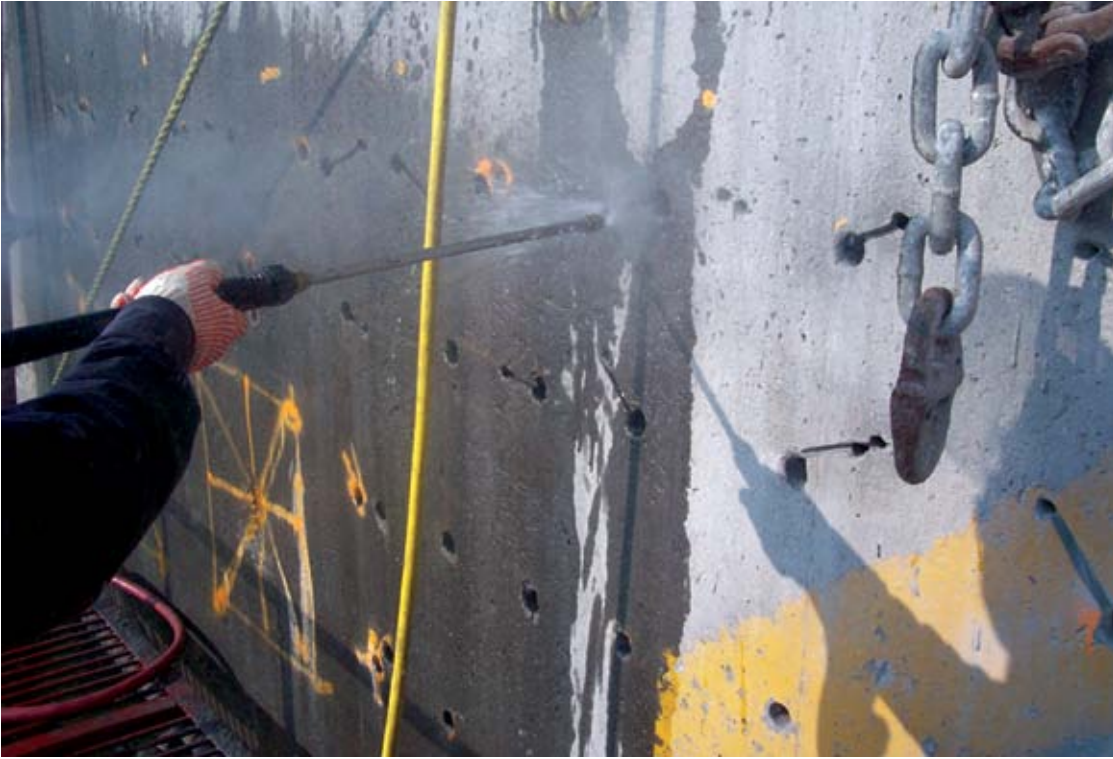
Fig. 6: Removing and cleaning concrete

- Replacement of fragile or contaminated concrete;
- Cleaning and rehabilitation of damaged or contaminated reinforcing steel (Fig. 6);
- Installation of zinc sacrificial anodes; and
- Application of a protective coating on the concrete surface.

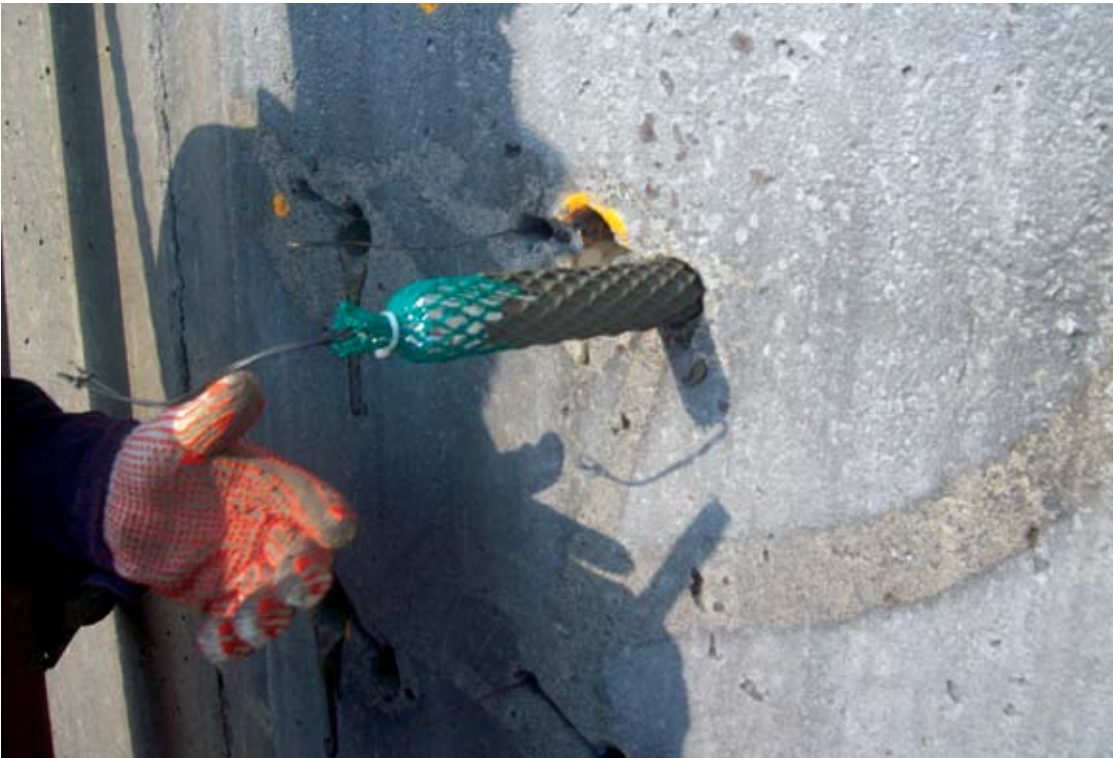
Fig. 7: Installation of zinc anodes

Photographic evidence and amounts of replaced concrete, rehabilitated steel reinforcing bar, and installed zinc anodes are presented in Fig. 7 and Table 5.

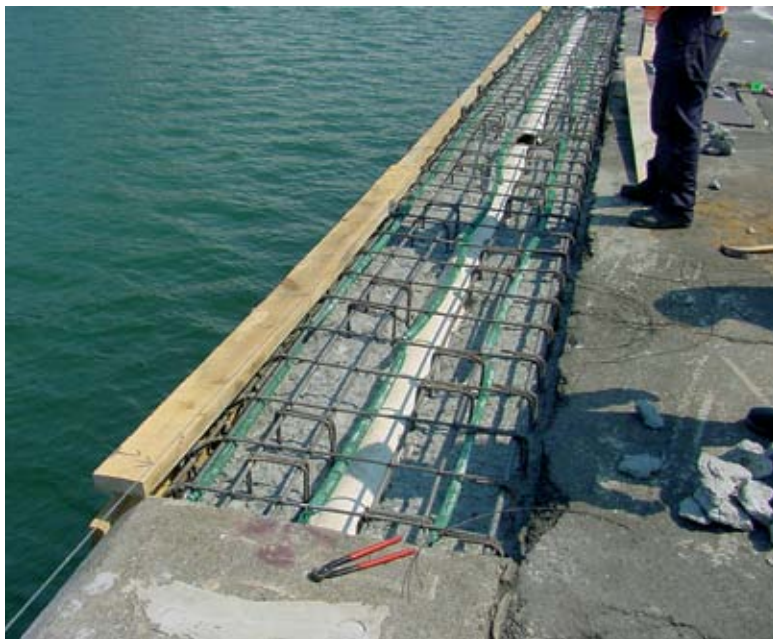
Fig. 8: Monitoring system in place

reinforcing bar repair, a cathodic protection system was installed using zinc sacrificial anodes and a protective coating was applied on the reinforced concrete structure. With the applied measures (Fig. 8), further corrosion of the reinforcing bars will be stopped, and the useful life of the repaired concrete structure will be considerably extended.

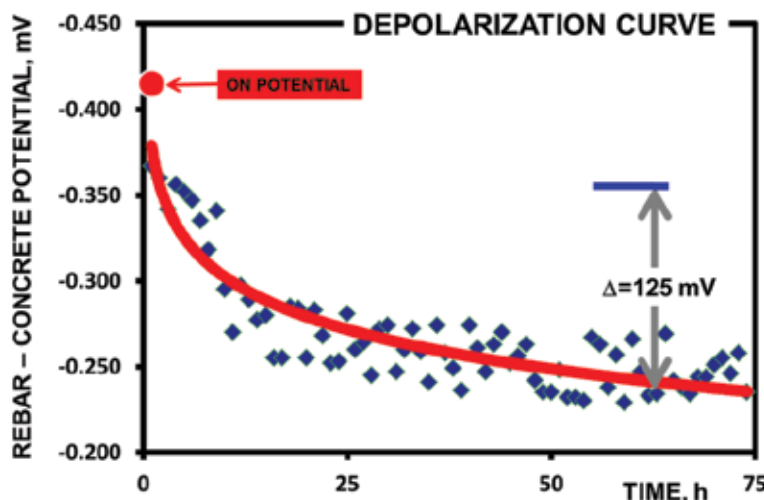
- The monitoring of current and potentials is possible in different points of the structure.
- Potential shifts were measured and compared before and after the installation of the cathodic protection system.
- Polarization curves were registered showing over 100 mV in polarization (Fig. 9).

Fig. 9: Depolarization curve
