# VENTURA PROMENADE PROJECT

BY GEORGE LEPORTE

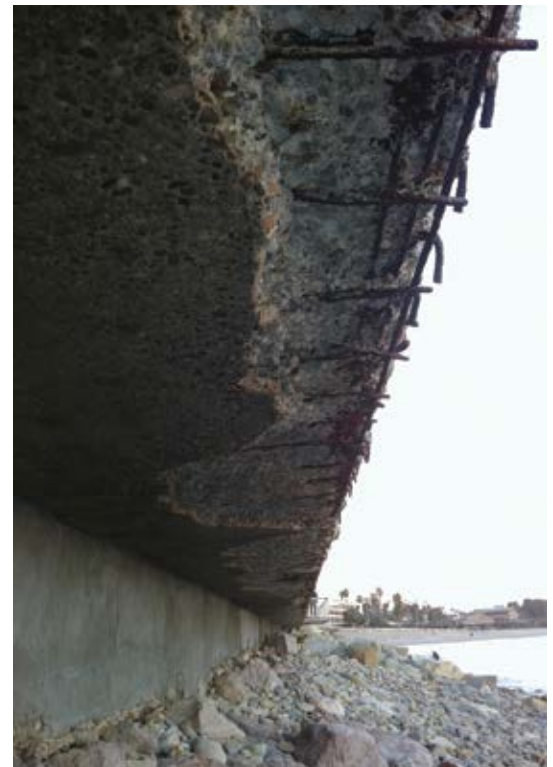
An example of king tide pounding waves can be seen in Fig. 2. These relentless waves and the constant saltwater exposure create a rigorous and demanding environment for concrete structures. These harsh conditions were extremely corrosive to the reinforcement strengthening the Promenade,

Fig. 3: Existing conditions

and the resulting expansive deterioration is one of the factors that created the need for repairs.

The 2300 ft<sup>2</sup> (214 m<sup>2</sup>) of spall repairs were scheduled to be completed in 90 days. The initial investigation (Fig. 3) led to a scope for the project that required the contractor to chip away loose concrete to a depth of approximately 2 in. (15 mm) and attach stainless steel wire mesh secured with stainless steel pins (Fig. 4). To minimize structural damage beyond the delaminated concrete, the repair crew used lightweight electric demolition hammers. The initial demolition went very smoothly because of the low October tides and the failed concrete, which practically fell off by itself (Fig. 5).

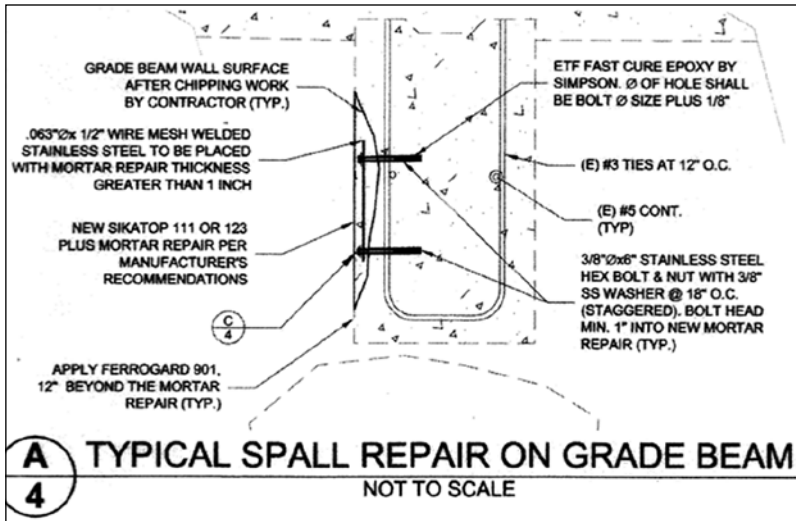
Fig. 4: Plan details

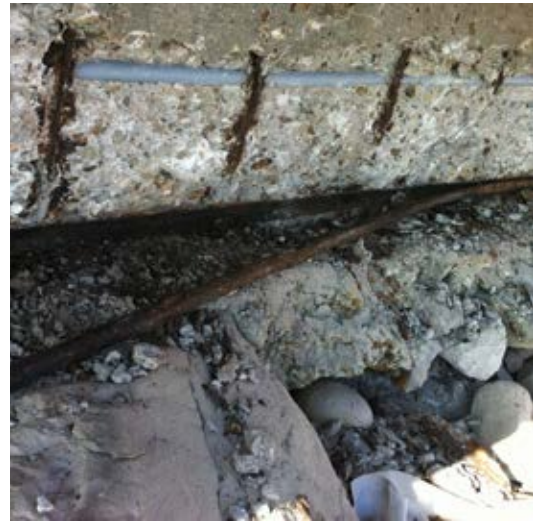
Fig. 5: Initial demolition

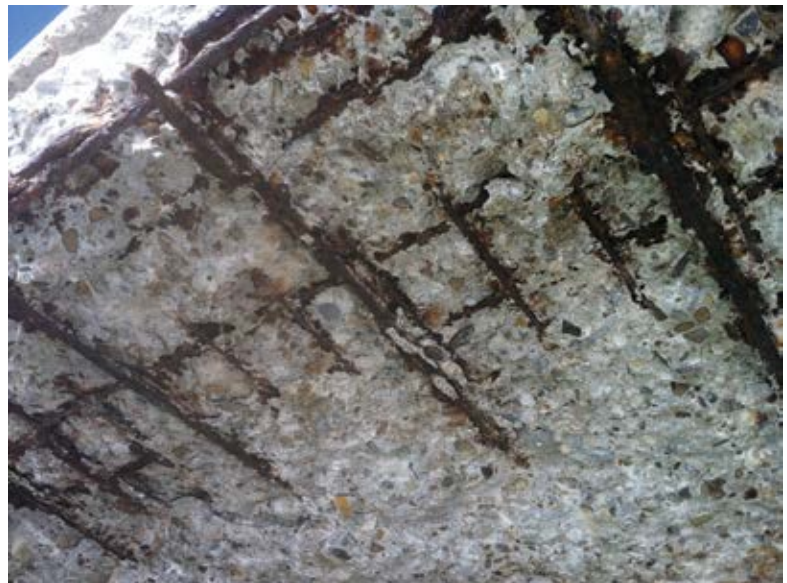
Fig. 6: Condition after initial demolition

Properly trained concrete restoration contractors are aware that all unsound concrete in the repair area must be removed or the applied patching mortar will simply fail and spall again. Most concrete failures are caused by corroded or rusted underlying reinforcement. This project was no exception. As the deteriorated concrete was removed, the depth of the spalls proved to be at least twice the depth that was anticipated and specified (Fig. 6); sometimes it reached as far back as 3 ft (0.9 m) under the cantilevered Promenade.

Because of a possible change in the scope of the project, a meeting with the engineering team was arranged to evaluate the revised conditions. The engineer agreed to follow standard repair methodologies recommended by the manufacturer, the American Concrete Institute (ACI), and ICRI. These procedures involved removing all unsound existing concrete; removing concrete behind the reinforcing steel to provide proper clearance and anchoring of the repair material; cleaning the reinforcing steel down to clean steel with a wire wheel brush; replacing reinforcement with more than 20% deterioration; coating clean steel with a heavy-duty corrosion-inhibiting primer; and patching the repair with a polymer-blended, corrosion-resistant spall repair mortar.

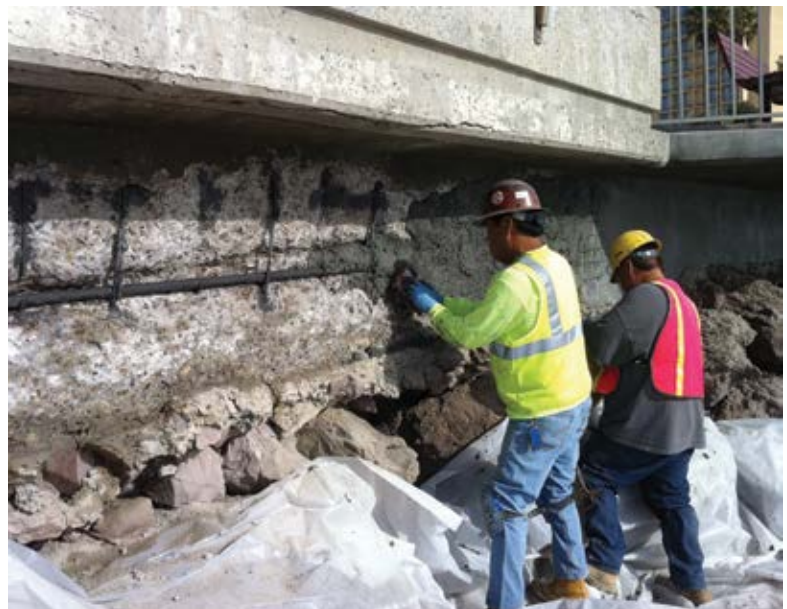
Fig. 7: Patching grade beam wall

Patching began by repairing the back “grade beam” wall spalls (Fig. 7) with a high-strength, polymer-modified mortar designed with special adhesive qualities for vertical applications. The repair mortar was also chemically treated with a rust inhibitor to further lengthen the life of the spall repair and remaining concrete wall. All of the repair products were approved for use and exposure to potable water and are environmentally stable products. Parapet nose spalls needed to be formed with a double chamfer detail with a similar, pourable mortar (Fig. 8).

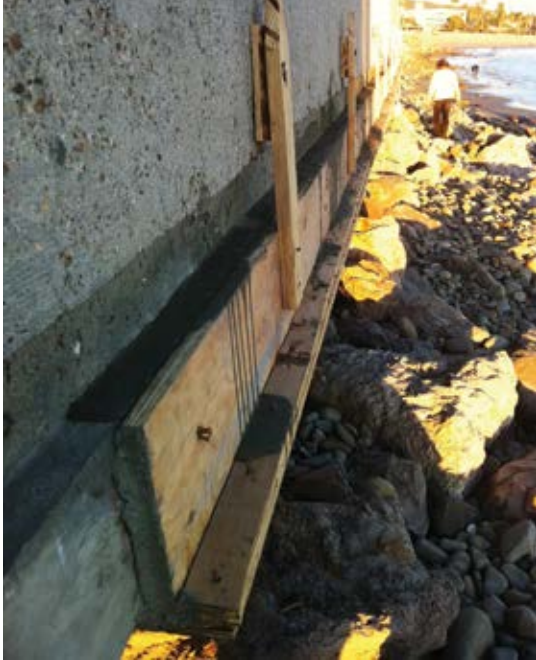
Fig. 8: Forms in place

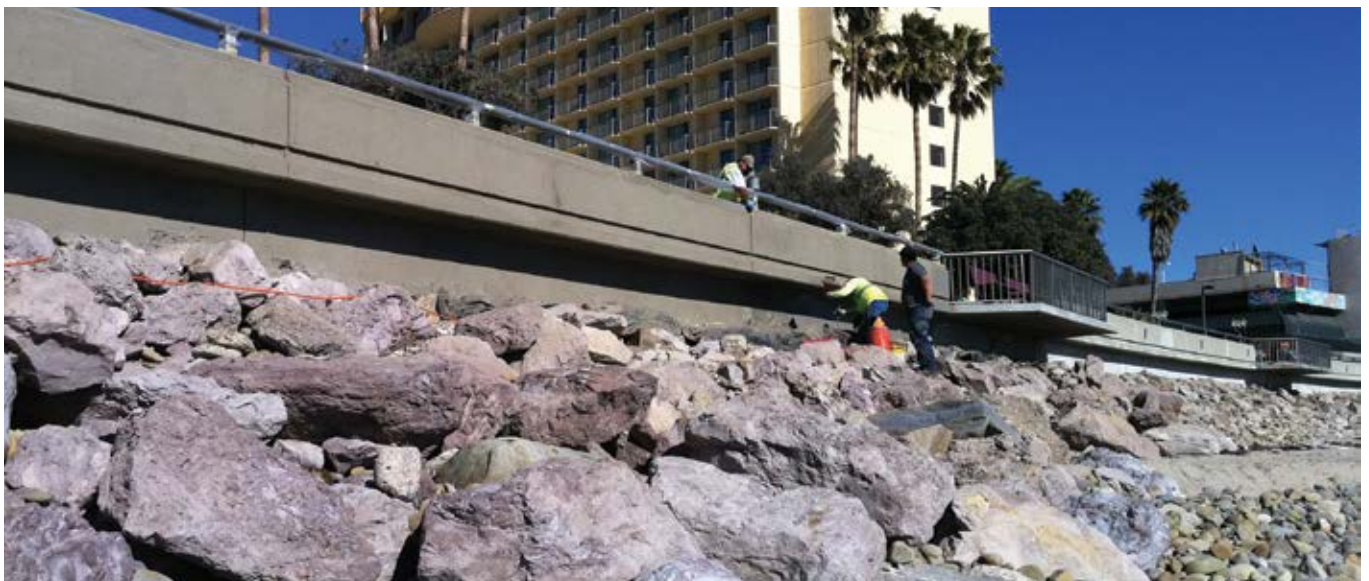
Fig. 11: Applying final finish

Once the repairs were completed, the city of Ventura required additional insurance coats of a penetrating rust inhibitor and a final protective coat of polymer-modified, cementitious, waterproof, protective slurry mortar to give the wall a uniform cementitious, waterproof finish (Fig. 11). This final coating was applied with an air compressor using a stucco hopper, and the coating was back-rolled or brushed for the final finish. Work was conducted around the high tides and work areas were protected with plastic.

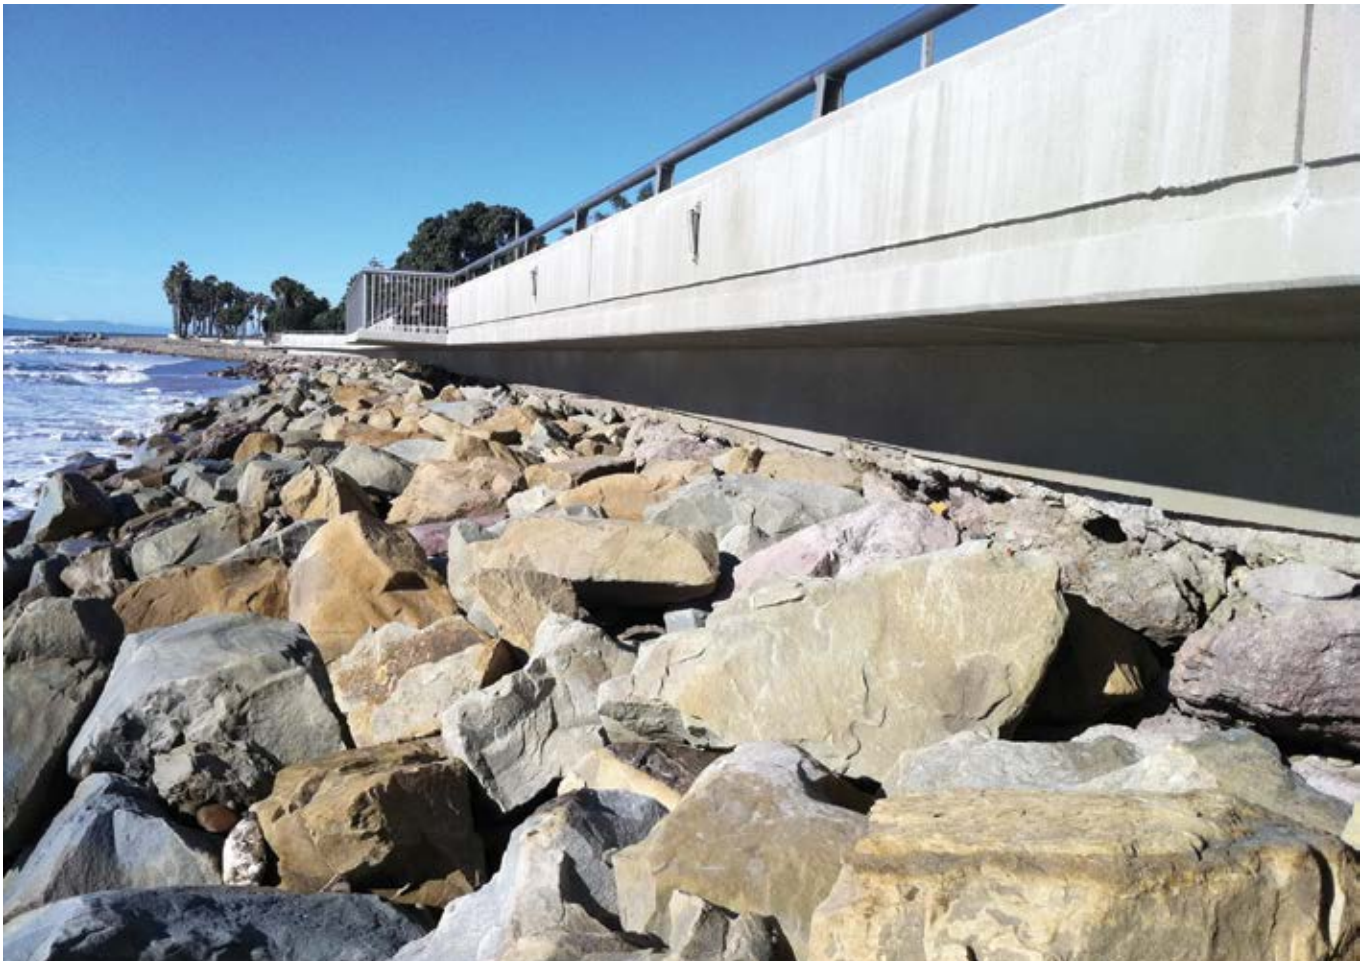
Fig. 12: Completed project

The completed project (Fig. 12) restored the beauty of the city's centerpiece and extended the life of this structure for future generations.
