CARBON FIBER-REINFORCED POLYMER REPAIR OF REINFORCED CONCRETE PIPE

BY DARYL A. LITTLE

FLAWS DISCOVERED DURING CONSTRUCTION

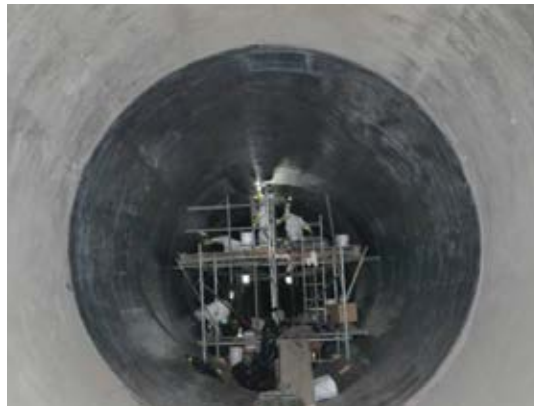
Fig. 1: Completed CFRP-lined section

The bureau determined that a CFRP lining would make the sections watertight and provide long-term serviceability despite the large rock pocket repairs that were made. CFRP has good wear and impact resistance; and because it is capable of handling the external and internal loads, the safety factor for the barrel sections was increased. Based on the bureau's suggestion, the contractor agreed to line those sections with CFRP. Figure 1 shows a completed section of the lined siphon.

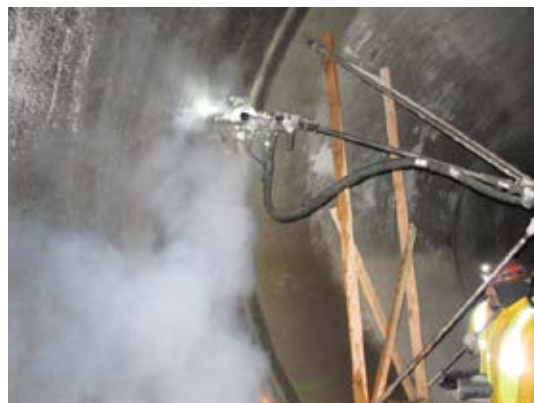
Fig. 2: High-pressure hydroblasting

The concrete surface was prepared using high-pressure water cleaning, or hydroblasting, in accordance with the ASTM D4258 water cleaning method. This procedure removed the surface laitance and provided a concrete surface profile of

Level 3 per ICRI Technical Guideline No. 310.2. Hydroblasting the concrete surface is shown in Fig. 2, whereas Fig. 3 shows the surface of the pipe after the water cleaning work was completed. The lighter areas seen in Fig. 3 are the locations that were repaired prior to hydroblasting. Then, the equipment was set up to dehumidify the pipe, dry the walls, and ventilate the work area.

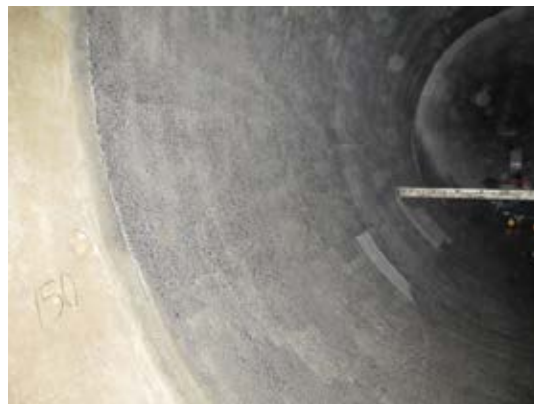
Fig. 3: Hydroblasted surface

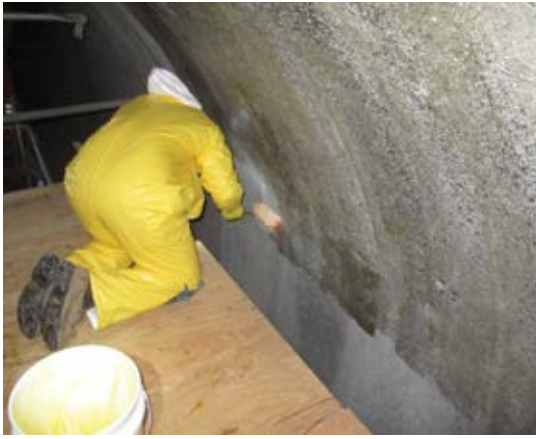
Fig. 4: Application of epoxy primer

The need for personal respirators was eliminated because all of the epoxies used in the application of the carbon fiber were 100% solids and contained no solvents or volatile organic compounds (VOCs). All epoxies were mixed outside (in the open air) prior to transport into the pipe, and an epoxy primer was applied using paint rollers, as shown in Fig. 4. After the primer was rolled on, saturation epoxy was applied to the surface using trowels (Fig. 5).

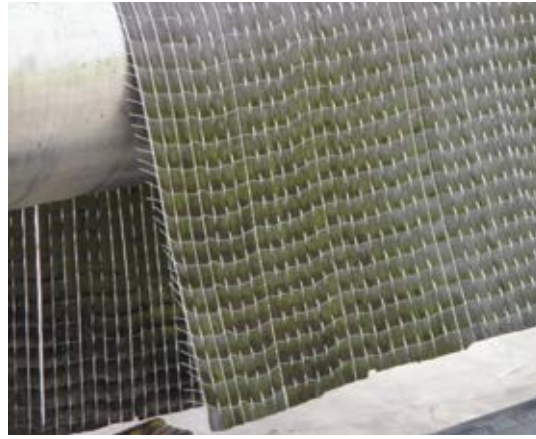
Fig. 6: Unidirectional carbon-fiber fabric

The carbon-fiber fabric is shown in Fig. 6 and had a unidirectional carbon-fiber weave. Large rolls of fabric were saturated with epoxy using a saturation machine (Fig. 7) and rolled onto plastic pipes. As the fabric was being rolled onto the pipe, it was also cut to the appropriate length for installation. The saturated fabric rolls were then wrapped in

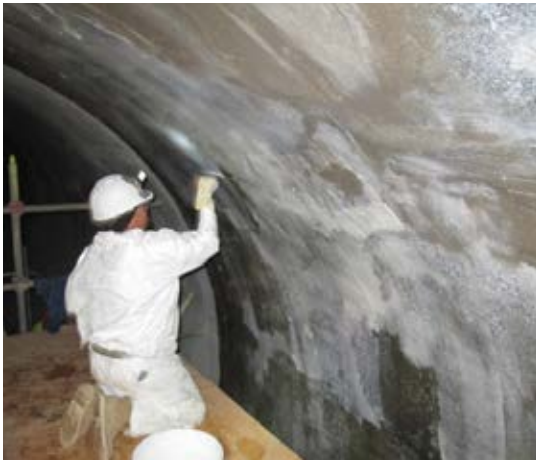
Fig. 5: Application of saturation epoxy

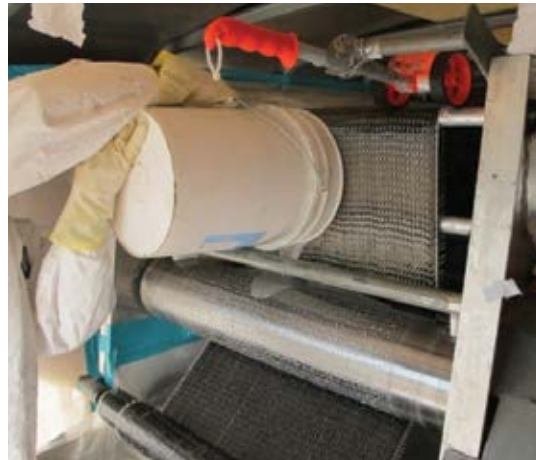
Fig. 7: Saturation of carbon-fiber fabric

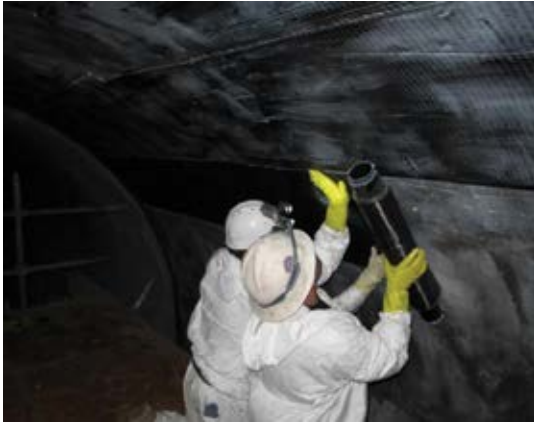
Fig. 8: Longitudinal application of fabric

The design of the proposed liner specified three layers of fabric for the installation. The CFRP was installed by first unrolling fabric in the longitudinal direction, as shown in Fig. 8. The second and third layers were then applied by unrolling the fabric in the hoop direction (shown in Fig. 9). The number of hoop layers required is dependent on the structural requirements of the CFRP repair. Air pockets and wrinkles were smoothed out of the fabric using putty knives and hands, as shown in Fig. 10. After each layer of fabric was applied, the saturation epoxy was troweled onto the surface (Fig. 11).

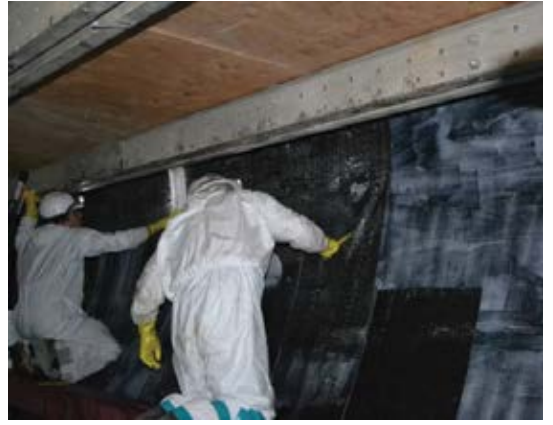
Fig. 10: Smoothing out fabric

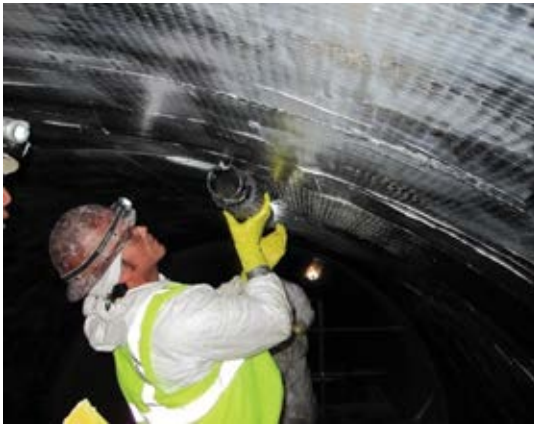
Fig. 9: Applying fabric in hoop direction

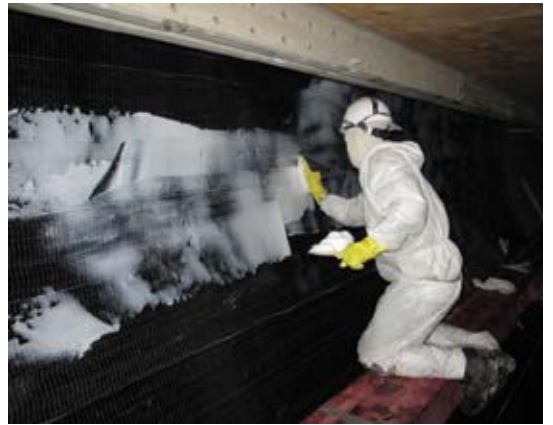
Fig. 11: Application of saturation epoxy

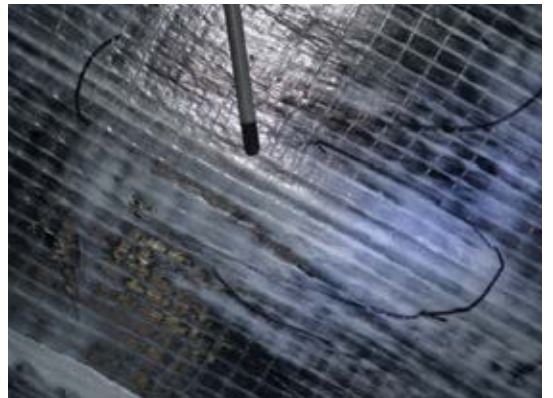
After the CFRP had cured for 24 hours, it was inspected for bubbles, delaminated areas, and fabric tears using a sounding method. Repair areas (Fig. 12) were identified and repair methods selected based on the size of the defect. Defects smaller than 2 to 3 in. (50 to 76 mm) were repaired by drilling a hole in the defect (Fig. 13) and injecting saturation epoxy (Fig. 14). For defects larger than 2 to 3 in. (50 to 76 mm), the delaminated layers of CFRP material were removed as shown in Fig. 15, and squares of saturated fabric for each layer removed were applied to the surface (Fig. 16).

Fig. 12: Delaminated areas identified for repair

The patch applied was larger than the defect with a 4 in. (102 mm) overlap, and each additional layer of fabric applied had a 4 in. (102 mm) overlap onto the previous layer. The CFRP will be inspected after 1 year of service and then every 5 years during the required pipe inspection.

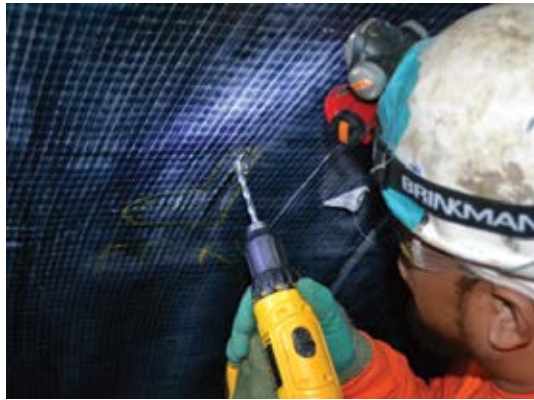
Fig. 13: Hole being drilled for epoxy injection

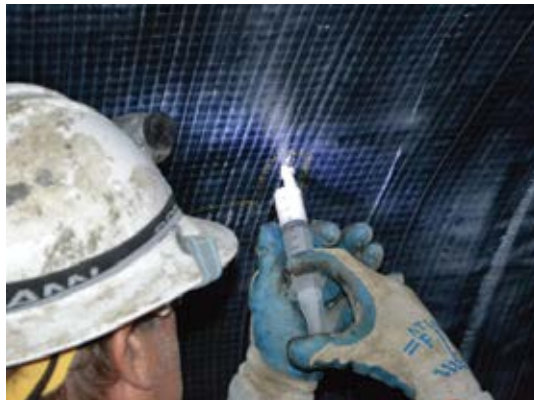
Fig. 14: Epoxy being injected

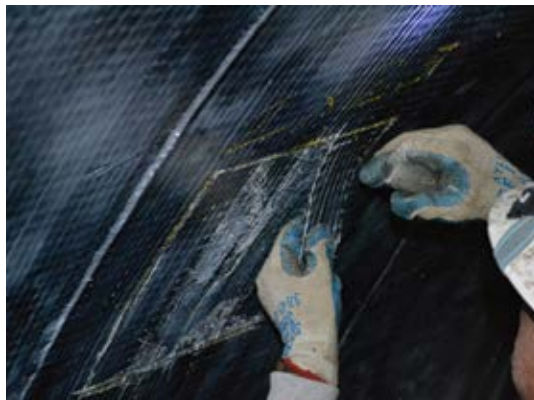
Fig. 15: Cutting out delaminated layers

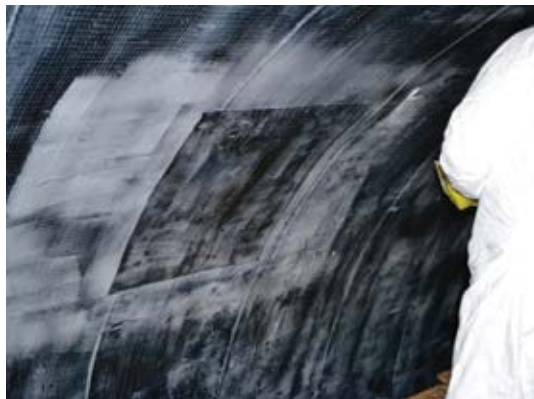
Fig. 16: Patch repair of delaminated area
