# Maynard Street Parking Structure Renovation and Restoration

Award of Excellence Winner,  
Municipal Category

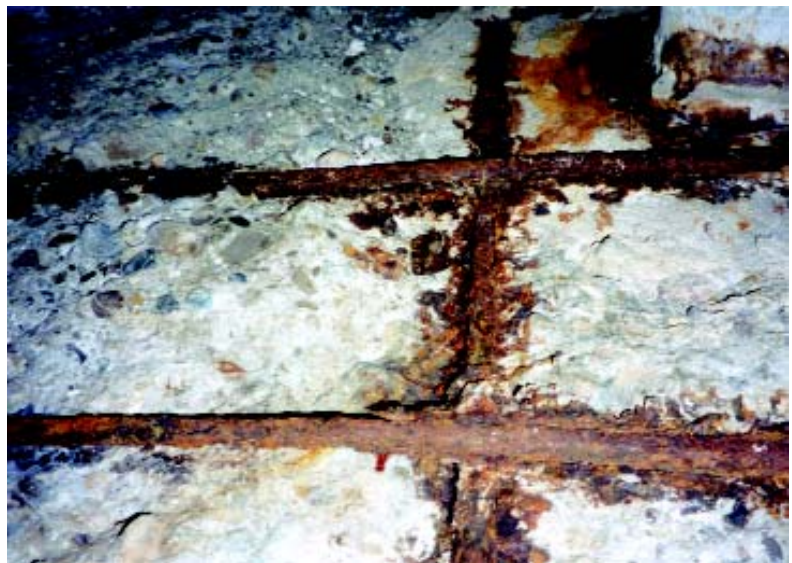
- *Supported Floor Survey* – A chain drag was completed on all supported slab surfaces. The chain drag revealed that in areas not restored in 1991, 27% of the floor area was delaminated on the top side of the floor surface.
- *Ceiling Survey* – A detailed visual review and selective sounding of the underside of the floor slab and beams were completed. Approximately 5% of the underside of the floor slab was

Spalled floor surface

- Full-depth slab replacement on 135,000 square feet of the deck surface. New state-of-the-art concrete slab specifications called out for two inches of concrete cover, low-permeability concrete, corrosion-inhibiting admixtures, and crack-controlling fibers.
- Microsilica concrete overlay on 20,000 square feet.
- Deck areas that were not replaced were repaired with conventional patches.
- The drainage in the entire structure was improved by providing increased sloping of the decks and replacing the drainage system.

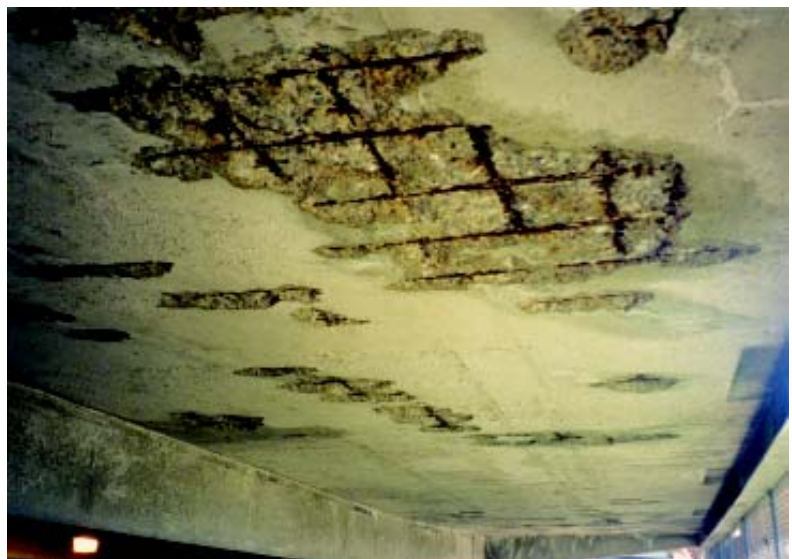
Ceiling spalls

delaminated along with over 500 square feet of beam delamination. There were also found to be approximately 2,000 square feet of column delamination and 500 square feet of wall delamination.

Because of the complexity of the restoration, several different application methods were used. Shotcrete was used for most ceiling repairs of reasonable size. Smaller ceiling areas were completed with trowel-applied repair mortars. For the beam/column repairs, a combination of form-and-pour shotcrete and trowel-applied mortars were used, depending on the size and the location of the

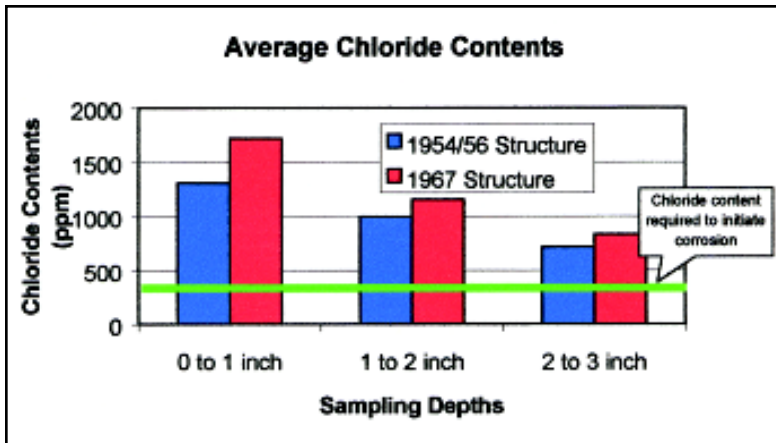
Figure 2: Chloride ion concentrations

- *Compressive strength testing* – The average concrete compressive strength of the 1967 portion of the structure was 3,583 psi. The average concrete compressive strength of the 1954/56 portion of the structure was 5,830 psi.
- *Petrographic analysis* – Testing on cores revealed that the concrete in the structure was of marginal to poor quality with relatively low air contents and high water/cement ratios.
- *Chloride Ion Analysis* – Chloride concentrations of approximately 300 to 400 parts per million (ppm) along with the presence of moisture and

oxygen are needed to support corrosion of mild steel reinforcement in concrete. The chloride ion concentrations are shown in Figure 2.

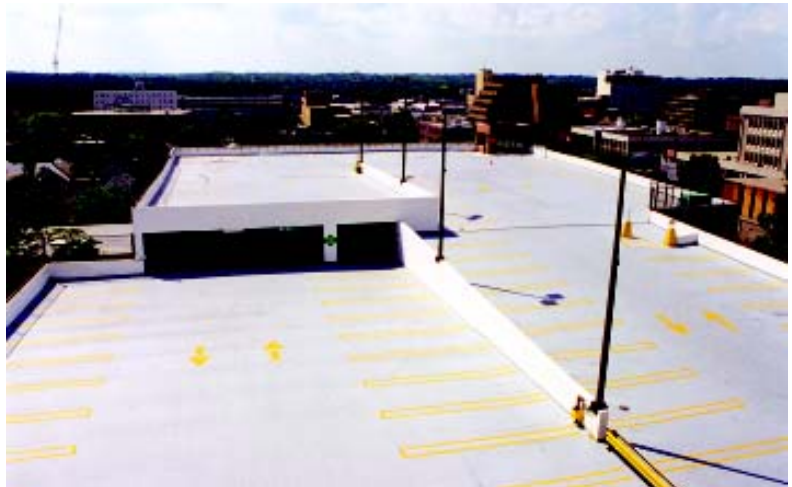
*Completed rooftop deckcoating*

- The entire 250,000 square feet of deck surface received a waterproofing membrane.
- Deterioration in the columns and walls was repaired.

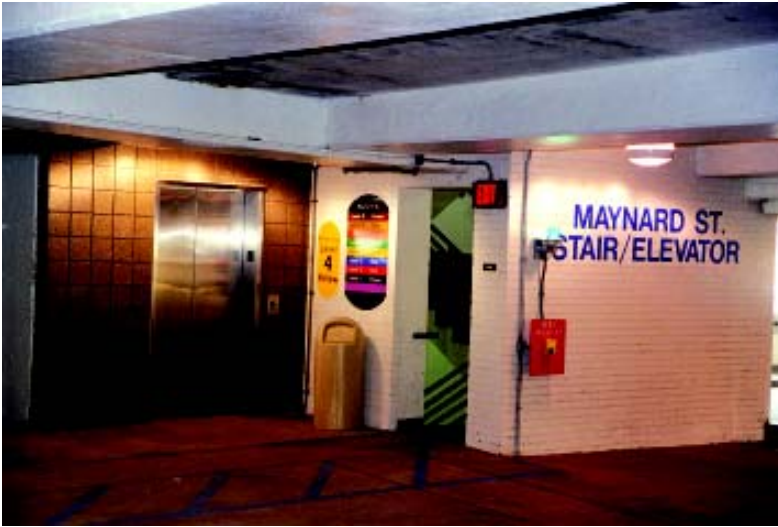
The small 1967 elevator had numerous breakdowns, causing people to walk up to eight flights of stairs. In addition, the size of the elevator cab prohibited wheelchair use and limited the occupancy to a maximum of 3-4 people. The area surrounding the elevator was also poorly lit.

*New elevator/stair area with new signage*

Finally, the 1967 vintage electric traction elevator was replaced with a large ADA-compliant stainless steel elevator. Installation of the new elevator required enlargements and structural modifications to the elevator shaft. The elevator shaft also had to be extended vertically by 10 feet to accommodate the new elevator machine room.

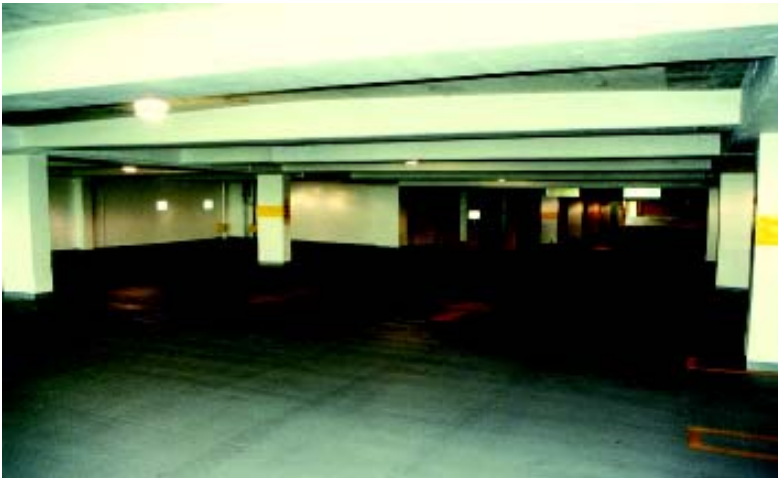
- *Lighting Review* – Light levels were measured at key areas of the structure to compare the existing light levels to recommended light levels for parking structures by the Illuminating Engineering Society (IES). The existing high-pressure sodium lighting was inadequate at cross-overs, entry/exit areas, and in the stair towers.

*New interior lighting makes brighter driving and parking areas*

The lighting was also improved in all full slab replacement areas, which received new metal halide

lights. Lighting in the remaining areas of the structure remained the previous high-pressure sodium type, but was supplemented with salvaged fixtures from the full slab replacement areas.
