Challenges of a Chloride-Laden Parking Garage Repair

A 1500-car garage occupies all three subterranean levels of Building 10, a 15-story medical research facility on the National Institutes of Health (NIH) Bethesda, Maryland, campus. Building 10's central location and high density make it a prime parking location for employees, visitors, and patients.

NIH Parking Garage

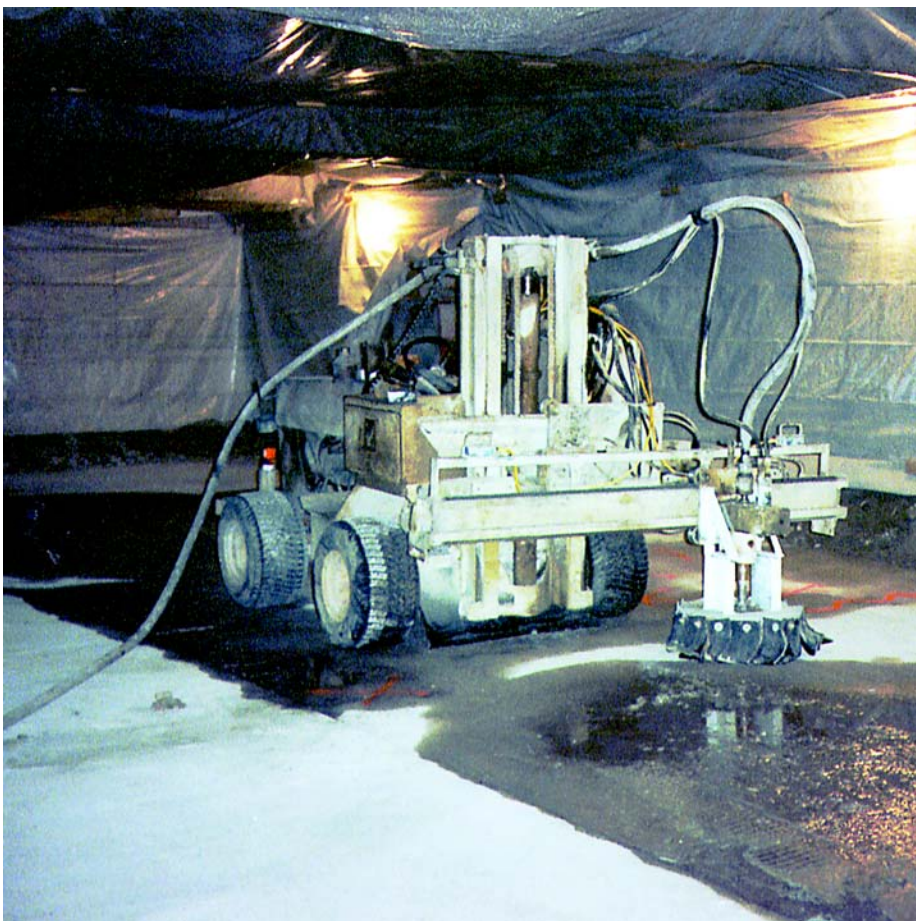
Remote-controlled Hydrodemolition Robot

Vibration, noise, and dust concerns resulted in selecting hydrodemolition for concrete removal. Jackhammering was scheduled only during off-hours to address small areas unsuitable for hydrodemolition. Large diesel engine-driven pumps raised the hydrodemolition water pressure from 70 to 20,000 psi (0.48 to 138 MPa) and it easily cut the 5000 psi (34 MPa) concrete. The pumps and engines were placed in a corner of the lowest level in the garage and surrounded by two sets of masonry walls to reduce noise. The diesel engines' exhaust and fan-cooled radiators were placed 100 ft (30 m) away, above grade, in a small enclosure that blended into the campus.

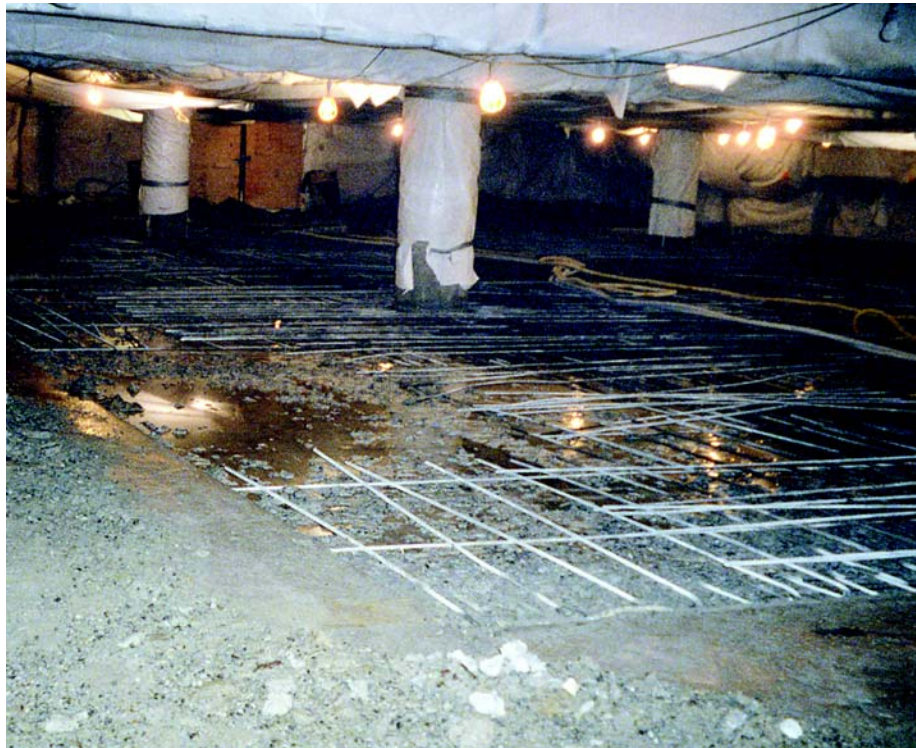
The garage, built in 1979, was identified as needing repairs in 1992. Completing repairs prior to occupying an 850,000 ft² (79,000 m²) horizontal hospital addition was a key goal because the garage would become the primary entry for patients and visitors. Investigation by the original parking consultant identified that 2/3 of the garage floor slab was chloride contaminated within the top 4 in. (10 cm). Further investigation also identified that the remaining slab was contaminated full depth because a salt-laden accelerator was used in the original concrete mixture.

Exposed top steel after hydrodemolition

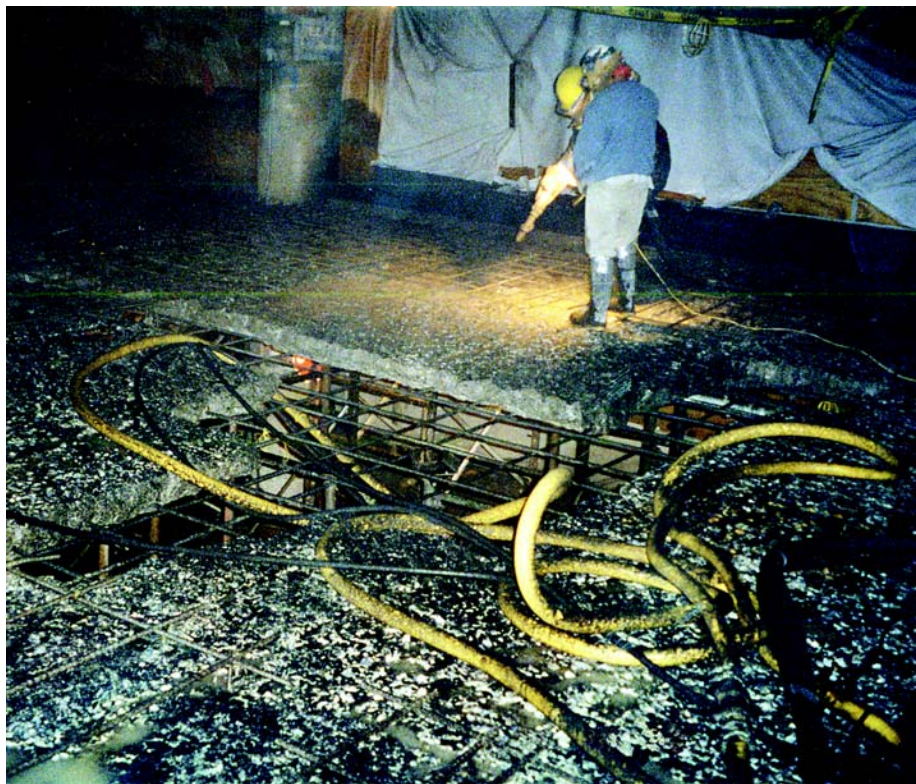
Cleaning of steel after hydrodemolition

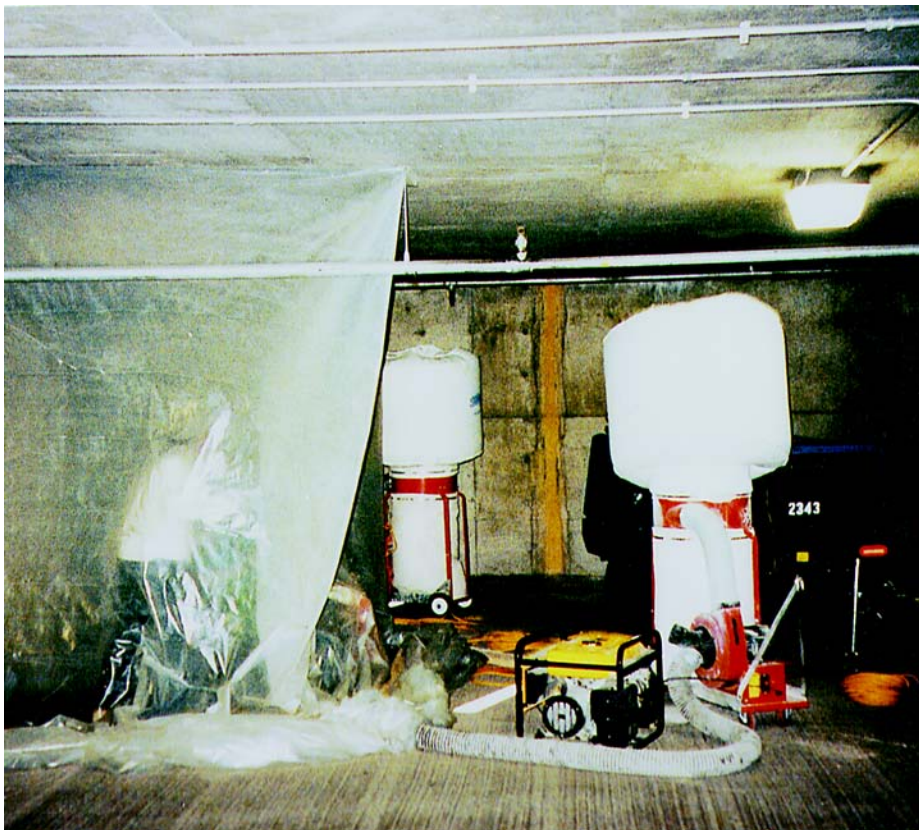
Shotblasting of column area inside containment before receiving coating

This structural system inherently cracks, and the areas near columns have high concentrations of microcracks and embedded steel near the surface. The second upgrade consisted of installing 10 x 10 ft (3 x 3 m) squares of traffic topping at columns. By coating around the columns, this most vulnerable area was protected at a greatly reduced cost.

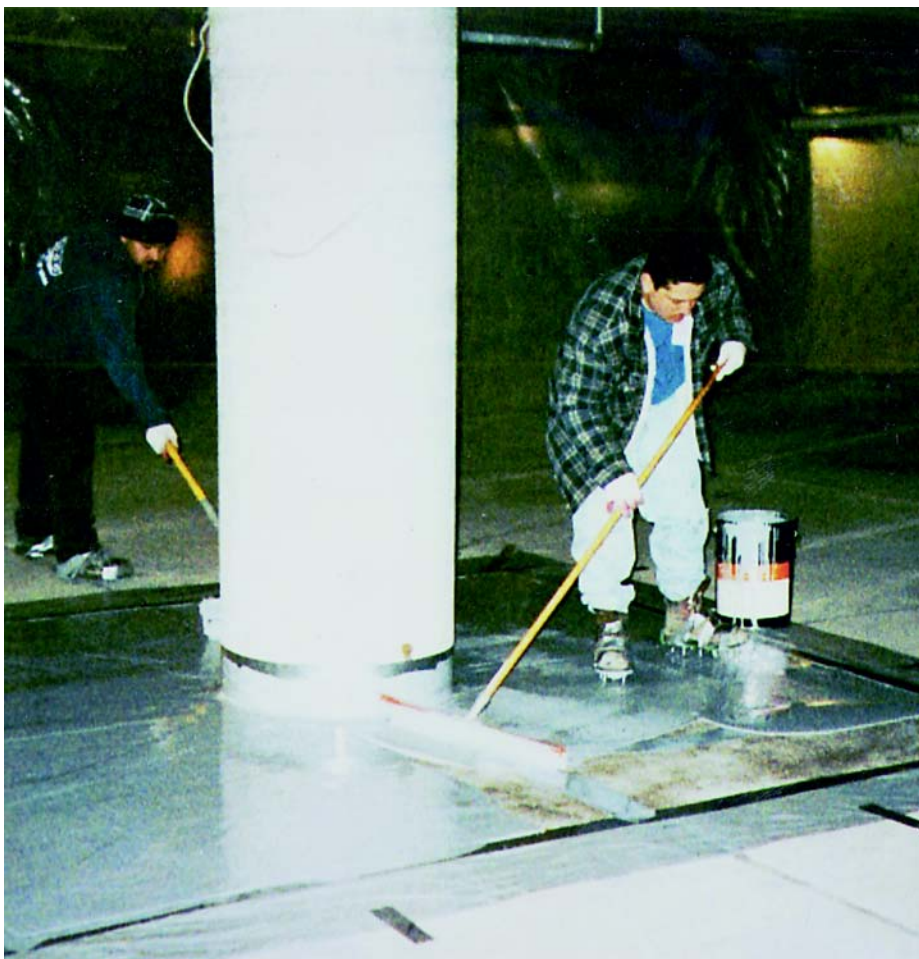
Column area after concrete repair receiving coating

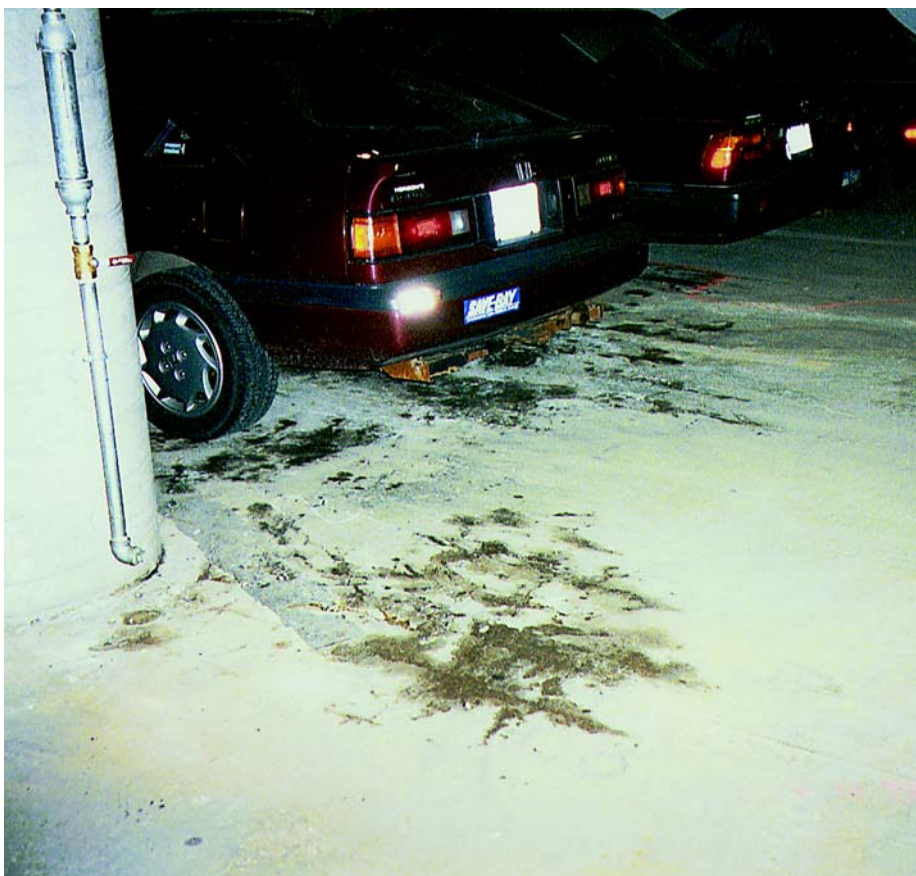
Column area before concrete spall repair

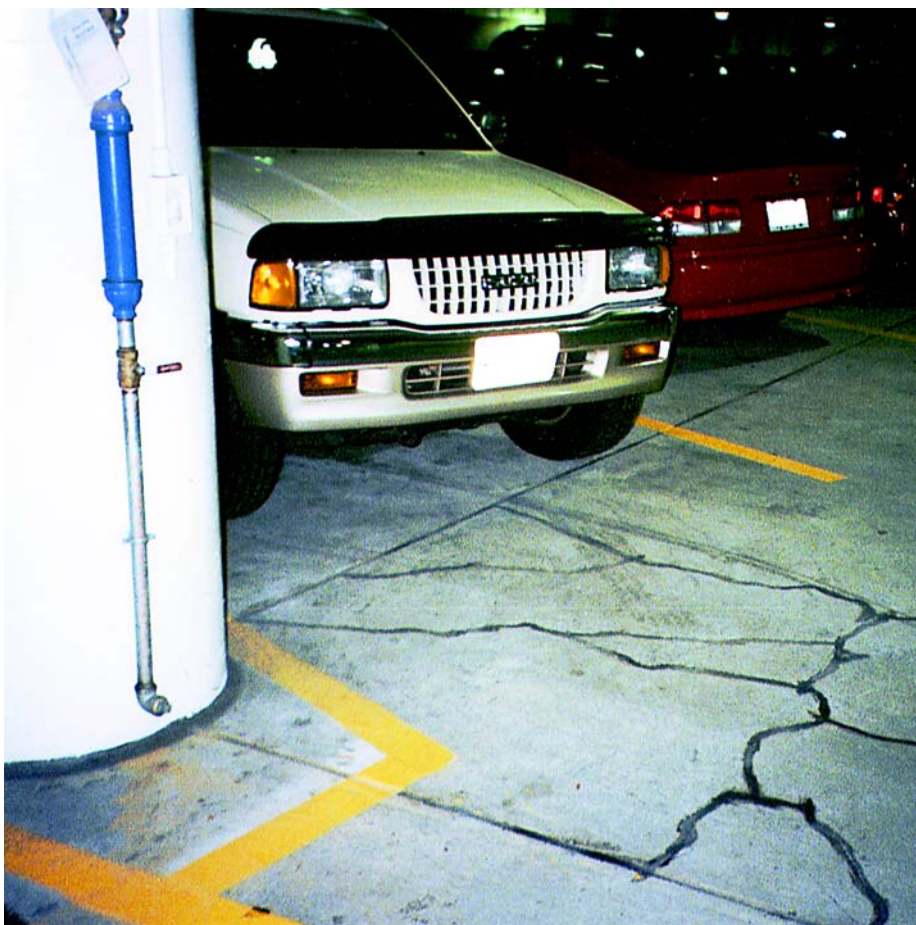
Column area after concrete repair
