Repairs Extend Service Life

Euclid/Regent Autoparks

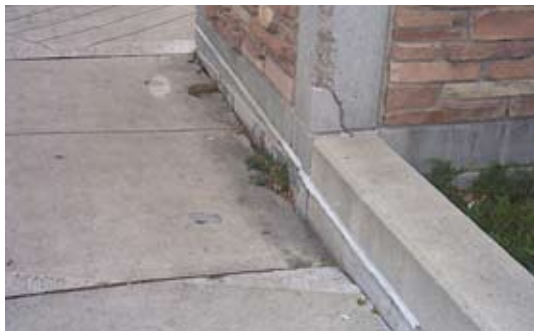
Of primary concern to the university was the settlement of the soil surrounding both autoparks, which resulted in broken and misaligned concrete. These misaligned sidewalks had resulted in tripping hazards and were a great liability to the university.

Settling sidewalks

Rigid polyurethane injection grout was pumped below the concrete slabs to lift and stabilize the settlement of the sidewalks and equipment pads.

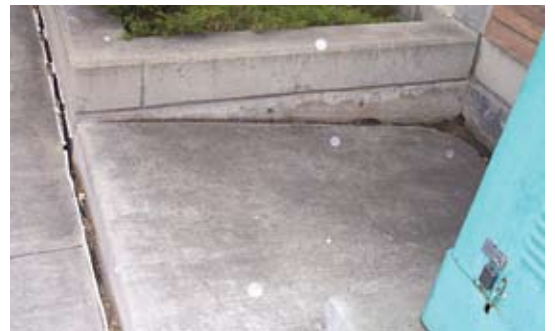
Also, at both autoparks, equipment support pads had tipped in toward the structures, resulting in damaged gas, electrical, and water lines.

Settling equipment pad

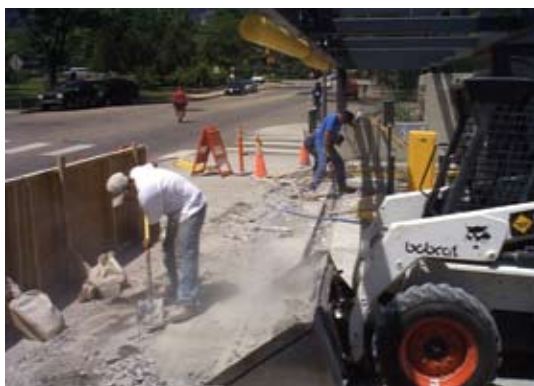
Lightweight equipment was used

For the concrete replacement areas, light equipment was used in the demolition. Fifteen-

pound jackhammers were used to minimize the damage to the surrounding concrete.

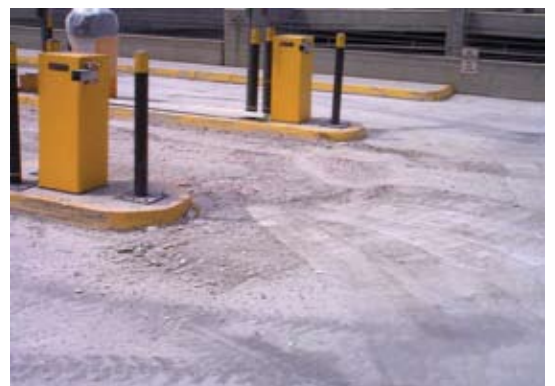
Shotblasted surface

Shotblasting was used to clean all areas receiving a silane or epoxy sealer.

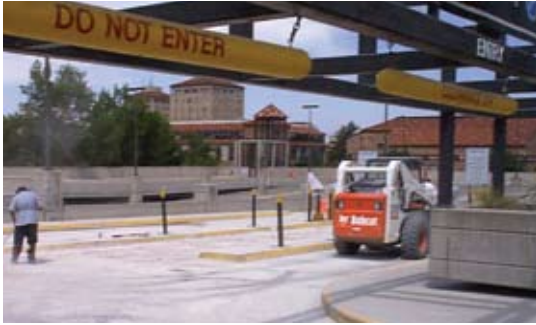
Slab prepared for deck coating

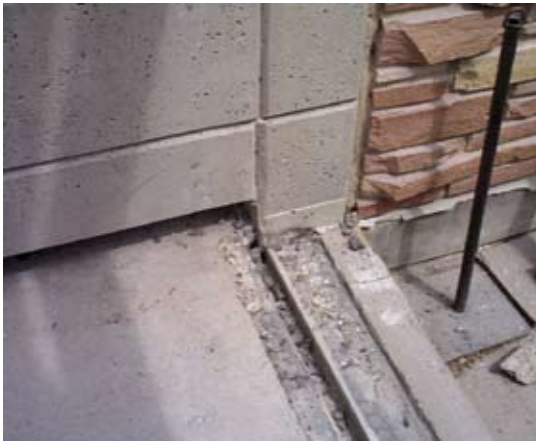
Expansion joint preparation

Where there were expansion joint blockouts, the existing delaminated concrete was removed and new blockouts and anchorages were cast onto the floor slab to support the new expansion joint system.

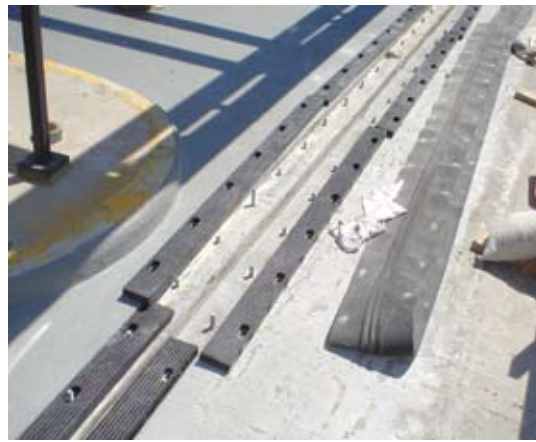
Expansion joint installation

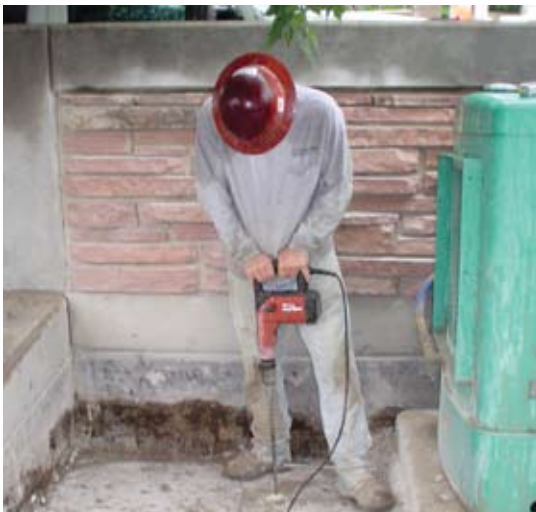
Drilling of injection ports

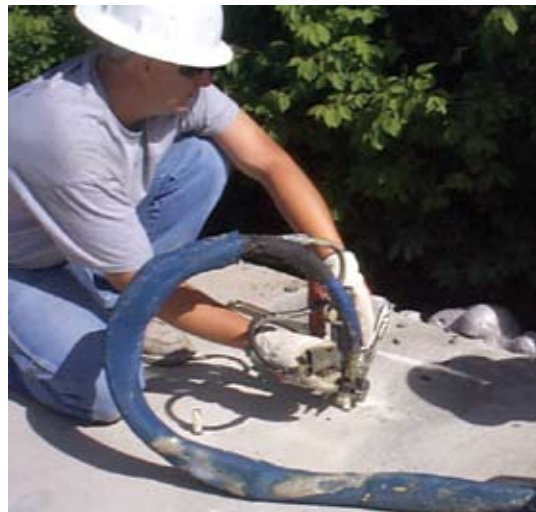
Pressure injection of grout

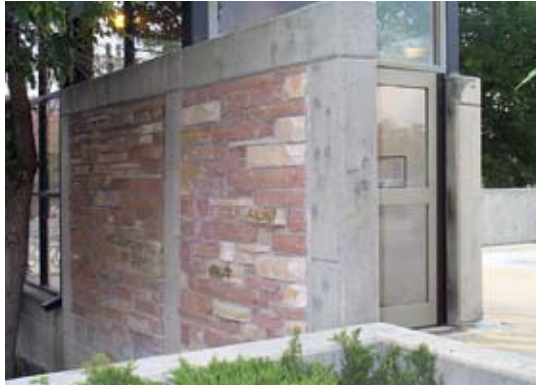
Exterior face and corner

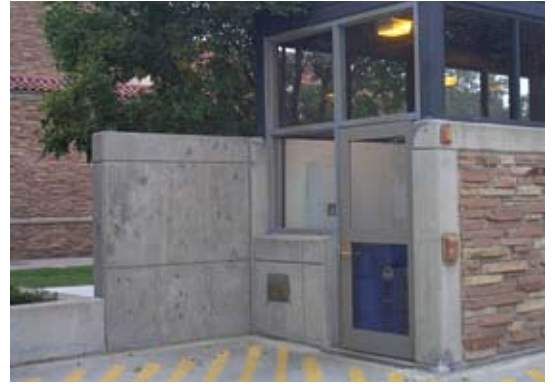
Interior face of wind wall

- Vehicular restraint system—The existing barrier restraint systems were tightened and strands were added for safety and code compliance;
- Patron safety—A concrete wind wall was constructed to shield a stair tower from the westerly winds. Flagstone was incorporated on the exterior face to blend with the existing walls; and
- ADA compliance—ADA ramps were updated when the sidewalks were replaced.
