# Philadelphia School Bus Parking and Repair Facility

**T**he Broad Street Bus Garage, located in Philadelphia, PA, was built in the late 1950s. The structure is a two-story building with a slab-on-ground lower level, a waffle slab second floor, and a steel framed roof with block and brick masonry wall construction on the exterior. Each level consists of approximately 60,000 ft<sup>2</sup> (5575 m<sup>2</sup>) of open space.

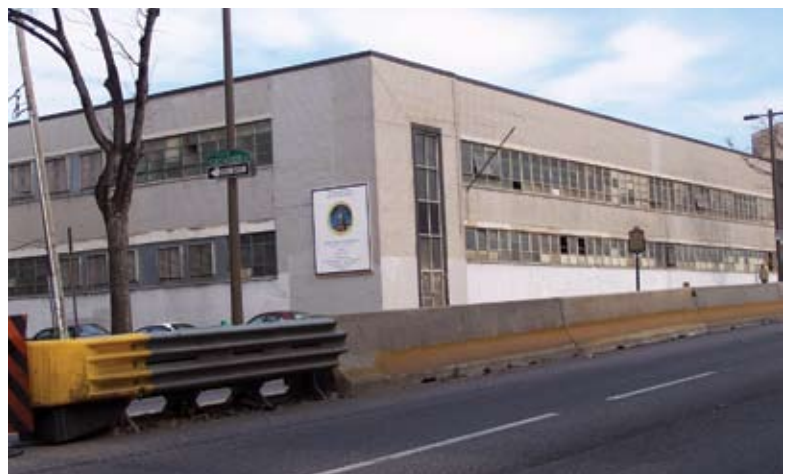
*Exterior of school bus garage facility*

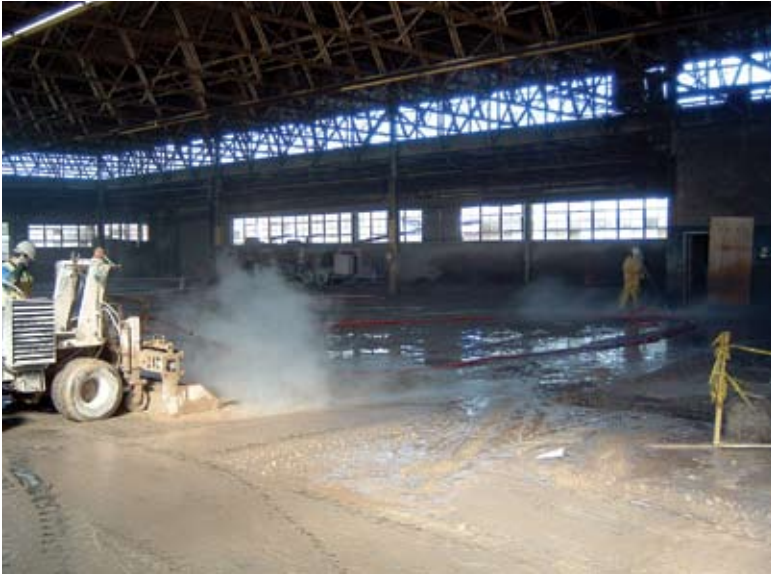
*Hydrodemolition of deck*

Hydrodemolition was used to profile 45,000 ft<sup>2</sup> (4180 m<sup>2</sup>) of the existing second floor concrete slab as well as 5000 ft<sup>2</sup> (465 m<sup>2</sup>) of full-depth removal. Sandblasting was used to clean the underside of the waffle pan configuration of the same floor. The minimum removal depth was 1 in. (2.5 cm), but delamination existed beyond that depth. In fact, this process revealed the necessity for full depth replacement in some areas of the floor.

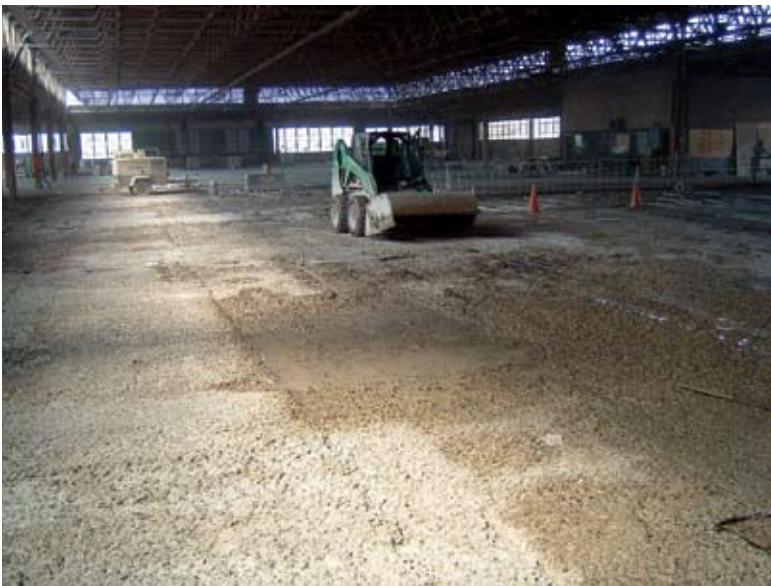
*Deck after hydrodemolition*

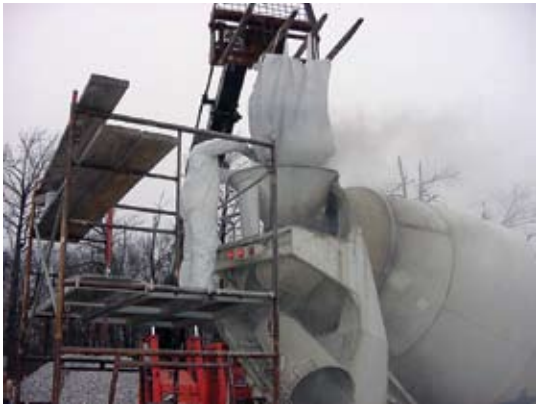
*Mixing super sacks into concrete trucks*

Nine of the super sacks of dry bagged material were emptied into the concrete truck at a site approximately 30 miles (48.3 km) west of the job site in New Jersey. There were days during the project that 18 trucks were lined up in succession with dry material waiting to be mixed and placed. Water was added, proportionately to the requirements of the material, to the mixture in the truck at the project site. The concrete was then mixed and pumped into the building with a concrete pump. The specification required an independent testing agency to test and inspect at least one composite sample for each 100 yd<sup>3</sup> (76 m<sup>3</sup>) of each concrete mixture placed each day.

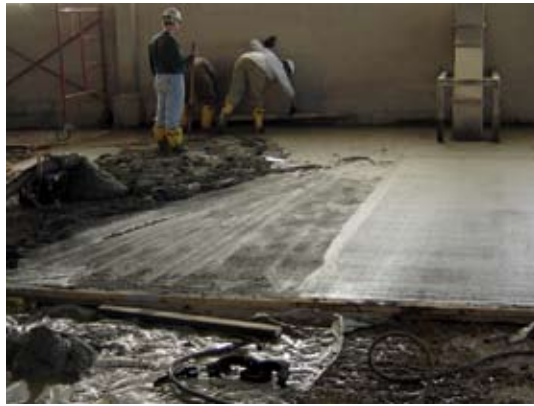
*Placing pumped concrete*

and a concrete pump would be used to pump the material through the window openings onto the slab area.

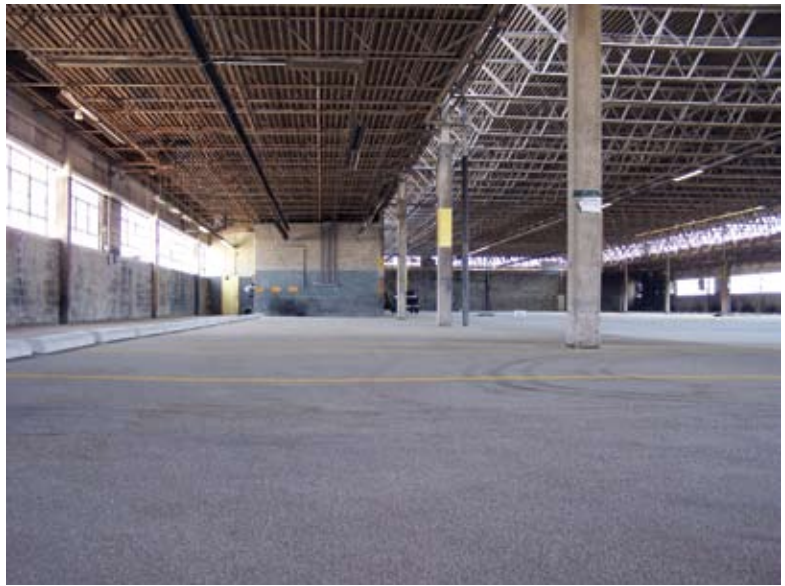
*Bus terminal repair completed*
